Reviving the Concrete Giants: The Role of Structures as Building Enclosures

By Patrick E. Reicher, REWC, REWO, CCS, CCCA, SE; Demetria E. Boatwright, PE, SE, CDT; and Colin P. Rueb, PE, SE, CDT

This article was presented at the 2024 IIBEC International Convention and Trade Show.

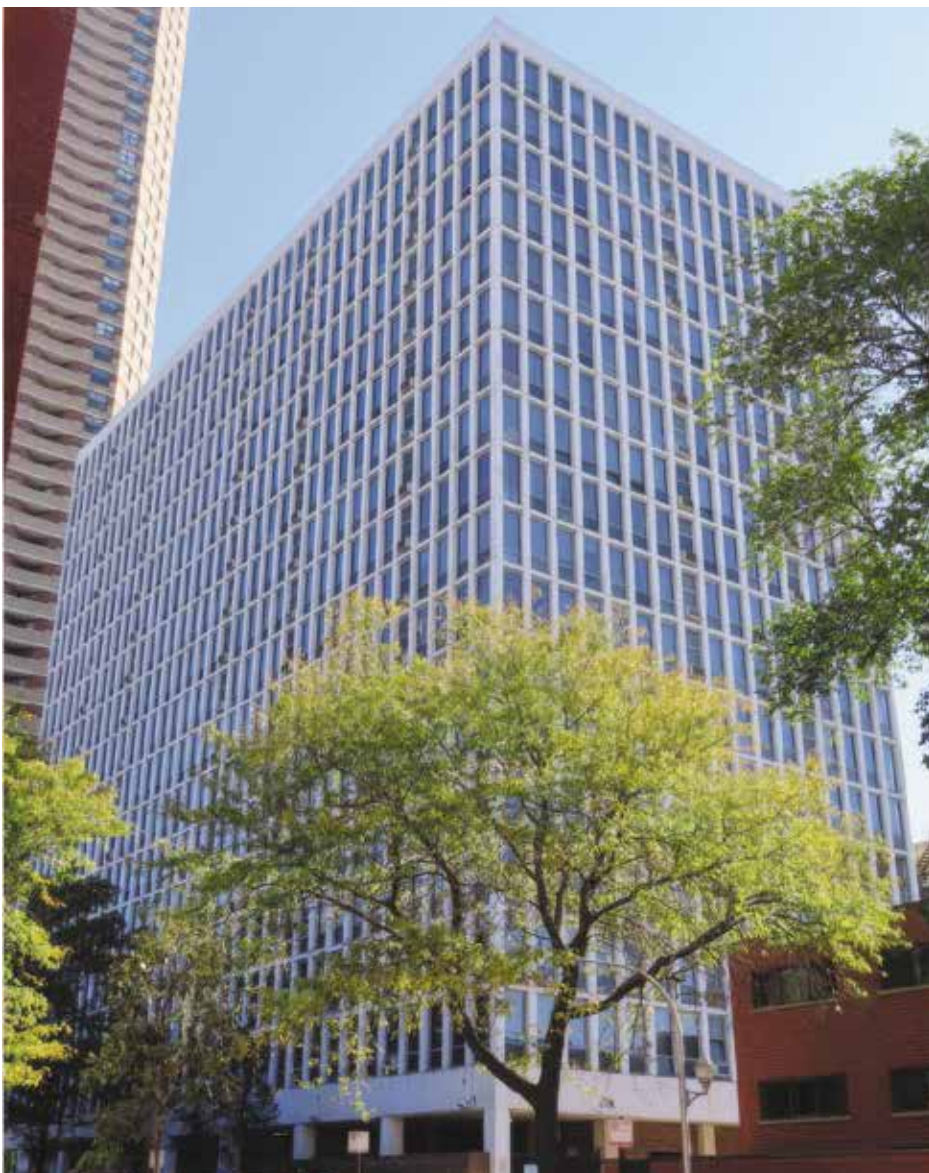
Figure 1. Building exterior walls consisting of concrete columns, concrete slab edges, windows, and sealant joints.

Exterior walls for cast-in-place concrete-frame buildings typically consist of exterior concrete elements (for example, columns, slab edges, and walls), windows, and exterior sealant joints (**Fig. 1**). Collectively, these exterior walls are considered face-sealed barrier walls. Exterior wall insulation is typically located on the interior face of the exterior walls (**Fig. 2**). To resist water penetration, the exterior walls rely primarily on the weathertight integrity of the (sometimes coated) concrete surfaces and sealant joints. Face-sealed barrier walls only offer a single line of defense against water penetration and are considered by some as a “zero-tolerance” wall system. Water that penetrates beyond the exterior surfaces of the wall and sealant joints will likely result in water penetration into the building and/or deterioration of water-sensitive materials, including corrosion of embedded steel reinforcement and degradation of drywall and insulation on the interior side of the walls. Water is also able to penetrate cracks at skyward-facing surfaces unless a remedial solution, such as routing and sealing cracks and/or applying a waterproofing coating, is provided and the repairs are maintained over time.

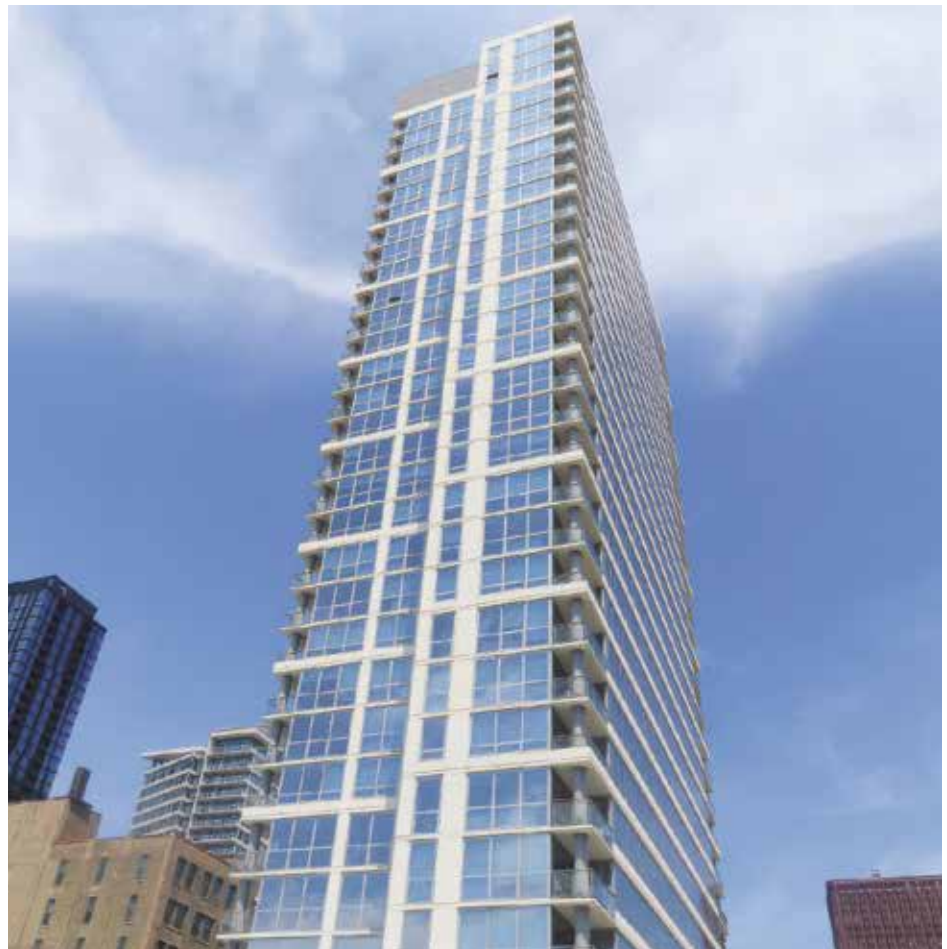
Figure 3. Modern building (circa 2018) with exposed concrete beams, wall areas, columns, slab edges, and balconies.

Although modern high-rise residential and commercial buildings provide more natural daylighting than older buildings, many modern structures are constructed with exposed exterior concrete. In these buildings, aluminum-frame curtainwall systems or other high-performing fenestration are typically arranged in a continuous ribbon window configuration at each floor. The concrete slab edges and some columns and shear wall components remain exposed to the building exterior (Fig. 3).

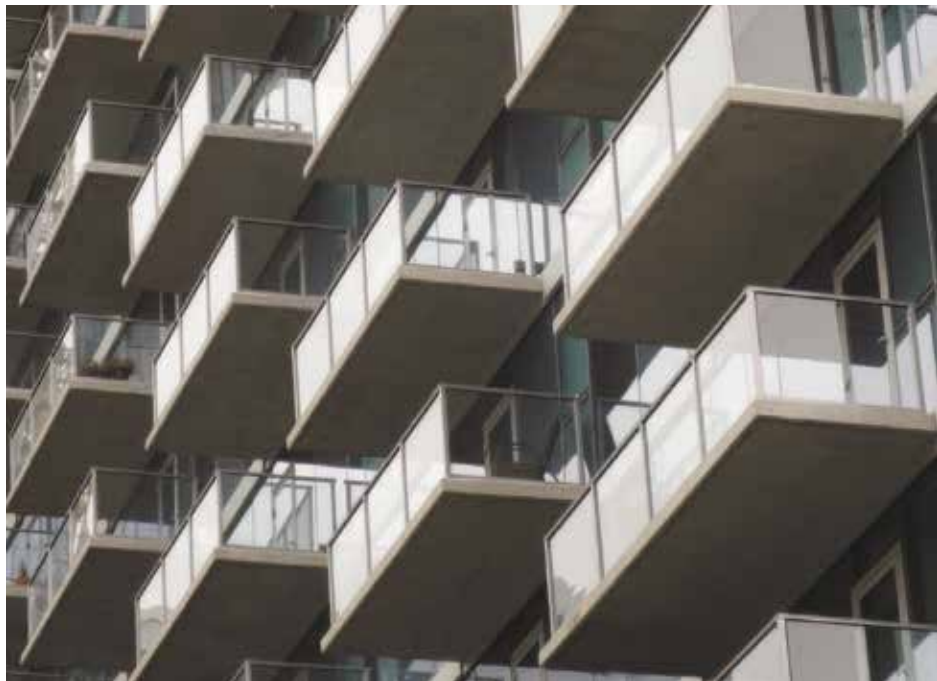
Figure 4. Concrete-frame balconies cantilever beyond the building exterior wall.

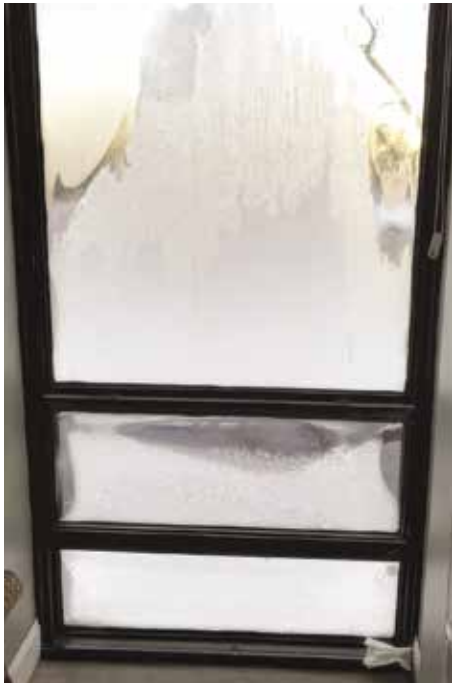
Figure 5. Condensation at a concrete-frame building in a cold climate.

Condensate on windows and doors can result in water runoff onto window stools and floor surfaces, resulting in deterioration and/or buckling of moisture-sensitive finishes (Fig. 5). Condensation within concealed spaces, such

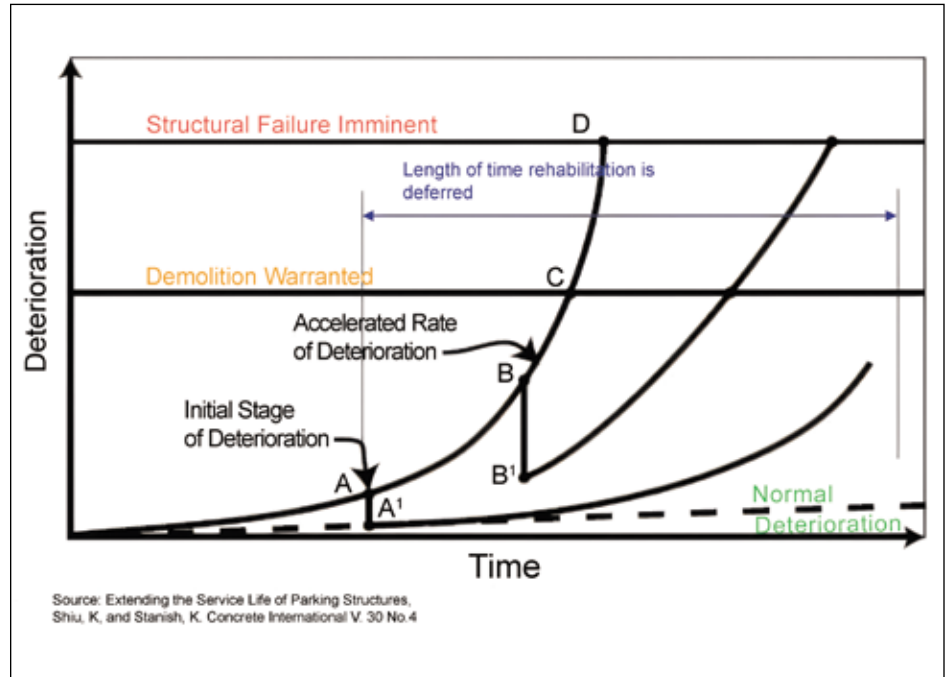
Figure 6. Schematic representation of the relationship between deterioration and time of a concrete structure exposed to environmental factors.

Properly designed and constructed concrete structures are resistant to most natural environments; however, they can be exposed to conditions that initiate chemical and/or physical deterioration mechanisms. Following the onset of initial stages of deterioration, the deterioration tends to accelerate exponentially over time.²² Due to these factors, even the most durable concrete structures require periodic evaluation and routine maintenance throughout their design life to ensure safety and functionality. If maintenance and repairs are deferred indefinitely, structural failure can occur (Fig. 6).

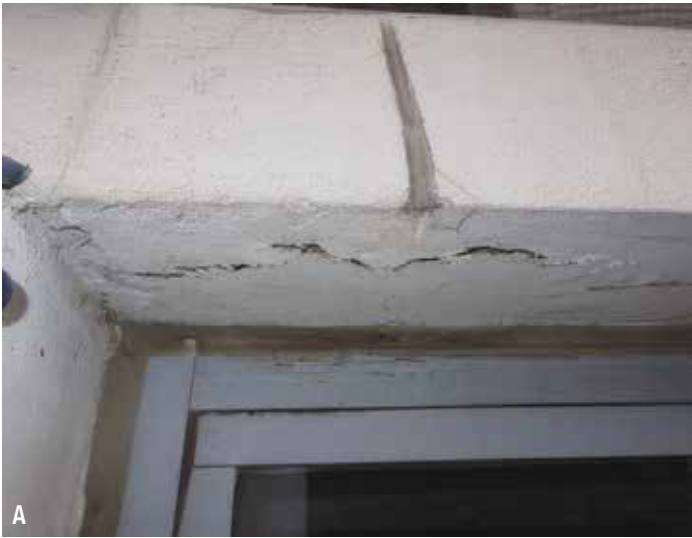
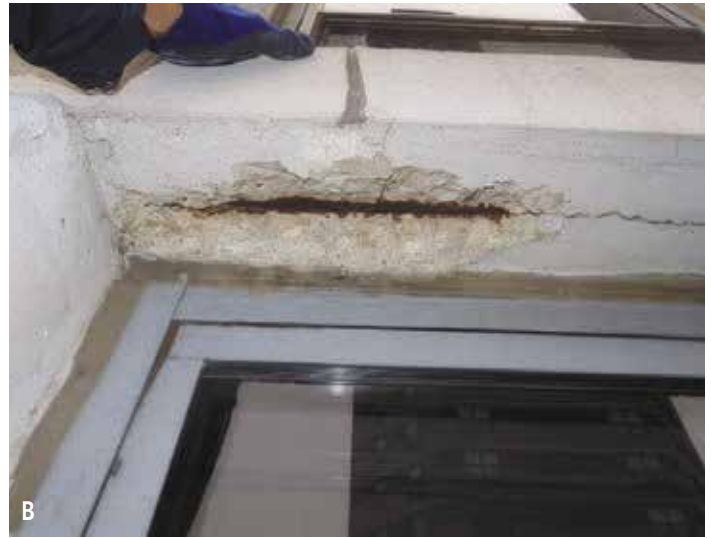
Figure 7. (a) Potentially hazardous delamination and cracking at concrete slab edge soffit; (b) corroded reinforcing steel exposed following removal of spalled concrete.

- **Corrosion of reinforcing steel:** Whether due to carbonation, chloride contamination, or other means, corrosion of embedded reinforcing steel forms expansive corrosion

products that increase the internal stresses in the concrete, eventually resulting in cracking, delamination, and/or spalling (Fig. 7).

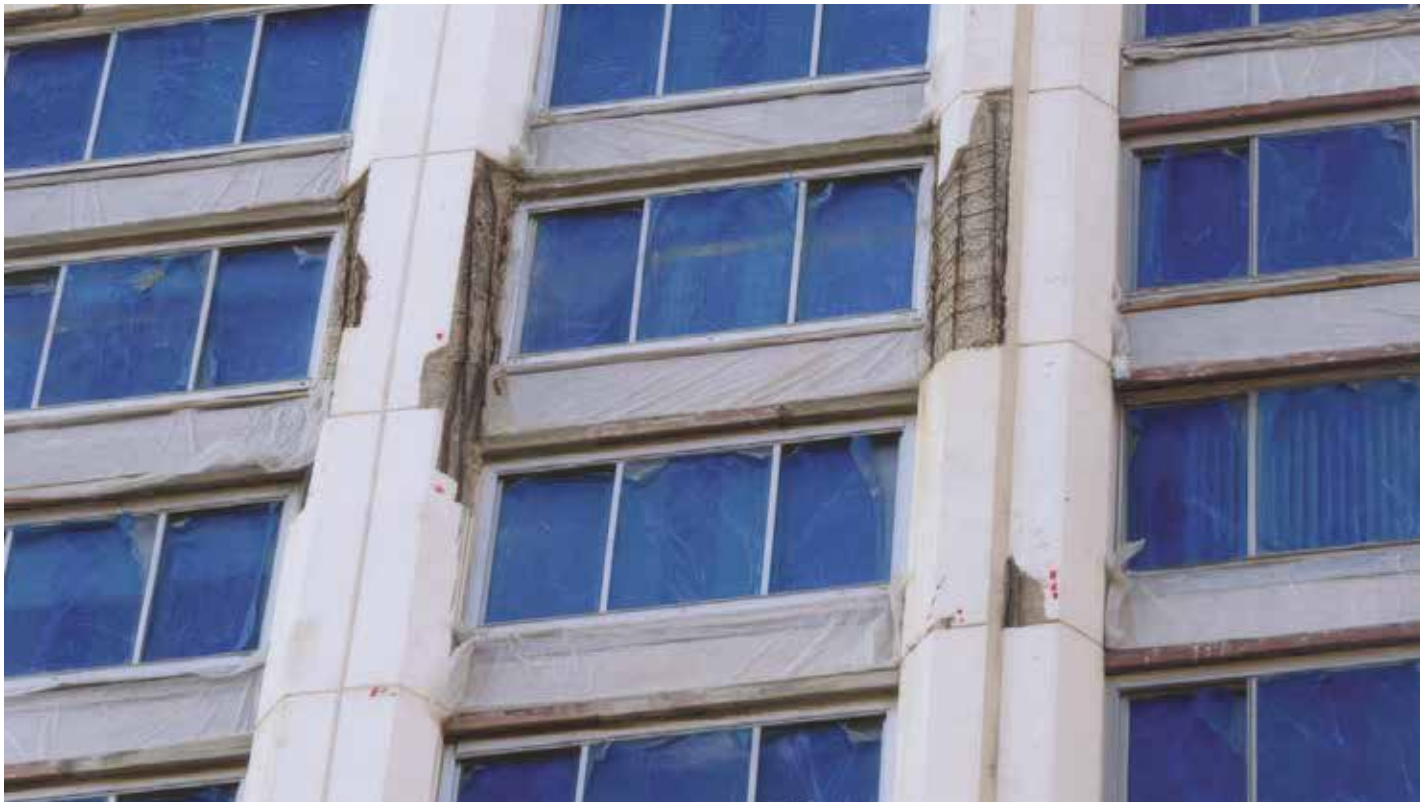
Figure 11. In-progress concrete exterior wall repairs.

Every building is unique, and there is no one-size-fits-all concrete repair strategy. Industry-standard details and specifications should be adapted to meet project-specific needs. Repair projects should consider the geographic location of the project, exposure to freeze-thaw cycles, exposure to deicing salts in cold regions or saltwater in coastal regions, and the materials used during original construction (**Fig. 11**).
