Unmasking the Layers: A Journey Through a Masonry Reclad Litigation Case Study

By Mallory Buckley, RRO, PE, BECxP + CxA+BE; Robert Hancock, MBA, JD; Kimani Augustine, PE; Weijie Liu, EIT, BECxP + CxA+BE; and Eliana Zhen Yan

This paper was presented at the 2024 IIBEC International Convention and Trade Show.

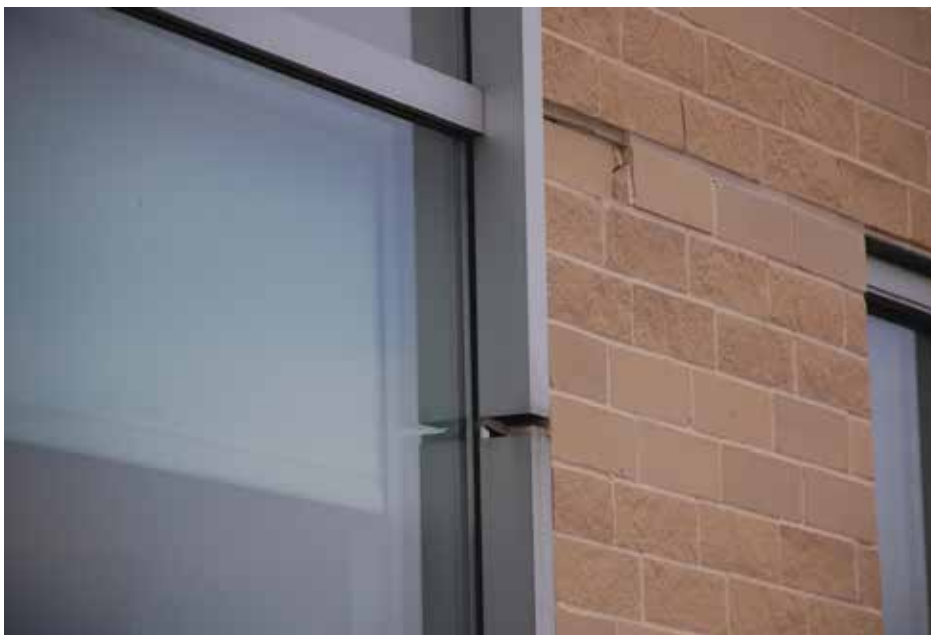
Figure 1. Dislodged stone observed as part of the initial investigation reports.

identified 15 stone units that appeared to be laterally displaced, thereby presenting potential falling-debris life-safety hazards. Following further evaluation and tactile push tests, it was confirmed that all 15 stone units were partially to fully dislodged, with four of them posing an immediate fall hazard risk (Fig. 1). Emergency stabilization measures were implemented, and it was recommended to the owner to proceed with a comprehensive assessment of the stone facade to determine the extent of distress and causative factors.

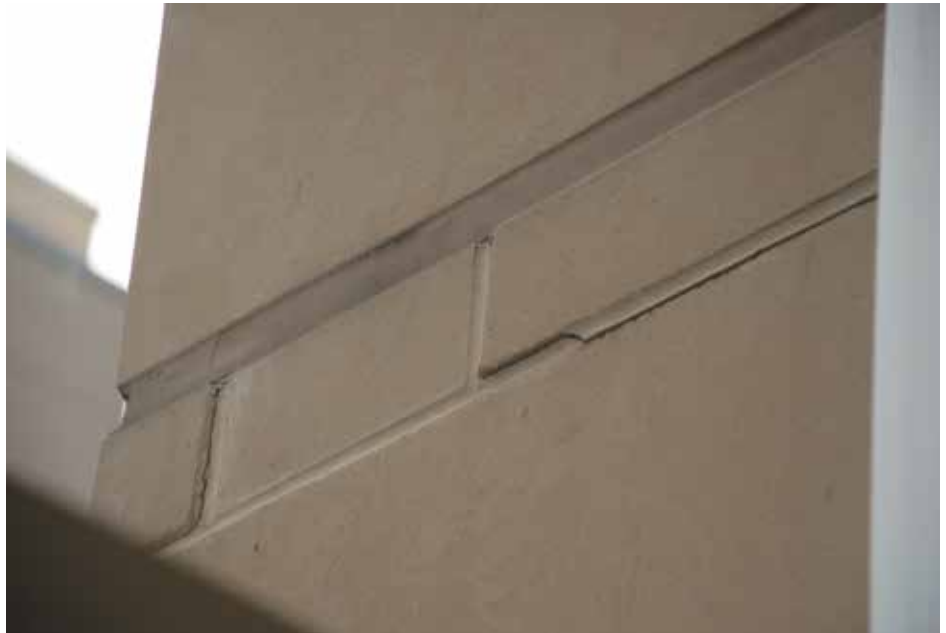
Figure 2. Loose stone observed as part of the initial investigation reports.

In October 2017, Walter P Moore performed a phase 2 assessment focusing on the northwest and southwest corners of the building due to the extent of visible masonry distress observable from the ground at these areas (Fig. 2). This comprehensive evaluation included the removal and documentation of dislodged stone units, examination of mortar joint conditions, and assessment of masonry veneer anchor assemblies. The findings emphasized the need for further evaluation of the remaining stone facade areas of the building to identify other potential areas of concern and associated causative factors contributing to these masonry distress conditions.

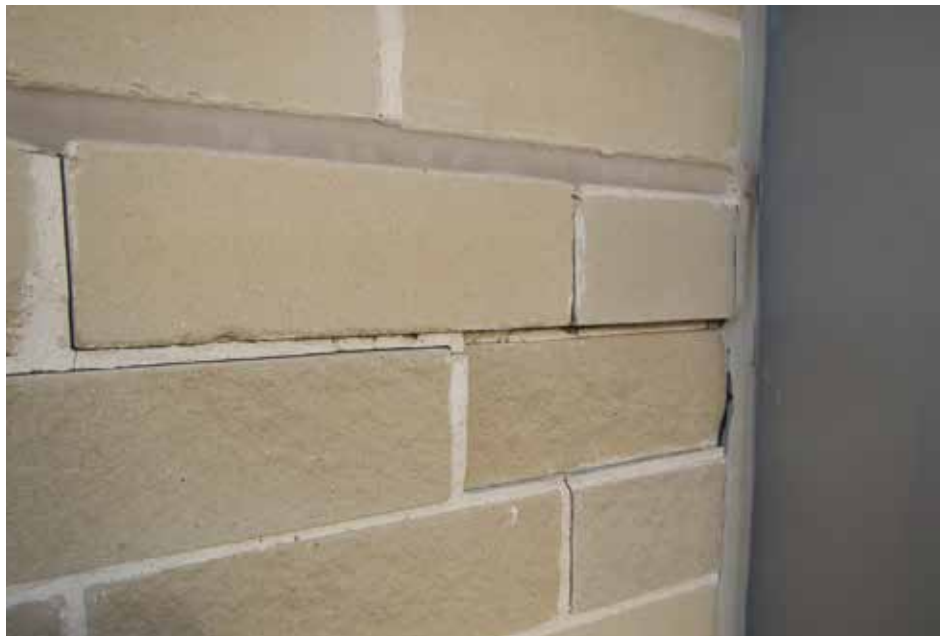
phase 3 assessment revealed extensive mortar cracking (Fig. 3) as well as multiple as-built construction deficiencies, such as improper and excessively spaced masonry anchors; discontinuities in the air-water barrier, including at window transitions; inadequate support of fenestration assemblies; and, most critically, numerous additional dislodged stone elements.

Figure 3. Extensive mortar cracking as observed in the Phase 3 investigations.

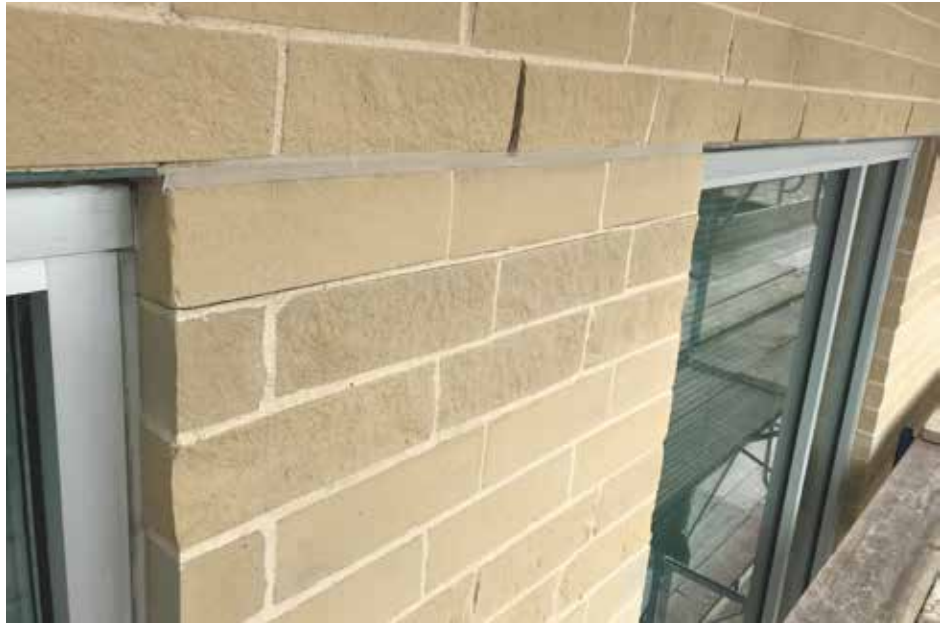
Figure 4. Example of photo documentation of masonry condition pre-masonry demolition.

The documentation process of the masonry veneer pre-demolition focused on deficiencies in the masonry veneer. The typical deficiencies included cracked mortar joints, loose masonry stone units, and deficient movement joint sizes. The documentation of the air/water barrier over sheathing post-masonry demolition focused on the deficiencies within the cavity wall system. The typical deficiencies included penetrations and discontinuities in the air/water barrier, unadhered through-wall flashing components, and inadequate spacing and improper fastening of masonry veneer anchors. Our documentation

As previously discussed, the initial investigation phases included visual observations, a limited arm's-length survey via aerial lift and suspended scaffold access, borescope, and exploratory openings. The initial investigations were essential to understand the underlying cause of observed masonry veneer dislodgement and the extent of associated deficient as-built conditions in the building's enclosure. During the masonry recladding phase, the exterior wall system was reviewed utilizing the following phasing scheme: pre-masonry demolition, post-masonry demolition, and post-sheathing demolition (Fig. 4 to 6). This allowed for thorough documentation of

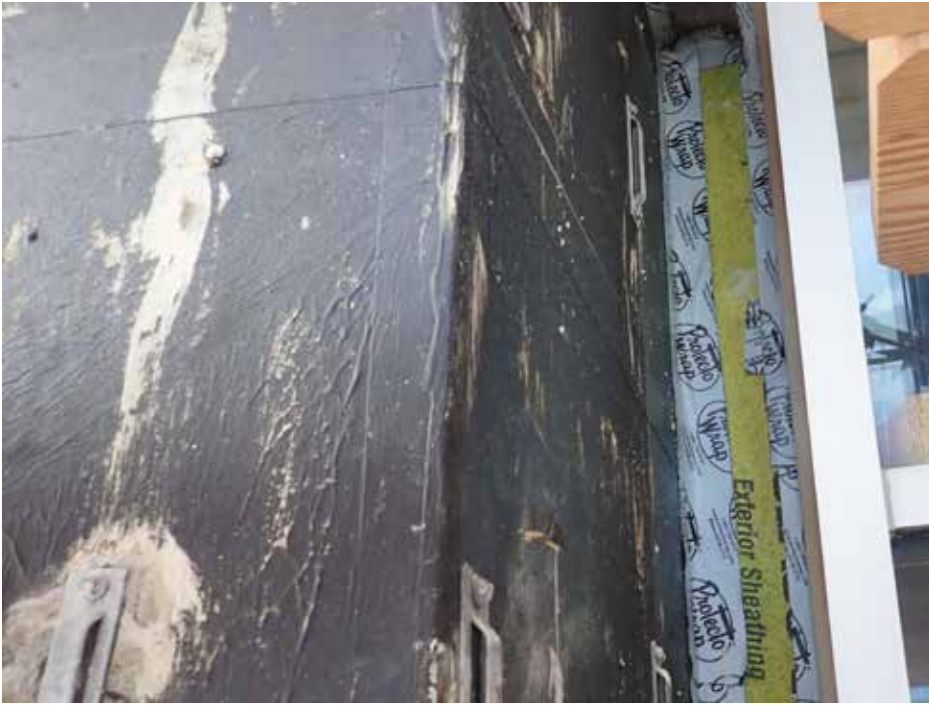
Figure 5. Example of photo documentation of masonry cavity wall post-masonry demolition.

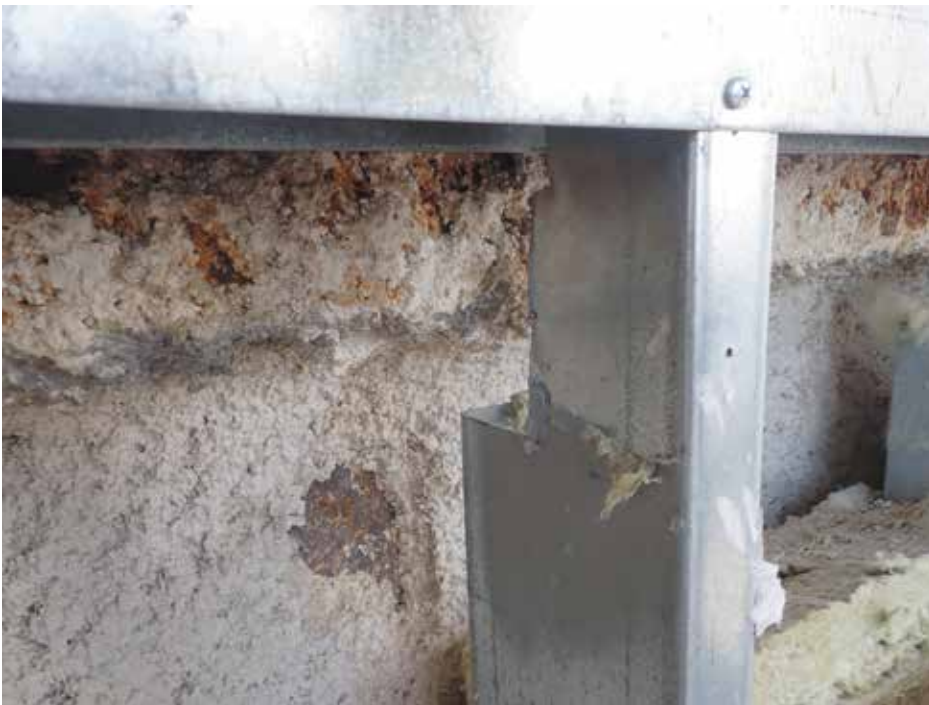
Figure 6. Example of photo documentation of backup wall post-sheathing demolition.

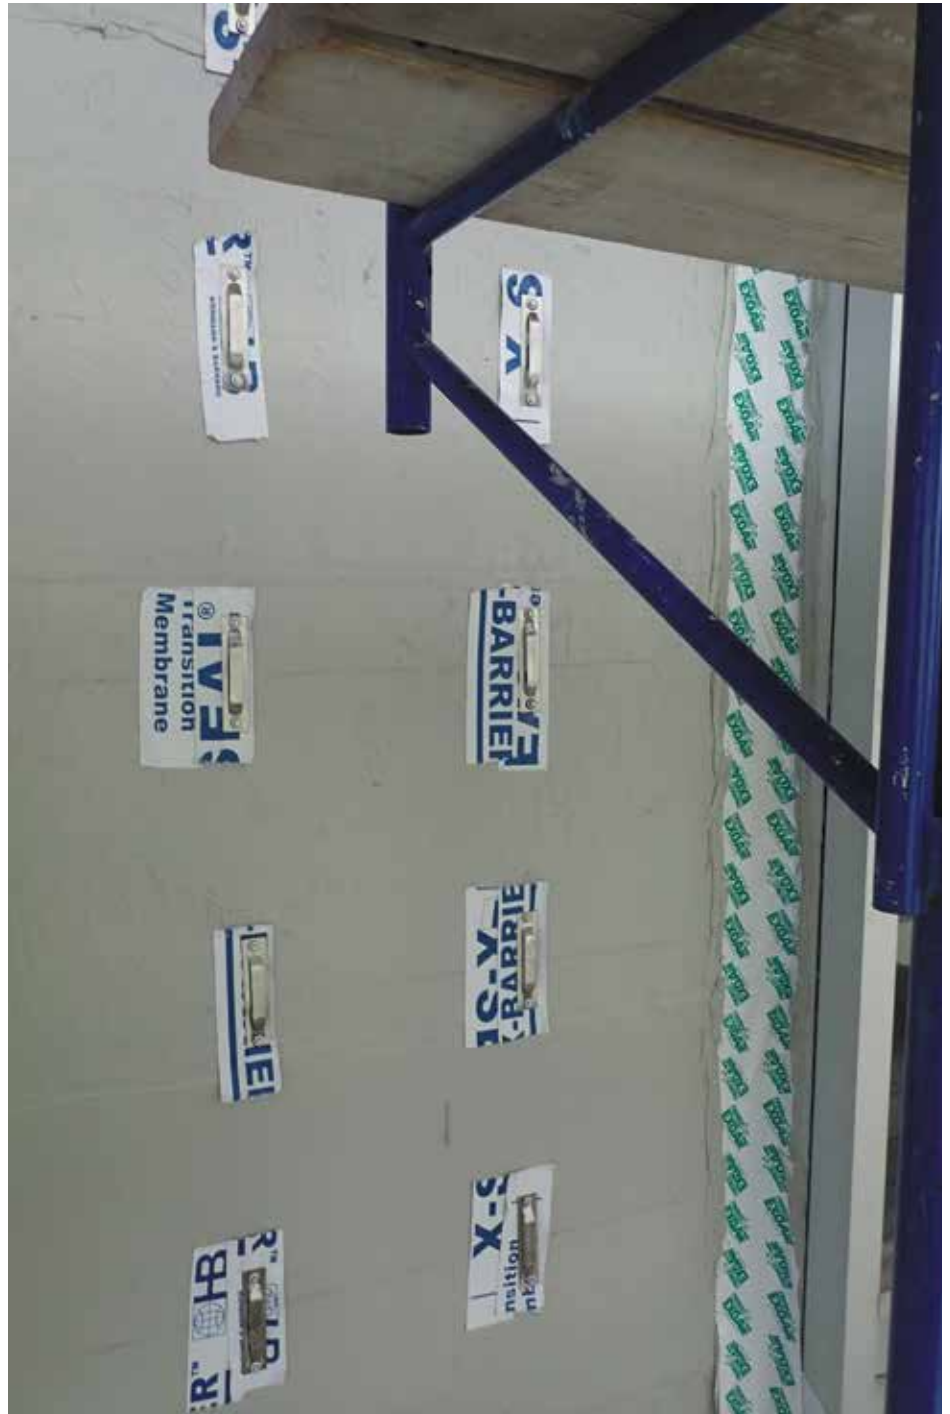
Figure 7. Installation of new sheathing, air barrier, and brick ties during masonry reclad.

The selected general contractor commenced work in December 2018, with a scope that included demolition of the existing facade stone, veneer ties, and other architectural elements to allow for repairs and documentation of backup wall conditions. The reclad work involved various aspects such as flashing and sealing window perimeters, adding stone masonry veneer ties, constructing new stone masonry cladding, and installing flashing at key transition areas (Fig. 7 and 8).

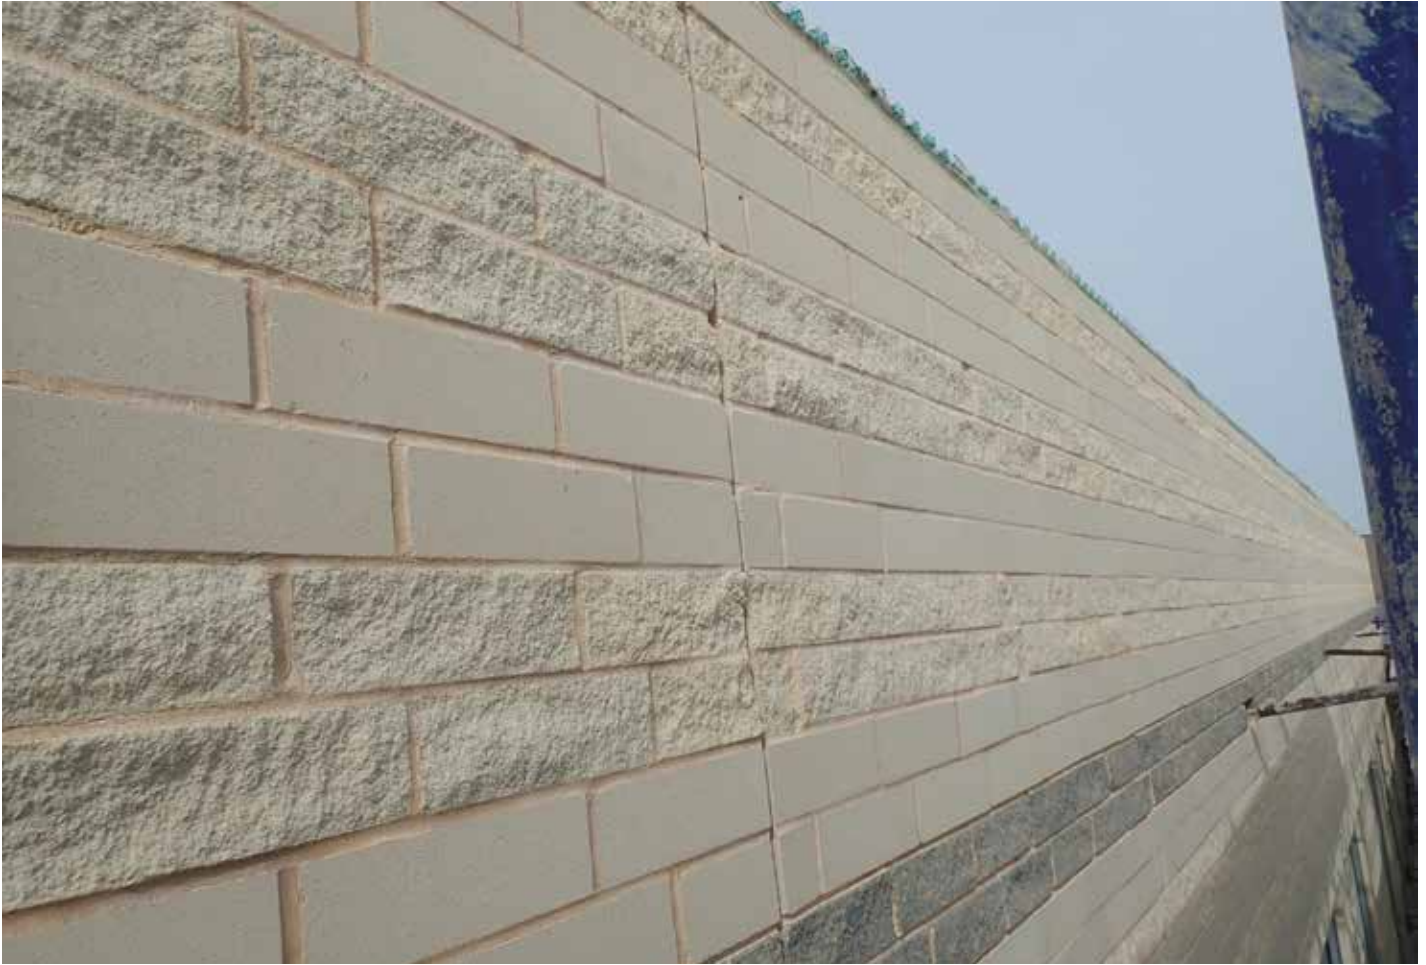
Figure 8. *Installation of new masonry units during the reclad construction work.*

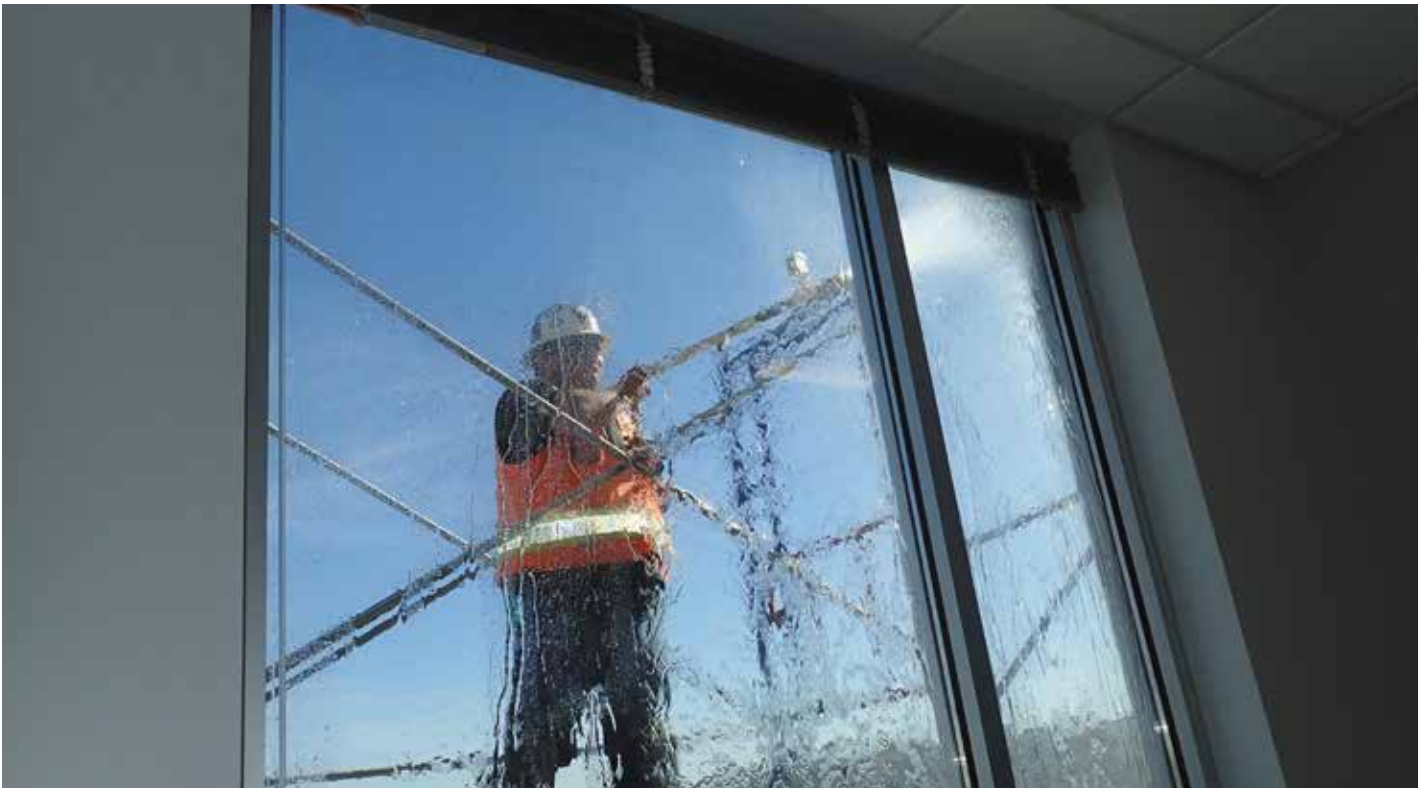
Figure 9. *AAMA 501.2 nozzle water testing was performed at a punch window in order to evaluate potential water leakage.*

Testing played a significant role in quality assurance, including mortar testing, air- and water-leakage testing at windows and window perimeters, and field adhesion testing (Fig. 9). These measures ensured that the repairs met the required standards and specifications.
