Elements of a Collapse

Abstract

Lyle D. Hogan, FRCI

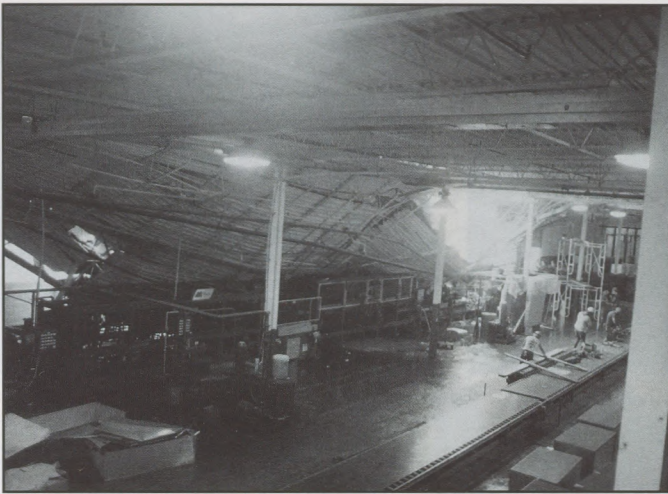
Photo 1

Roofing assemblies rarely make headlines until an event of significant non-performance. Structural failure is foremost among these (photos 1 and 2). The occurrence leaves owners panicked, occupants inconvenienced (if not injured), and reporters clamoring for more rolls of film.

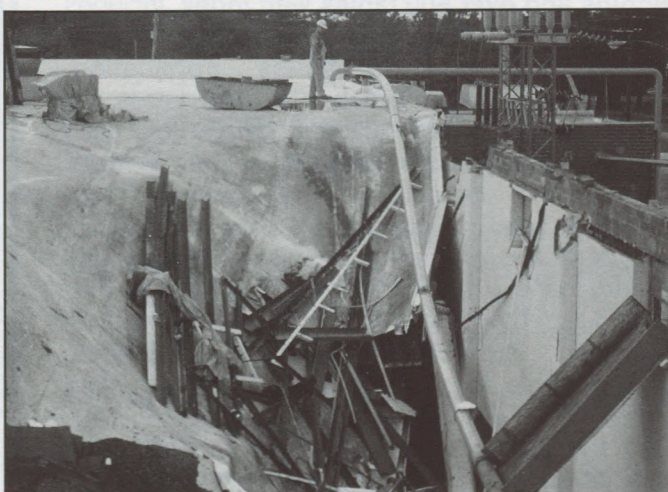
Photo 3

On the other hand, metal buildings and conventional steel structures may deform slowly. The shifting weights of drifted snow and stockpiled rooftop loads (Photo 3) may take several minutes to fail. It is not uncommon for steel structures to experience a "partial collapse", marked by extreme deformation of members yet falling short of complete failure.
