# Steep Roof Construction Using Engineered Wood Trusses

BY LYLE D. HOGAN AND RICHARD REYNOLDS

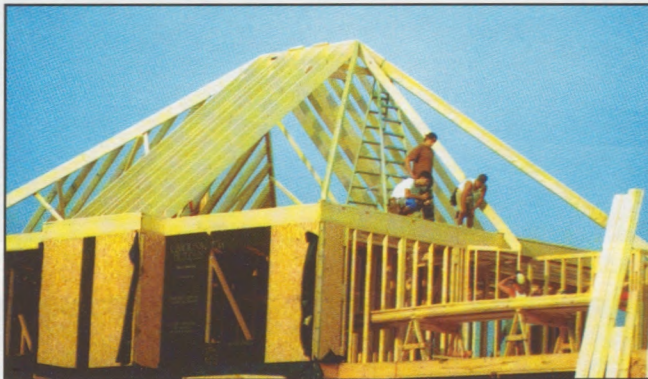
*Figure 1: Built-in-place (stick-built) framing.*

Steep roof inclines may be created with site-fabricated "stick-built" elements of lumber or by engineered wood trusses manufactured in a factory-type setting. *Figure 1* depicts the former, a system of built-in-place framing as opposed to engineered trusses. Site-built roofs have a long history of application. Wood trusses, however, offer many advantages, including design that accounts for applied load conditions and tighter quality control. This makes them a product of choice for the majority of residential and light commercial roof applications.

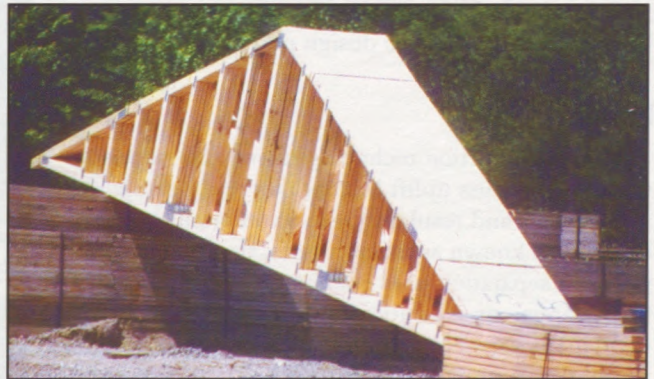
*Figure 2: Bundle of pitched gable and trusses. Having only vertical web elements, these are to be supported along the entire length of the end walls.*

Many different pitched truss profiles may be encountered. The typical pitched truss is a dual-pitched symmetrical truss having a horizontal bottom chord (*Figure 2*). Having no triangulation web elements, the product shown is intended to be supported throughout its length by the

wall and is therefore called a gable end truss.

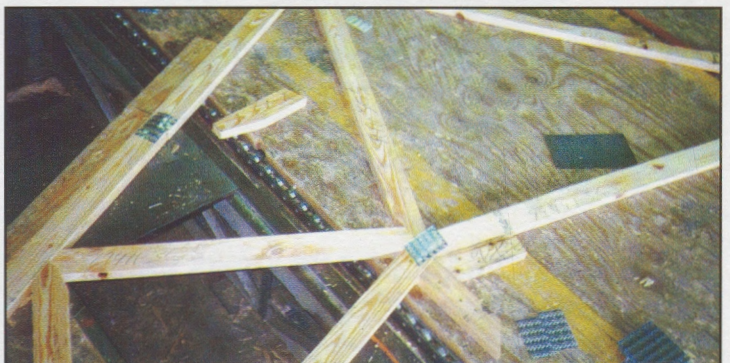
Figure 6: Metal plate-connected wood truss being assembled on the truss manufacturing table (jig). Photo courtesy of Blue Ox Industries, Inc., Kernersville, NC, (800)-672-2145.

Considering their relatively small size, the load-car-rying capability of truss plates is remarkable. When pressed into position on a splicing table or jig (Figure 6), the metal connector plates have demonstrated commendable performance for over 40 years. It is noteworthy that rough handling of trusses may induce loosening of the connection. Back-out (of the truss plates) by only 1/16" may diminish load-carrying capa-bility to only 60% of the design performance value.<sup>4</sup>

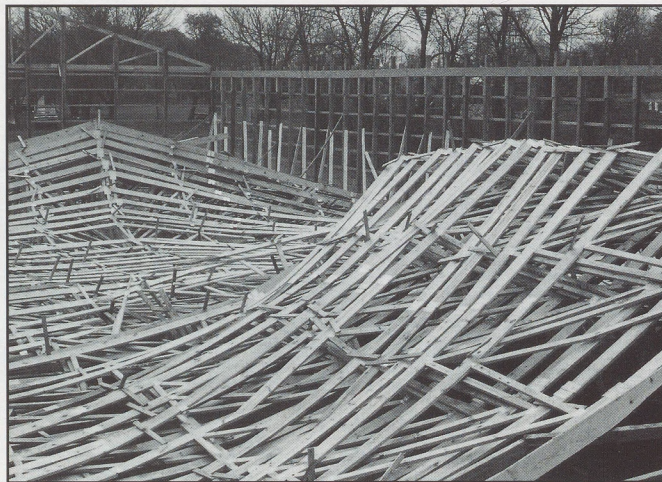
Figure 8: Use of "killer cleats" as installation bracing can lead to truss collapse such as this. Photo courtesy of Wood Truss Council of America.

only for initial alignment. An improper practice for temporary bracing is the use of short 1x or 2x lumber spacers. These members are called killer cleats. Some instances of temporary bracing observed by the writers have failed to inspire confidence (Figure 8). Moreover, it is not always understood that these temporary pieces, even closely spaced, do not substitute for permanent bracing. Study in the aftermath of wind destruction has occasionally revealed the omission of any lateral bracing (Figure 9).

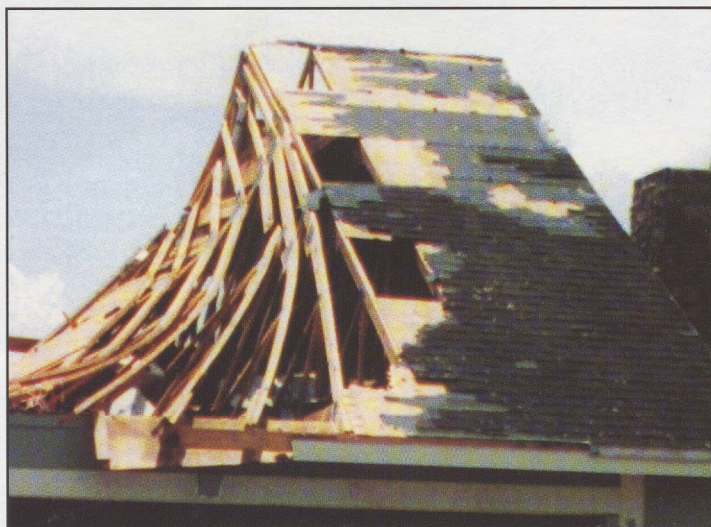
Figure 9: Progressive failure of truss system from inadequate lateral bracing. Photo courtesy of RCI.

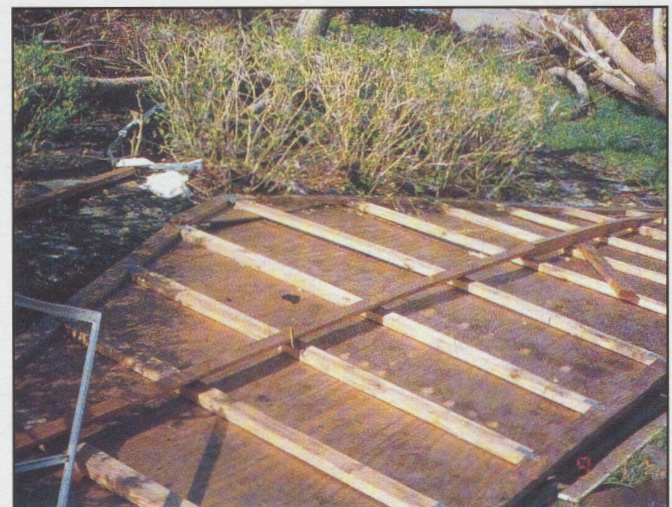
Figure 13: Loss of entire endwall during windstorm. Photo reprinted courtesy of FEMA, Washington, DC.

Gabled roofs may warrant closer scrutiny than those closing with hips. As shown in *Figure 13*, loss at gable ends is a fairly common mode of wind damage, frequently

traceable to the marginal (or absent) lateral bracing.
