Ensuring Installation Quality: Field Testing Methods for Building Enclosure Components

By Sadil Eidda, EIT

THIS CASE STUDY illustrates some of the testing methods which can be employed in a new construction project to assess the adequacy of the installation of the building enclosure components. The testing techniques include ASTM D4263, *Standard Test Method for Indicating Moisture in Concrete by the Plastic Sheet Method* (concrete moisture testing);¹ ASTM E1186, *Standard Practices for Air Leakage Site Detection in Building Envelopes and Air Barrier Systems*, Procedure 4.2.7, *Chamber Depressurization in Conjunction with Leak Detection Liquid*;² and dry film thickness (DFT) measurement. While these field-testing methods contribute to quality assurance, they should be viewed primarily as tools for an evaluation of the adequacy of installation of certain building enclosure components. By recognizing potential issues and addressing them, the project aims to reduce the likelihood of structural problems, which may lead to improved energy efficiency and cost savings.

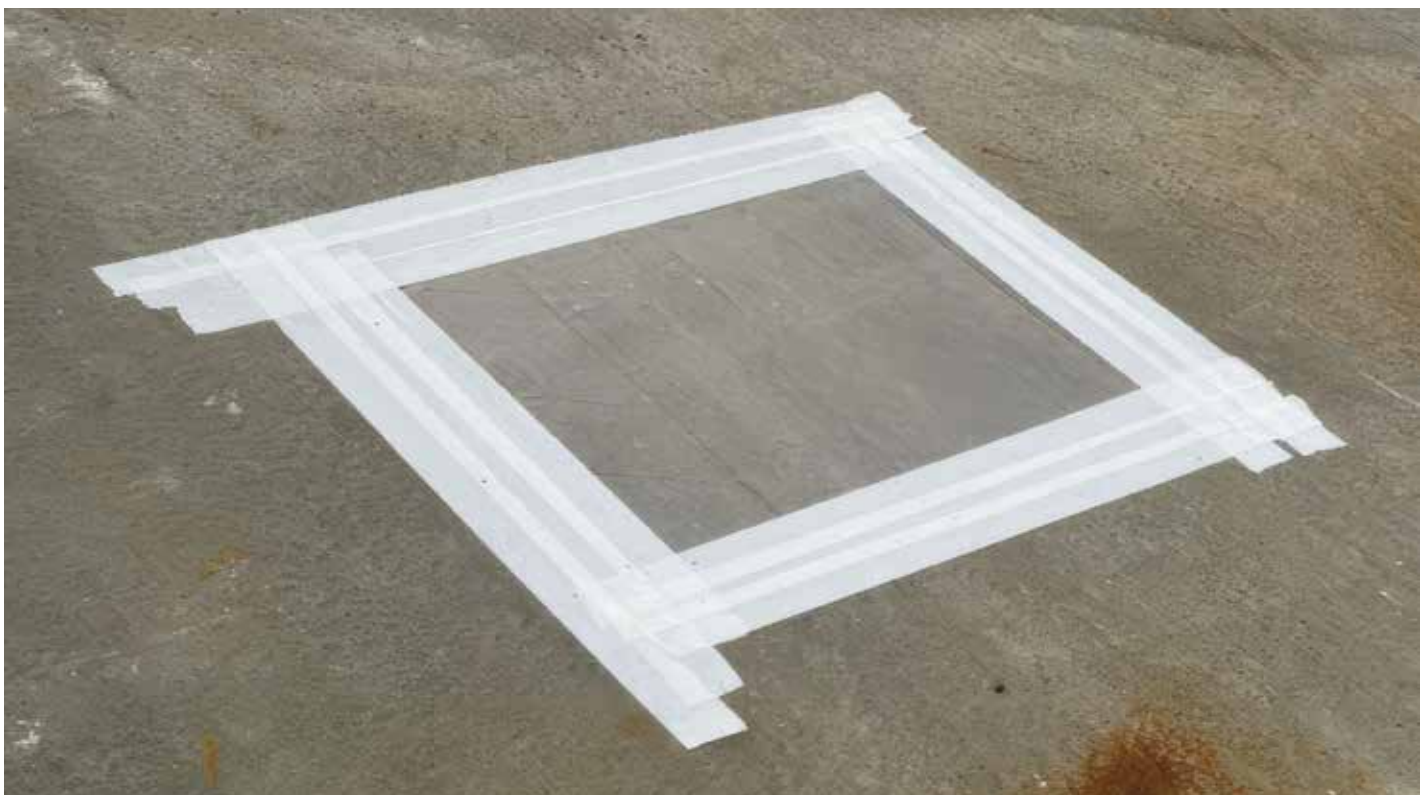
The concrete moisture testing was conducted using ASTM D4263, *Standard Test Method for Indicating Moisture in Concrete by the Plastic Sheet Method*. This test aims to detect the presence of moisture in concrete surfaces. This method helps in determining whether moisture is escaping the concrete's surface, suggesting possible issues with moisture vapor transmission⁴ that could affect the adhesion of adhesives, flooring materials, and coatings. However, as previously mentioned and noted by industry professionals, this method has been criticized for its unreliability. An 18 in. by 18 in. (457 mm by 457 mm) polyethylene sheet is placed over the concrete surface by sealing its edges to conduct the test. The sheet is taken off after 16 to 24 hours, and the underside of the sheet along with the concrete surface are inspected for moisture. Visible condensation on the sheet or darkening of the concrete indicates excessive moisture, which indicates that moisture is being emitted from the concrete; thus, if the vapor barrier is applied over the concrete without allowing the concrete to dry first, it will affect the performance of its adherence (**Fig. 1**).

Figure 1. Plastic sheet taped at concrete surface on the roof per ASTM D4263, Standard Test Method for Indicating Moisture in Concrete by the Plastic Sheet Method.

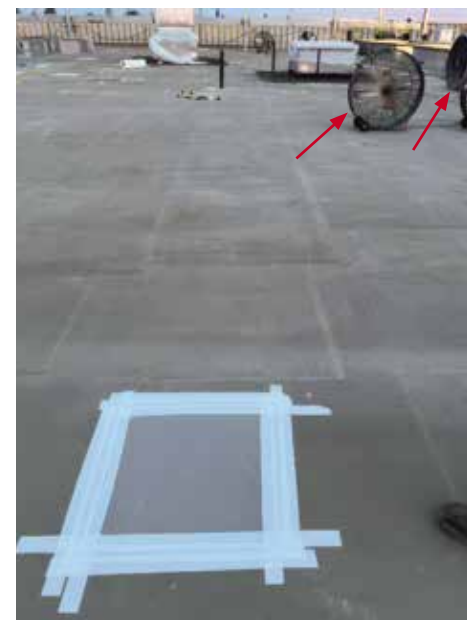
In order to confirm that the concrete had sufficient time to dry and to monitor the moisture, we had to address the concrete moisture issues in cases where some sections did not pass the test prior to installing the vapor barrier, we had two available options based on the project conditions and limitations⁵:

Figure 3. Fans added around concrete for dehumidifying purposes (shown by red arrows).

The dehumidifying technique was utilized for this project to keep up with the project timeline (Fig. 3). The tests performed after implementing dehumidification passed, as this method expedited the drying of the concrete.

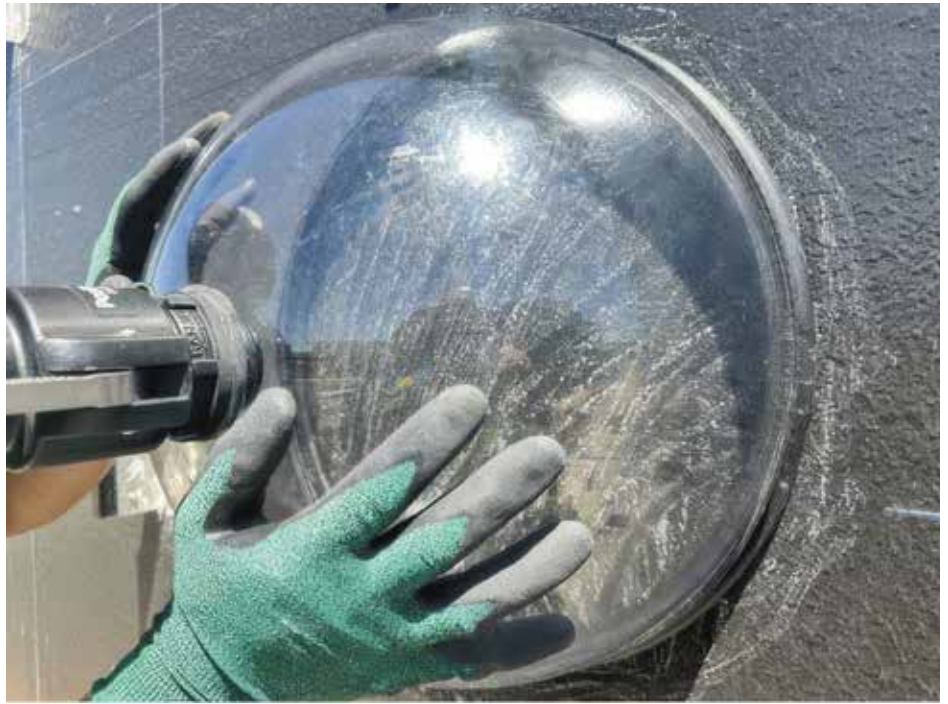
test dome was attached to the surface of the building enclosure at the test location and securely sealed (Fig. 4). The test area was depressurized from the normal atmospheric pressure of 14.7 psi to 0.0725 psi (101,325 Pa to 500 Pa). In case of failure, bubbles would be formed in the test solution, and the air barrier would need to be patched at the leak location to repair it. This test was done 8 to 10 times at isolated locations at each elevation of the building, focusing on sheathing joints and cladding attachments (Fig. 5). The test was passed at every location we tested during this project. In other words, no bubbles were observed throughout the test locations at all elevations. This test helped in detecting air leaks, which would have been eliminated if identified.

Figure 4. Testing process per ASTM E1186, Standard Practices for Air Leakage Site Detection in Building Envelopes and Air Barrier Systems. No bubble formation was observed.

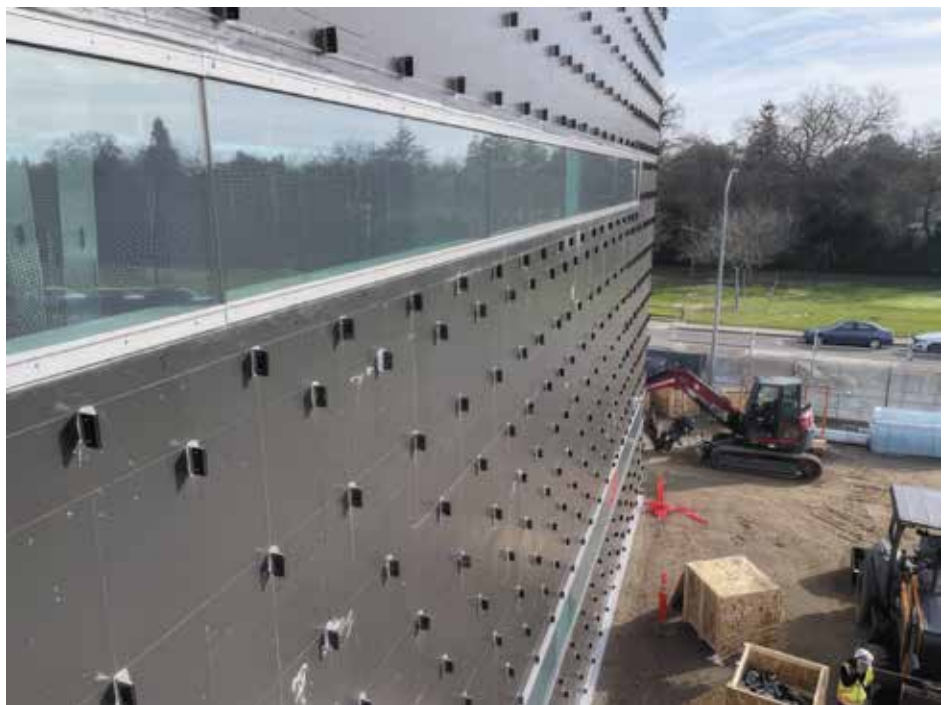
DFT testing was performed at selected locations on each elevation of the building to verify the thickness of the coating, which was applied on top of the sheathing, after it had dried (Fig. 5). The testing was done at nine locations at each of the north and south elevations and three locations at each of the west and east elevations. The north and south elevations were divided into three areas based on the completion of the coating installation, and each area was assigned three locations to be tested, totaling nine tests per elevation. For the west and east elevations, each elevation was treated as a single area, with three test locations assigned to each. The assignment of the areas was based on the differences in the elevation lengths, as the north and south elevations measure approximately 410 ft (125 m), and the east and west elevations measure approximately 152 ft (46 m).

Figure 5. Partial view of an elevation prior to the dry film thickness and chamber depressurization in conjunction with leak detection liquid tests.

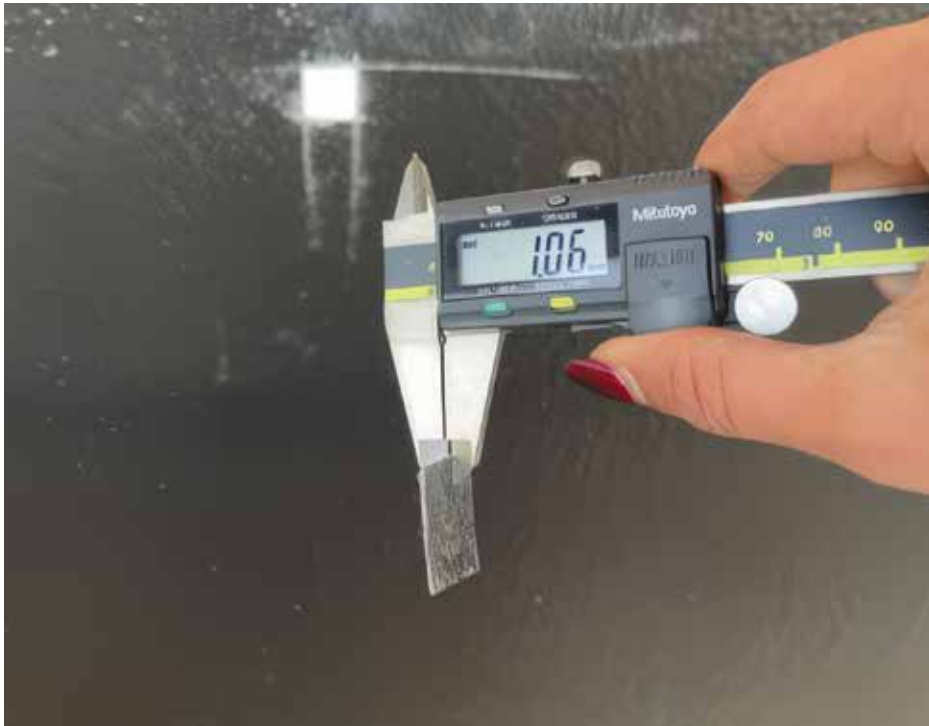
be approximately 15 mils (0.38 mm), consistent with the sheathing manufacturer's specifications. The AWRB manufacturer's minimum requirement is 17 mils (0.43 mm) DFT at the cured state.

In Fig. 6, the test result came out to 1.06 mm (42 mils). Since the cut included the sheathing facer, which was 15 mils (0.38 mm), the DFT for

the coating alone would be 27 mils (0.69 mm), which is greater than the AWRB manufacturer's minimum requirement of 17 mils (0.43 mm). Thus, passing the test like the majority of the other locations that were tested. However, some of the other results yielded less than 17 mils (0.43 mm). The subcontractor was instructed to reapply the coating over the

Figure 6. Passing result in the dry film thickness test.

existing coating, using careful control to achieve the correct thickness that matched the AWRB manufacturer's standards. Ensuring that the membrane met these specifications confirms that it will serve as the air control layer as intended, as the membrane plays a crucial role in preventing air and water infiltration. This testing method validated the application process and confirmed that the installed thickness meets the AWRB manufacturer's specifications.
