Attic Ventilation Guidelines to Minimize Icings at Eaves

BY WAYNE TOBIASSON, JAMES BUSKA AND ALAN GREATOREX

ABSTRACT

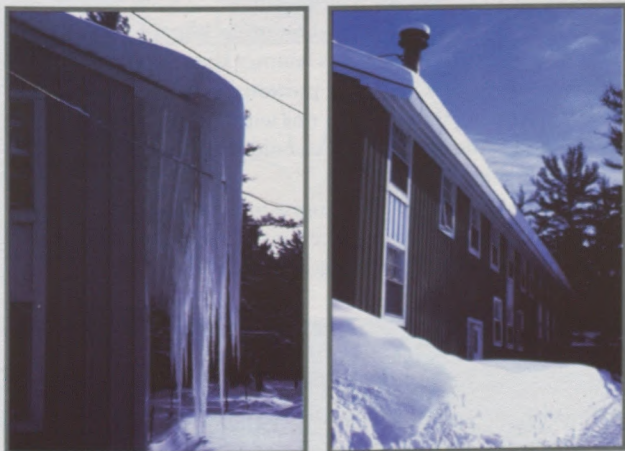
Figure 1: Two identically-constructed roofs photographed at the same time. The building on the right, with no icings, was unheated.

Figure 1 shows two roofs located near Watertown, NY. The two photos of identically constructed buildings were taken within minutes of each other. One roof contains large ice dams and icicles, but the other is ice free. Why? The snow on top of the chimney of one roof is the clue to the difference in behavior. That building was not being heated, while the other building was at room temperature.

This example is used to illustrate that building heat, not the sun, is the primary cause of ice dams and icicles on roofs. When the sun melts snow on roofs, it also warms the eaves, and this tends to minimize the growth of icicles. Certainly, some icicles can form on unheated buildings and from solar heating, but they are usually small, infrequent, and do not cause chronic problems.

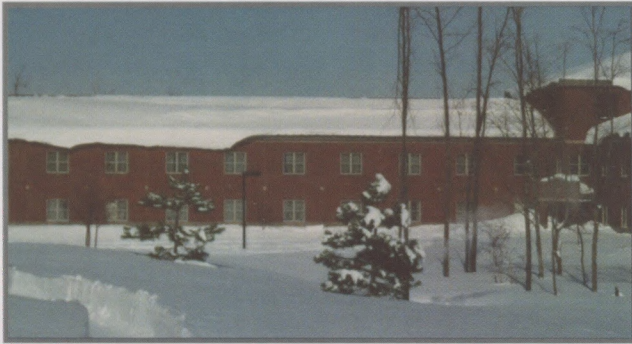
Figure 2: Some creep of snow and cornicing is evident, but no icings occurred on this roof.

A few years ago, many buildings were built at Fort Drum near Watertown, NY. All these buildings have standing seam metal roofing systems above ventilated attics. Standing seam metal roofing systems have both strengths and weaknesses when used in cold regions⁶. Some of these roofs have remained clear of icicles and ice dams (Figure 2). Several have experienced some problematic icicles and ice dams (Figure 3)

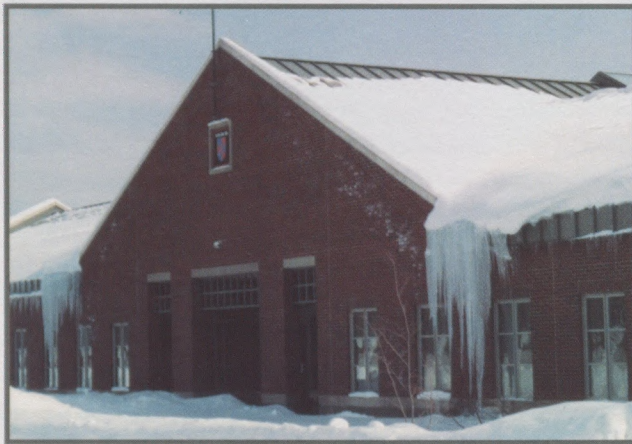
Figure 3: Minor icings occurred along the eaves of this roof and problematic icings developed at the base of valleys.

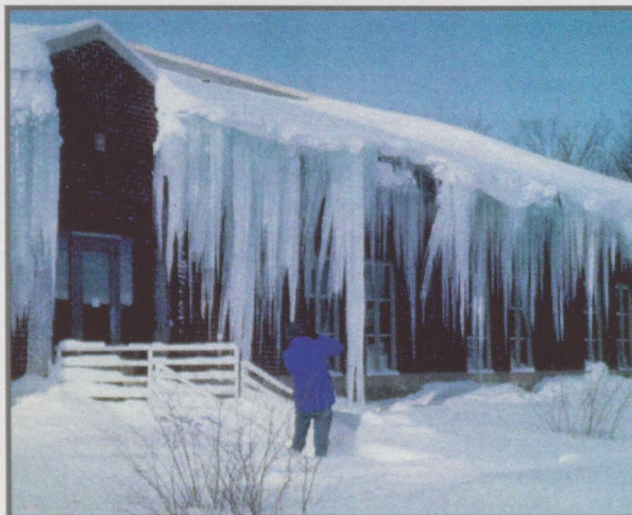
Figure 4: Severe, problematic icings developed all along the eaves of this dining facility.

and others have experienced severe icicles and ice damming (Figure 4). The range in performance is related to the ability of each building's attic ventilation system to remove heat that enters the attic from the warm building below and heat produced by HVAC equipment located in the attic.

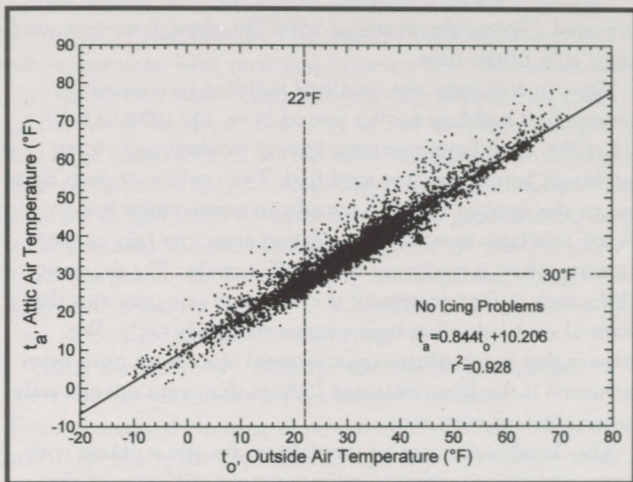
Figure 5: Attic temperature vs. outside air temperature for a roof experiencing no icing problems.

Plots of attic air temperature vs. outside air temperature are presented in Figures 5, 6, and 7 for buildings experiencing no icing problems, "some" icing problems and severe icing problems, respectively. Figure 6 is representative of two other buildings that also experienced "some" icing problems. The least-squares equation of best fit and its correlation coefficient (r^2) are presented on each figure. Horizontal and vertical lines, representing, respectively, an attic air temperature of 30°F and an outside air temperature of 22°F are also presented on each figure. The portion of each graph to the right of the vertical 22°F line is warmer than conditions observed to create icings. The portion of each graph below the 30°F horizontal line is also not within the "icing envelope" because the attic is then so cold that snow on the roof is not melted by building heat.

For the roof with no icing problems (Figure 5), very few data points fall within the icing envelope, as expected. For the roof with "some" icing problems (Figure 6), about 6% of the observations fall within the "icing envelope." For the roof with

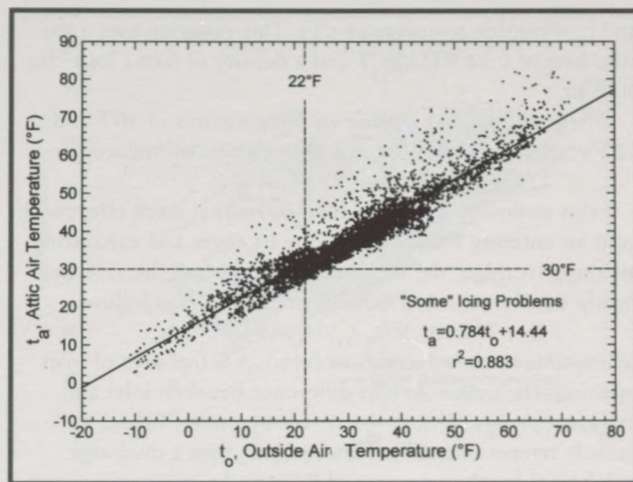
Figure 6: Attic temperature vs. outside air temperature for a roof experiencing "some" icing problems.

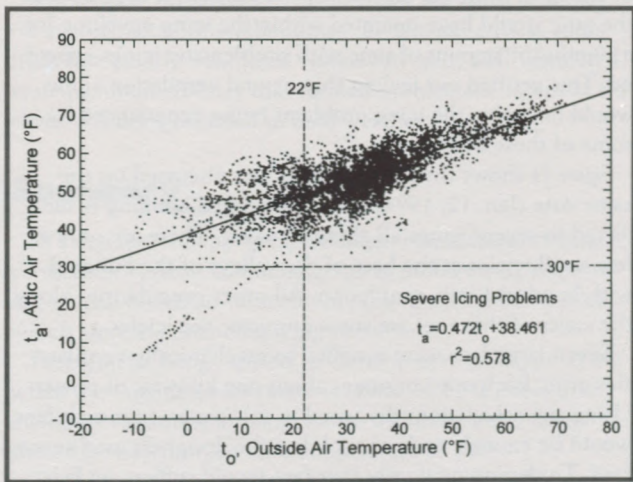
Figure 7: Attic temperature vs. outside air temperature for a roof experiencing severe icing problems.

severe icing problems (Figure 7), 23% of the data (i.e., 23% of the time during the winter) falls within the "icing envelope."

The separate line of points in Figure 7 that runs down toward the lower left corner of the graph represents a 5-day period when the heating system of that building was off due to mechanical problems. Those points provide further evidence that building heat is the primary source of icing problems since, once cool, that building performed out of the "icing envelope."

The attic described by *Figure 7* had experienced severe icing problems. However, it needed help in the form of improved natural ventilation or mechanical ventilation for less than 23% of the winter. We were not able to provide enough inlet area to completely solve this attic's icing problems using only natural ventilation. Thus, several large fans were installed near the ridge as shown in *Figure 9*. The fans were not dampered. This allows the fan openings to serve as outlets for natural ventilation, thereby reducing the amount of time that mechanical ventilation is needed.

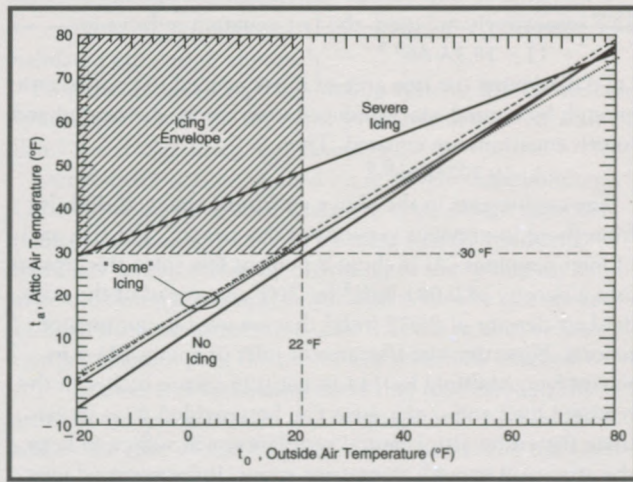
Figure 8: Lines of best fit for the three roofs shown in Figures 5-7, along with similar lines (dashed) for two other roofs also having "some" icing problems.

The lines of best fit for these three roofs are shown together as solid lines on Figure 8 along with similar lines, (shown dashed), for the other buildings we monitored that also had "some" icing problems. This information suggests that icings can be avoided by sizing attic ventilation systems to maintain an attic temperature of 30°F when the outside temperature is 22°F.

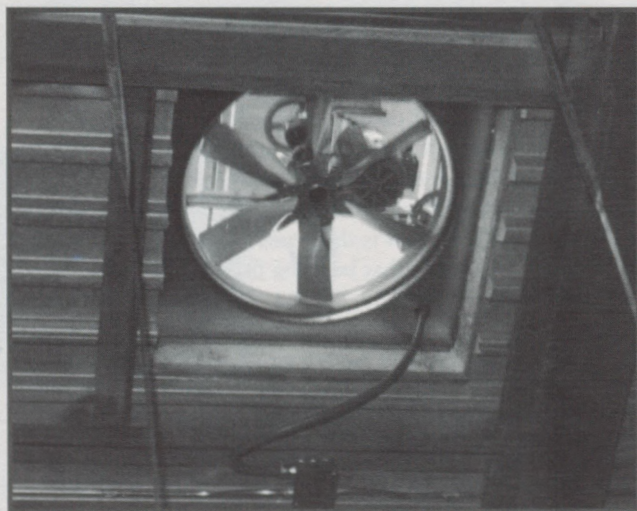
Figure 9: Attic ventilation fan installed near ridge of modified building.

The fans are thermostatically controlled, since they are needed infrequently. They operate only when the attic temperature is above 30 $^{\circ}\text{F}$ and the outside temperature is below 22 $^{\circ}\text{F}$. We installed instrumentation to monitor when the fans

Seven large fans were installed to mechanically ventilate this attic. Each one consumes about one kilowatt of power. Using the calculations discussed in this paper, four such fans would be enough to do the job but the designers used seven fans. To determine if only four fans would suffice, on Feb. 23, 1994, we had three of the fans turned off and blocked with sheet metal to preclude both mechanical and natural ventilation through them.

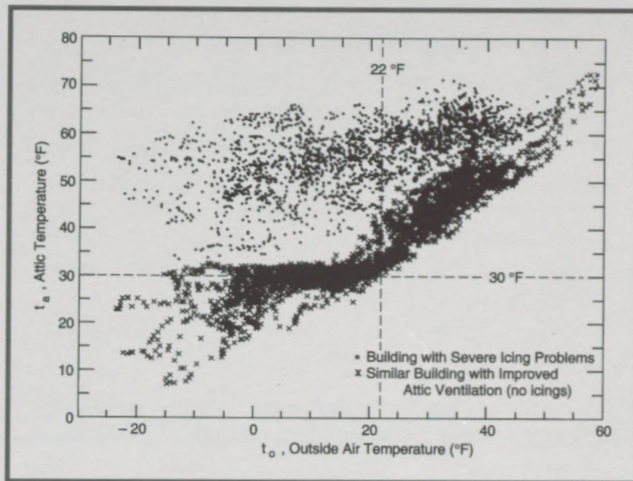
Figure 10: Attic temperature vs. outside air temperature for a building with severe icing problems and a similar building with improved attic ventilation experiencing no icing problems.

Figure 10 compares the modified building to a similar unmodified building for the period Nov. 15, 1993 to Feb. 23, 1994. Both buildings were having similar severe icing problems before one was modified. The portion of each data set to the right of the 22 $^{\circ}\text{F}$ outside air temperature line in *Figure 10* relates to natural ventilation since the fans cannot operate when it is warmer than 22 $^{\circ}\text{F}$ outside. The dramatic difference in that portion of the two data sets indicates that natural ventilation has been improved significantly. We expect that much of this improvement would not have been achieved if the fans contained louvers that were opened only when the fans were on.

The "hunk" taken out of the data set for the building with improved attic ventilation reflects the contribution of the mechanical ventilation system. The mechanical system has been able to keep that attic out of the "icing envelope" most of the time. Without mechanical ventilation, it appears that the attic would have operated within the icing envelope for a significant amount of time with problematic icings expected. This verified our feeling that natural ventilation alone would not solve the icing problems being experienced by some of these buildings.

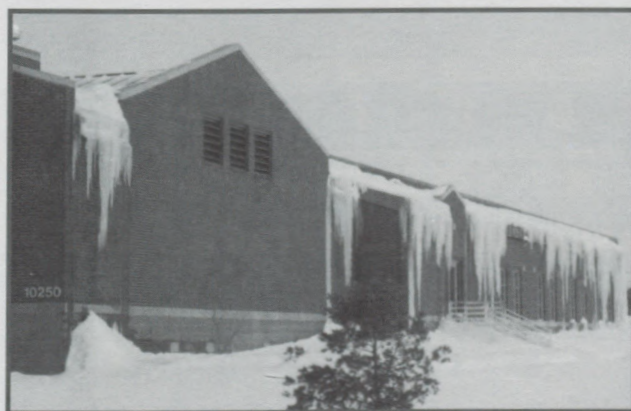
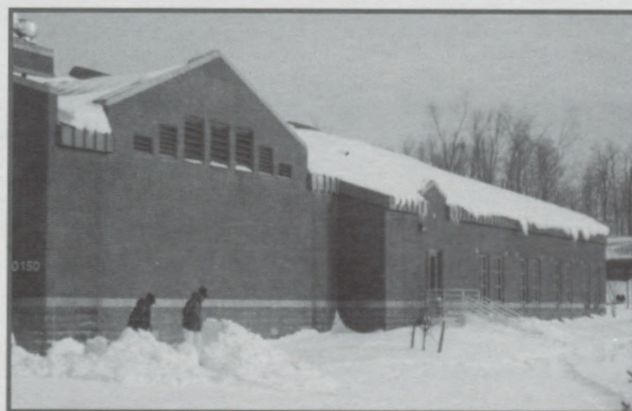
Figure 11: Both buildings from Figure 10 photographed at the same time. The unmodified building shown at the left was experiencing severe icings. The other building with improved attic ventilation had no icing problems.

Figure 11 shows the two buildings just discussed on the same date (Jan. 12, 1994). The unmodified building is subjected to severe icings all along its eaves. There are only a few small icicles at the base of the valleys of the building with improved attic ventilation. All other irregularities along the eaves of that roof are snow cornices, not icicles.
