Hail Damage to Shingles

Part II

By COLIN MURPHY, RRC, ROBERT MILLS AND REMO CAPOLINO

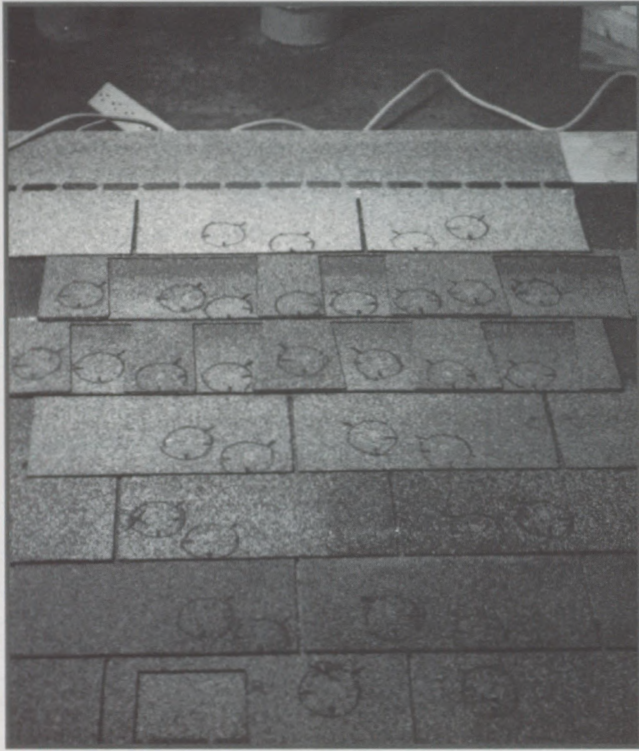
Overview of shingle test assembly

The field sampled shingles were visually and microscopically examined for hail damage. The samples were subsequently used in conjunction with new shingles to construct hail test specimens for examining the aforementioned assembly-related variables. All test panels were conditioned under heat lamps for a period of 72 hours prior to testing to activate the "hold-down" tabs and to allow the shingle components to conform to underlying shingles and substrate components.

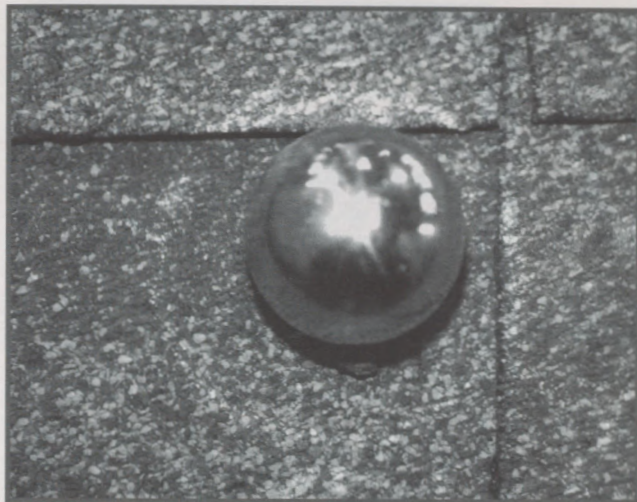
View of steel ball at impact location

As noted above, the Factory Mutual hail test method was first published in 1986 as an amendment to its Test Standard 4470. The method specifies use of fixed sizes and weights of steel balls dropped from fixed heights to incur a specific impact energy on the target area. The impact energies, based on the steel ball's potential energy prior to the drop, are set at 8 ft-lbf (11 Joules) for moderate hail and 14 ft-lbf (19 Joules) for severe hail. The test standard requires testing of an assembly including the insulation layer and fasteners (if any). The point of impact is viewed for 1) membrane damage and 2) loss of adhesion to the underlying layer when the assembly is fully adhered. Roof assemblies are tested for "severe hail" when use of the assembly is anticipated within an area designed for severe hail in the Factory Mutual Loss Prevention Data Sheet 1-47S.¹⁹ The hail test, which includes testing of both new and weathered samples, is set forth as one of several performance tests required for FM Approved, Class 1 Roof Covers, a category in which asphalt shingle systems do not apply.
