Don't Tread On Me

Guidelines & Helpful Hints for Walking on Roofs

BY KARL A. SCHAACK, P.E., RRC

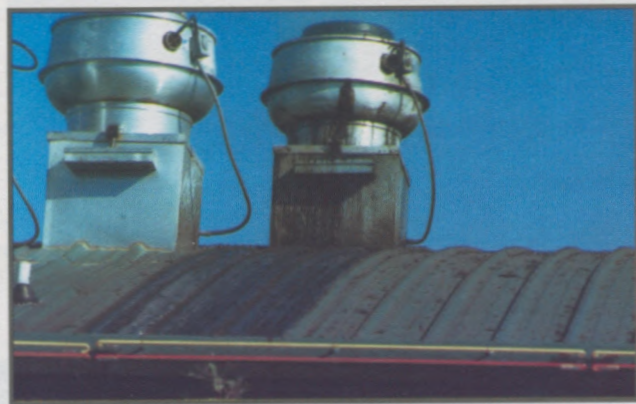
Grease discharged on surface of metal panel roof system.

Manmade emissions and/or contaminants such as grease and/or oil from HVAC equipment, exhaust vents, and facility operations (i.e., jet fuel at airports, grease exhaust vents above restaurants) can become deposited on the roof, consequently creating slippery surfaces for smooth-surfaced roof coverings. Other manmade types of elements such as sawdust and metal shavings (both commonly created during the construction/installation of the roof) can also create difficulties when accessing a roof.

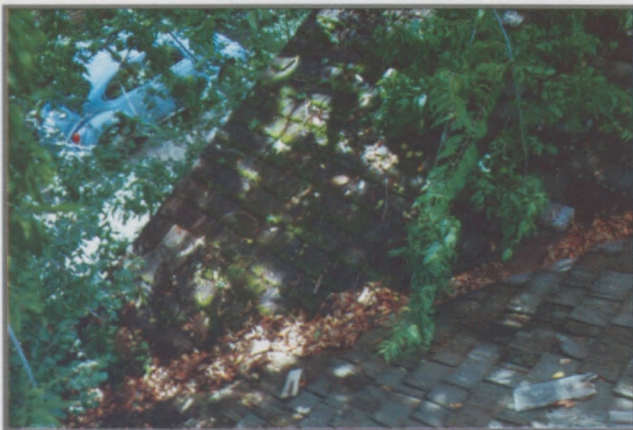
Moss growth on wood shingle roof covering.

algae/moss growth on the surface of the shingle, particularly in shaded areas of the roof. Algae/moss growth on the surface of wood shingles fosters problematic conditions that can prevent adequate foot hold. In addition, the ridge cap shingles are typically the least supported of the shingles due to the nature of the installation and are often thinner sections of wood. Therefore, walking on the ridge of a wood shingle roof covering should be avoided to prevent resultant damage.

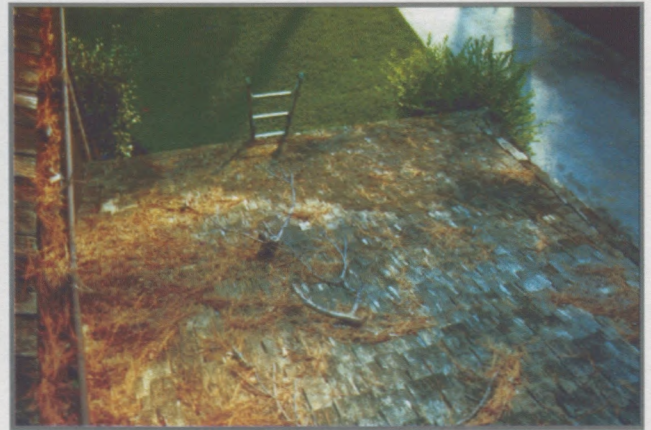
Pine needle accumulation on wood shingle roof covering.

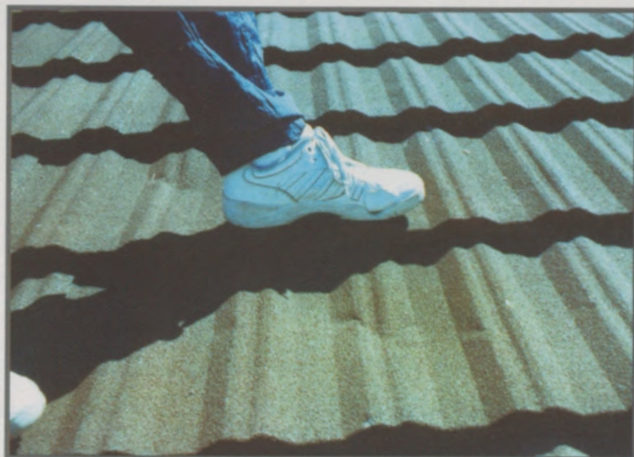
Proper foot position on metal tile panels.

installed over wood battens and joined to each other by snap-lock types of seams at the ends and sides. Since the panels are installed over battens, the portion of the panel between the battens is unsupported. Foot pressure applied in the field of the panel can cause permanent depressions. An individual should position footholds on the overlapped portions of the panels that are located over the wood battens. This particular portion of the panel is more resistant to foot impact.

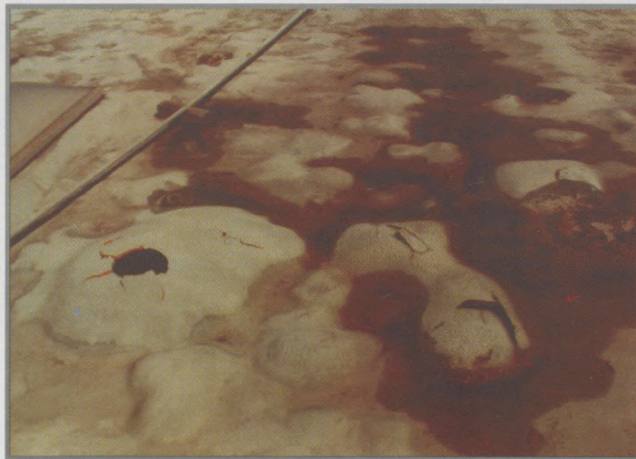
Blisters in spray-applied polyurethane foam roof system.

Similar to built-up roof systems, blisters and/or raised delaminated areas can be present in spray-applied polyurethane foam (SPUF) roof coverings. SPUF is installed in either single or multiple layers or lifts. A single lift commonly has an overall thickness of one inch. When a blister or delaminated area occurs, the top layer(s) separate(s) or become detached from the underlying substrate. This delaminated portion and relatively thin section of foam becomes unsupported and can easily be damaged by foot impact.
