# Hail Damage To Shingles

## Part III

BY COLIN MURPHY, RRC, ROBERT MILLS AND STEVE BUNN

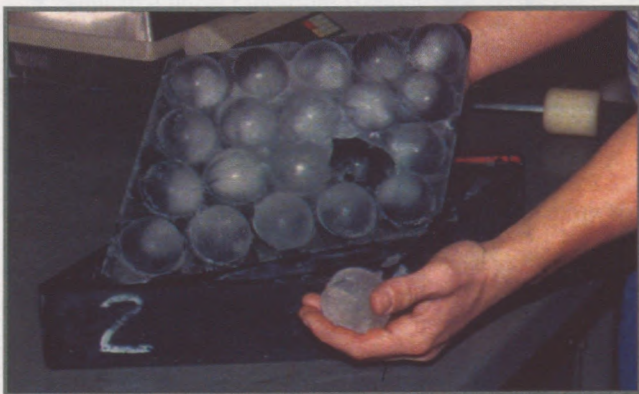
*Hailstones manufactured for Haag Engineering testing.*

In 1993, Haag Engineering developed a further test protocol utilizing frozen ice balls to simulate hailstones fired from a compressed air gun, as described in an article titled, "Hail and Composition Shingles."<sup>5</sup> The author, Scott J. Morrison, P.E., further refined the analysis of impact damage by desat-

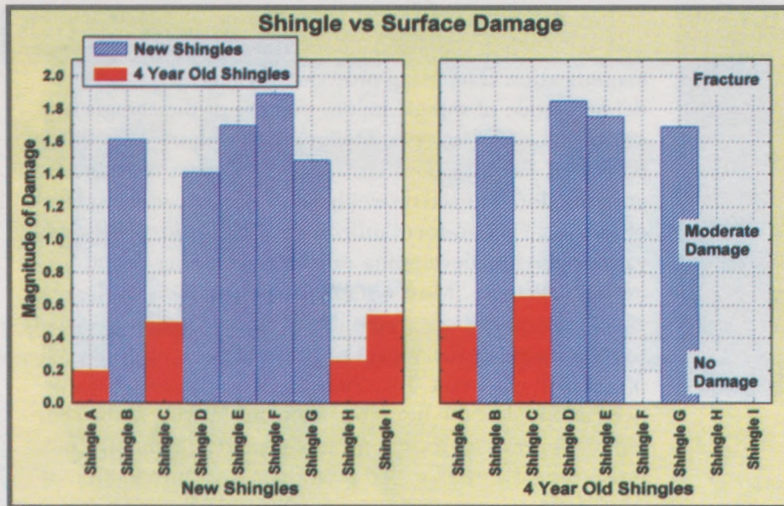
SBS modified shingles were more resistant to surface damage.

- ▼ SBS modified asphalt shingles exhibited less damage to both the surface and the mat when compared to all oxidized asphalt shingles tested within the series;

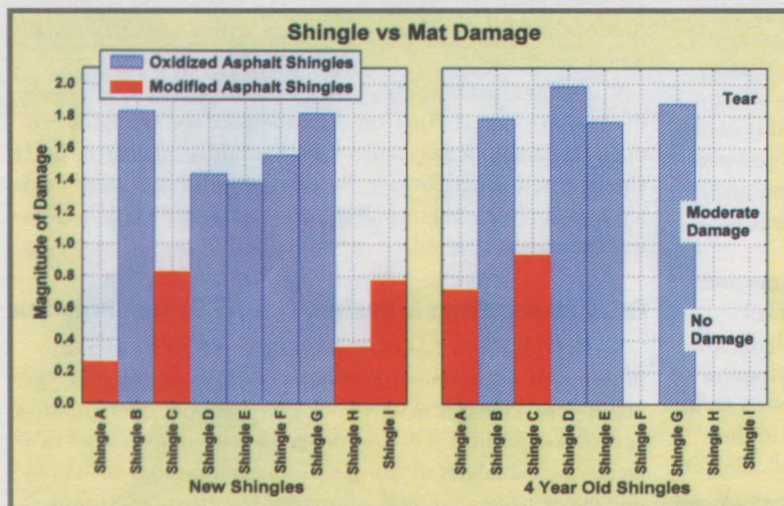
SBS modified shingles were less resistant to impact damage.

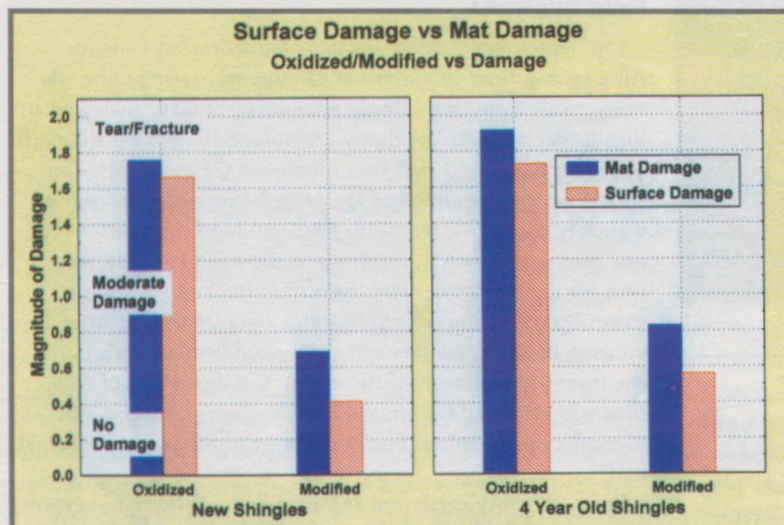
Surface damage is less indicative of mat damage for modified shingles.

- ▼ Surface damage and mat damage for SBS modified asphalt shingles are in general agreement; however, the visual observation of mat damage is greater than visual observations of surface damage;

- ▼ While the surface damage to oxidized asphalt shingles is a good indicator of mat damage, determination of mat damage in SBS modified asphalt shingles solely from visual observation of surface damage is difficult. As a result, to properly document damage to SBS modified asphalt shingles, the shingle must be desaturated to better identify the full extent of the damage. This issue becomes relevant as more SBS modified asphalt shingles enter the market and more insurance authorities turn to the UL 2218 procedure as a basis of premium reduction. The new UL 2218 test procedure requires a visual examination of the shingle surface; however, it does not require shingle desaturation for examination of the mat. The UL 2218 may not provide the most accurate measure of impact damage when testing SBS modified asphalt shingles.

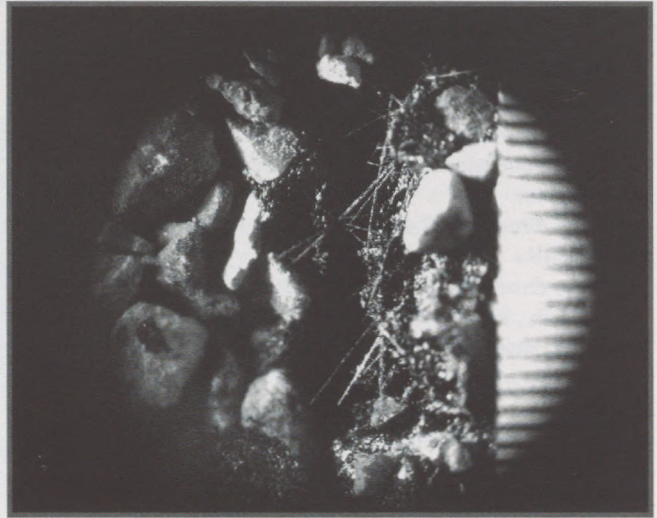
Severe hail: surface fracture damage.

Upon completion of the testing, the impacted area was removed and examined through 5x magnification. Three analysts qualitatively evaluated the damage on a three-point scale of 0 to 2. A recording of "0" indicated no damage, "1" indicated moderate damage and "2" indicated a surface fracture or other pre-defined severe damage. During the analysis, there was complete agreement between the three parties for approximately 85% of the samples. When there were differences in opinion, the group of three met to arrive at a mutual consensus on the numeric value. After the surface damage had been numerically recorded, the area of impact
