# Keeping Great Performances "Under Cover" at the Kennedy Center

**Required: The Best Materials and a Well-Orchestrated Effort to Apply Them**

BY SWEN E. SWENSON III, CSI

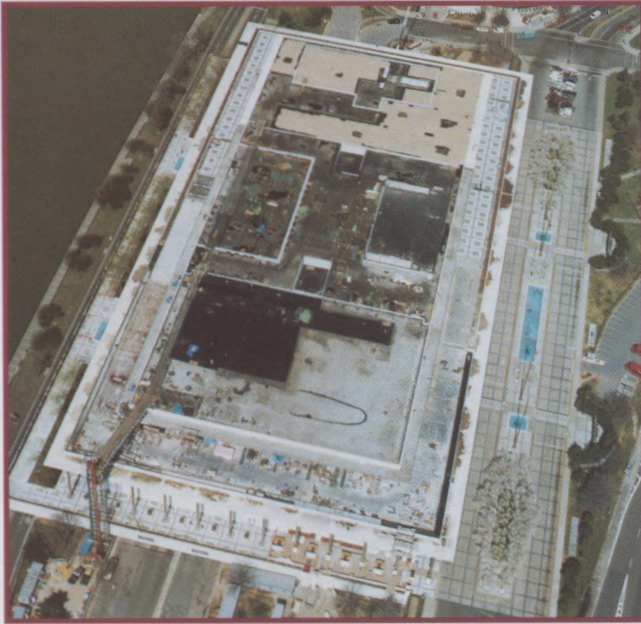
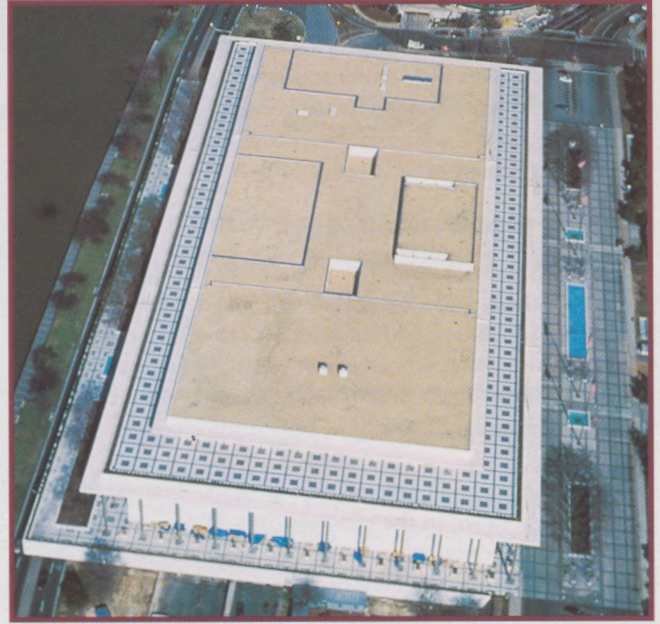
All phases of the job can be viewed in the photograph at the left. At the bottom (south end) is the external elevator that was used throughout the job. The south third of roof shows bare concrete slab and a section of the installed vapor barrier. The rectangular area on the east (right) side of the middle section contains the acoustic slabs that were left in place under the concrete in a creative solution that avoided the additional work of removing concrete deck. New 2-ply, insulation board, built-up roofing and gravel top coat were installed over the concrete, leaving the old insulation undisturbed. The tan areas on the north end of the building show finished roof with top coat of tar and river gravel. The photograph at the right shows the completed roof. Installation took 19 months.
