EVALUATING STORM DAMAGE TO FLAT-ROOF ASSEMBLIES

**Christopher W. Giffin and
James M. Brown
Wiss, Janney, Elstner
Associates, Inc.
Duluth, GA**

Evaluating Storm Damage to Flat-Roof Assemblies

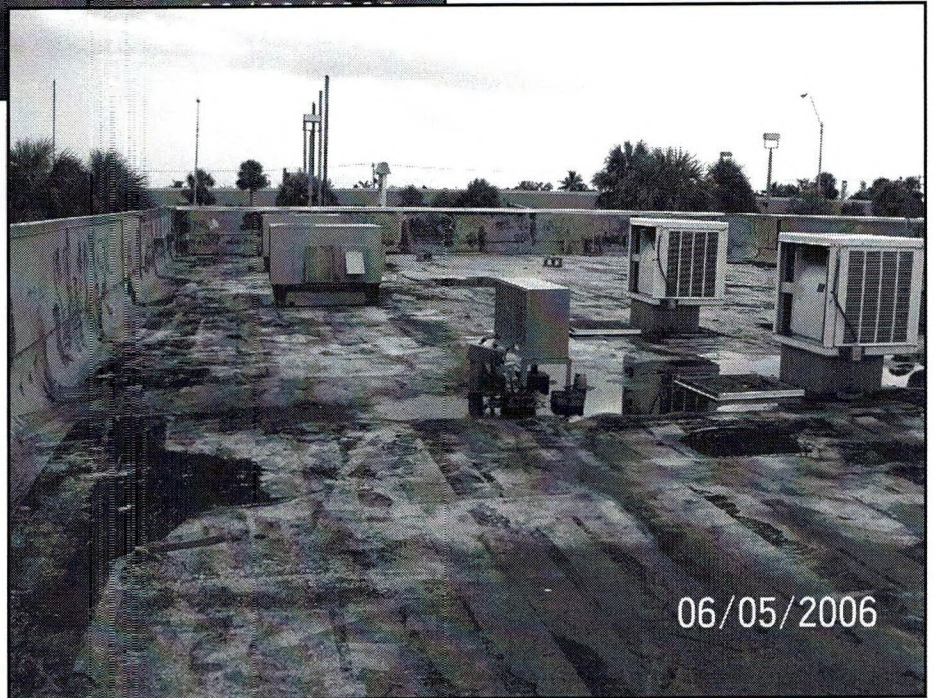
Figures 3 and 4 – Examples of natural weathering observed on a flat-roof system.

Natural weathering of granule-surfaced modified-bitumen and built-up roof membranes includes uniform loss of granules, exposed reinforcing fabric, cracked and brittle membranes, blisters, ridges, and splits (*Figures 3 and 4*). Natural weathering can also be from entrapped water

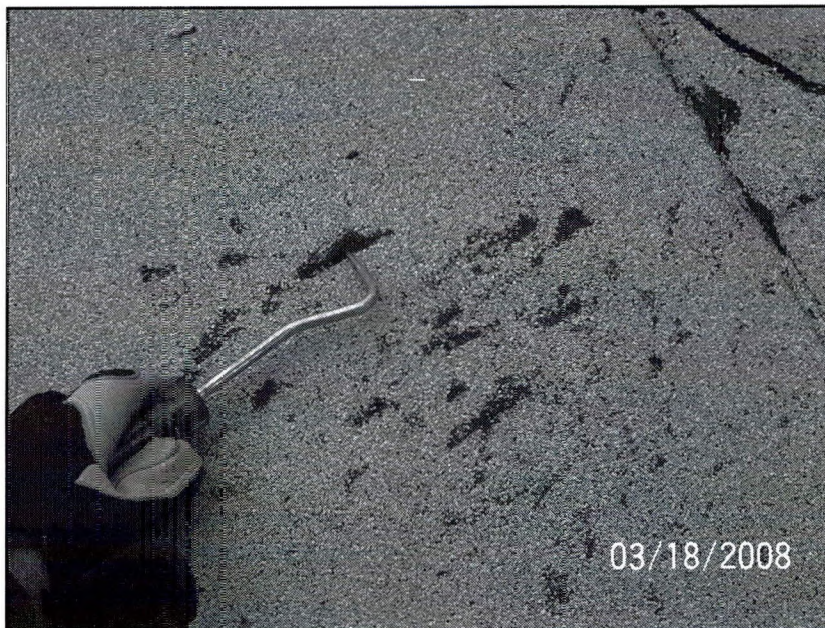
Figure 5 – Example of storm damage to granule-surfaced modified-bitumen membrane from glass debris.

Storm damage to granule-surfaced modified bitumen and built-up roof membranes includes punctures and scrapes from foreign object impact, scoured and missing areas of granules or gravel surfacing, uplifted and detached roof membrane, broken and damaged roof insulation, and missing areas of the roof assembly (Figure 5 and 6). Storm damage to fully adhered thermoplastic and thermoset membranes can include punctures, cuts and tears, uplifted and

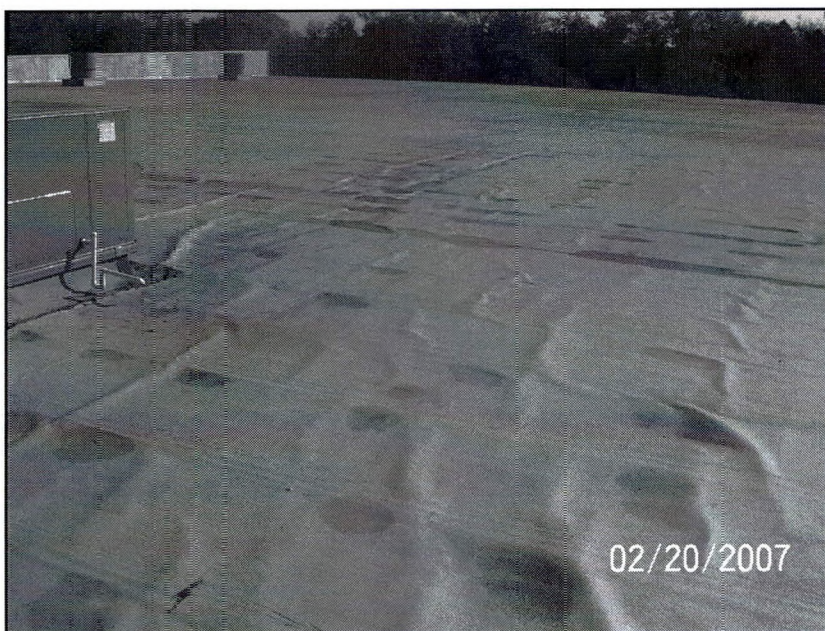
Figure 6 – Example of wind uplift damage to a portion of a smooth-surfaced modified-bitumen roof membrane.

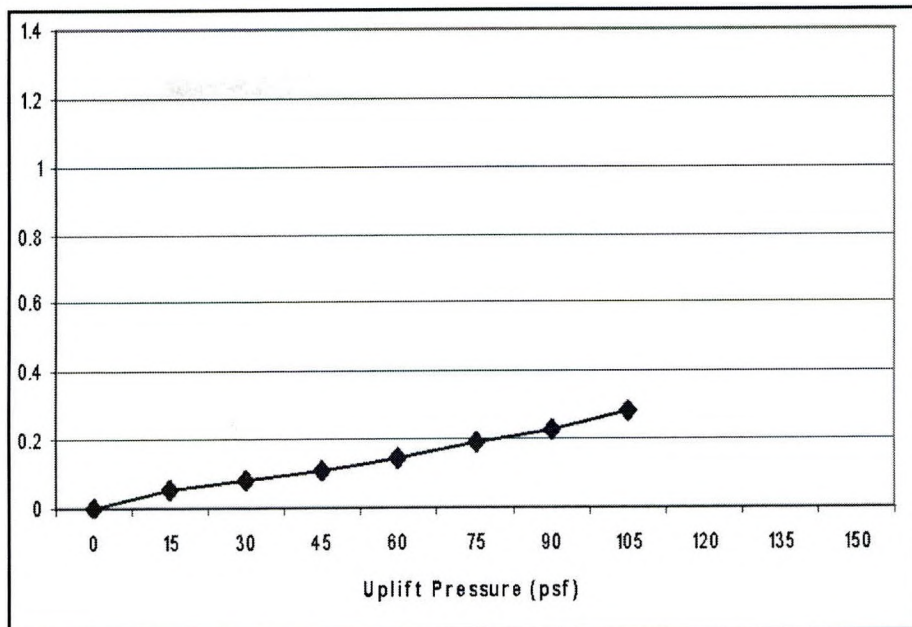
Figure 9 – Diagram Type 1 where the roof is well adhered during the uplift test.

cated by a shallow sloping line that gradually increases in deflection as the negative pressure is applied (*Figure 9*). The deflection of the roof also does not exceed 1 inch during the pressure increments. This test demonstrates that the roof assembly was well adhered and attached to the structure prior to the start of the test and remained attached upon completion of the test. As a result, the tested roof membrane was not uplifted by a storm event.

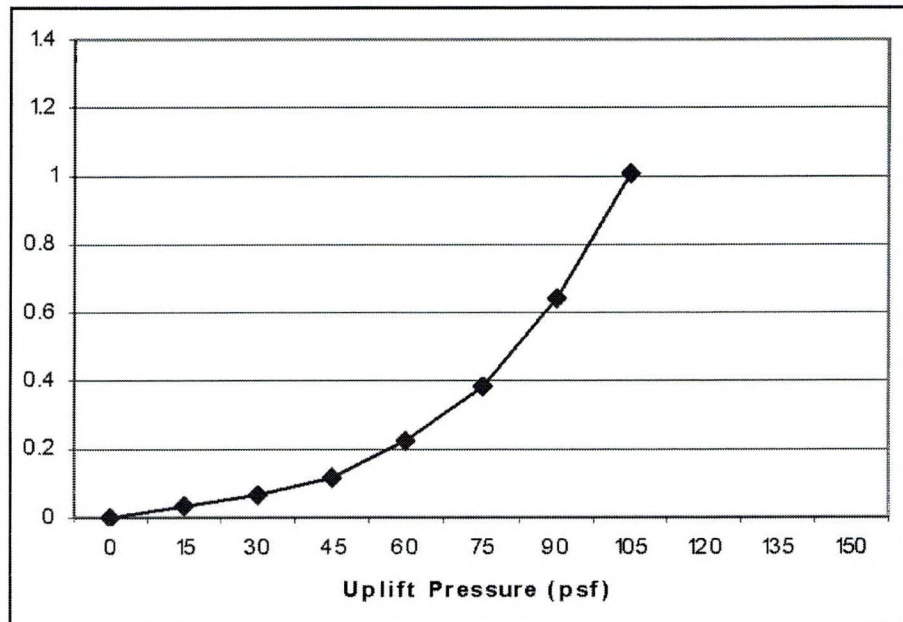
The second type of diagram is an increasingly steeper curve, or an exponential type of curve where the line starts out on a shallow slope, then increases during each pressure increment (*Figure 10*). This would indicate that the roof assembly resisted the initial negative loads applied, then progressively delaminated cohesively or adhesively as the pressures increased. The deflection recorded at the end of the test may or may not have exceeded 1 inch. With this diagram, there is no clear spike or sudden increase in the deflection as the pressure increases. This test demonstrates that the roof assembly was well adhered and attached to the

Figure 10 – Diagram Type 2 where the roof progressively fails during the uplift test.

structure prior to the start of the test and failed during the test, if the deflection exceeded 1 inch. As a result, the test also indicates the tested roof membrane was not uplifted by a storm event.

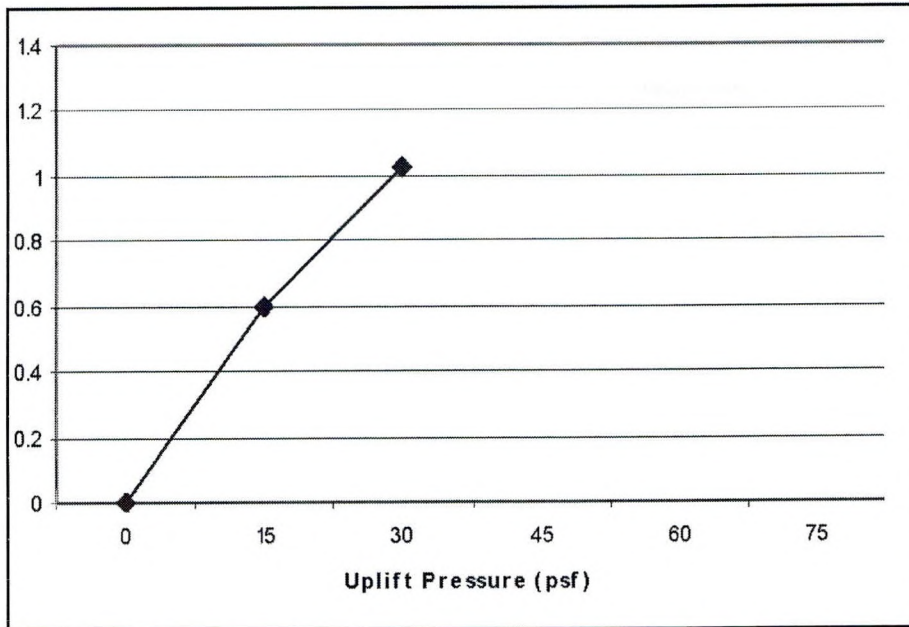
The fourth type of diagram is one that jumps steeply upward within the first pressure increment (*Figure 12*). This type of diagram would indicate the roof assembly was not attached, as it could not resist any load. Often, the deflection exceeds 1 inch within the initial 15-psf negative loading. This type of diagram might indicate that the roof was uplifted and damaged during a storm event. It is important to note that further investigation

Figure 12 – Diagram Type 4 where the roof membrane is not adhered.

and analysis are required to determine the failure plane within the roof assembly and the condition of the installed materials. This is often done with inspection openings at the test location to identify why and how the roof failed the test. The delamination and failure of the roof could be the result of installation problems, wet materials, natural weathering, or from storm damage.

The fourth type of diagram is the only one of the four mentioned where actual storm damage might have been detected. Inspection openings are required to verify the test results and to confirm if the lack of uplift resistance was from storm damage. The other three stress/strain diagrams indicate that the roof assembly was not damaged as a result of a storm. When a roof membrane is subjected to the negative pressures exerted on it by the effects of a storm, the roof materials will either resist the pressures or fail and become detached from the substrate. When roof assemblies are uplifted to the point of failure during a storm event, the effects are immediate and irreversible. The roof
