Blindside Waterproofing Systems for Hydrostatic Conditions: Lessons Learned & Good Practices

By Christopher McConnell, BTech

This paper was presented at the 2024 IIBEC/OBEC BES.

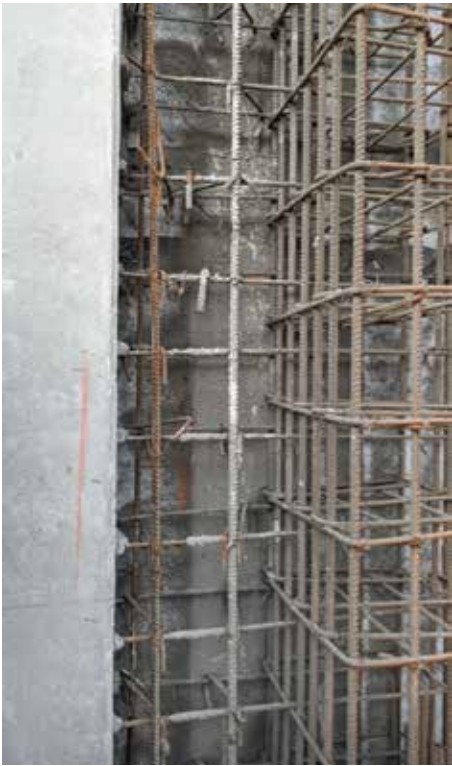
Figure 3. Shotcrete overspray on sheet membrane after form work was removed. No additional overspray removals were expected.

During the review of the documentation, we were able to identify several areas where the waterproofing was covered in overspray material from the shotcrete process (Fig. 3 and 4). This information helped us to see a possible correlation between some of the leak locations of the constructed walls (Fig. 5 and 6). We used this information to help in the selection of walls

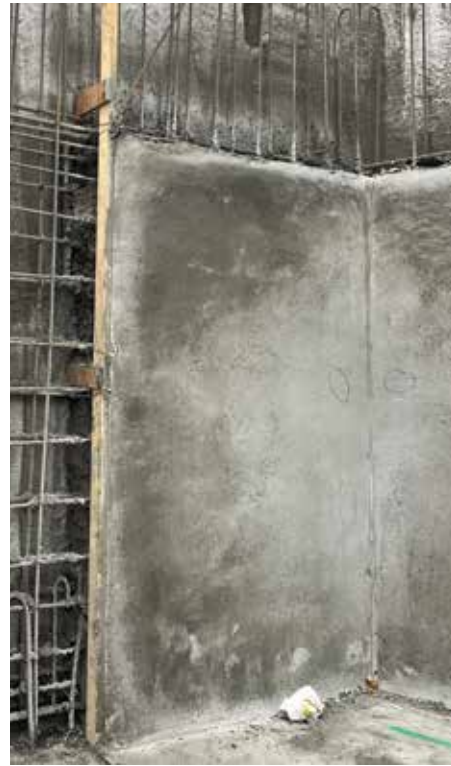
Figure 4. Shotcrete installation on sheet membrane and overspray is approximately 2 ft (0.6 m) beyond construction joints.

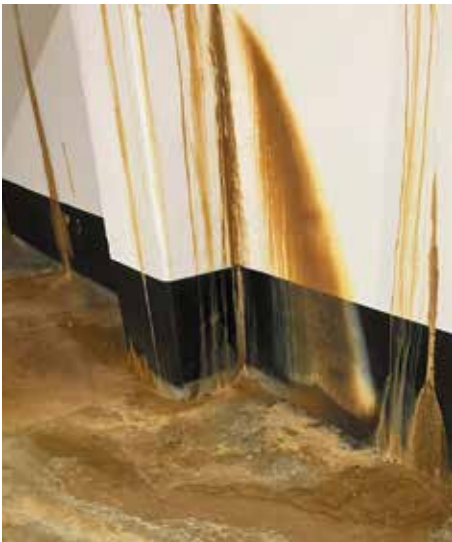
Figure 5. Water infiltration through foundation wall at column location.

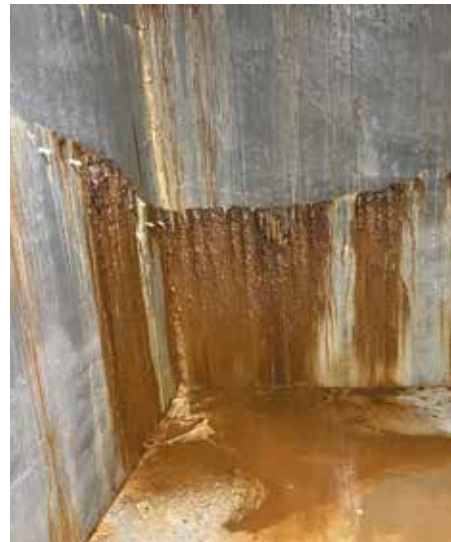
Figure 6. Water infiltration through foundation wall cracks at corner.

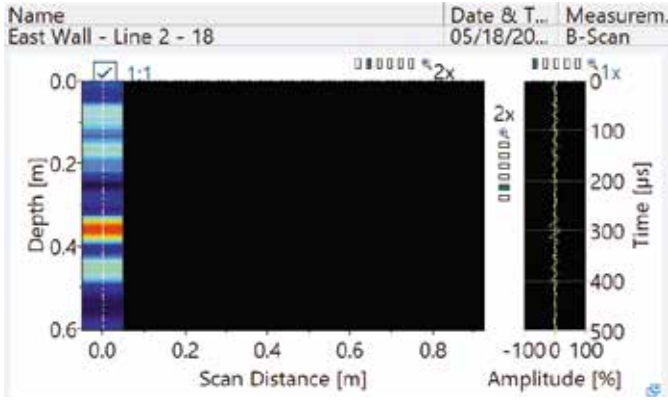
The UPE analysis provides information through acoustic stress waves from the interior surface of the foundation wall to the caisson wall and, in some cases, through the caisson wall. These waves help to locate defects or anomalies in the concrete wall that are dissimilar to solid concrete. This information can be utilized to extract information pertaining to the condition

of the shotcrete, which identifies anomalies along the path of the UPE signal. A review of these results can tell us if there are areas of voids, cavities, or gaps in construction. We were able to use this information to not only find areas of concern in the shotcrete but also to find areas of membrane bonding issues, with a good degree of accuracy. In addition, we found and mapped out the locations of tiebacks where the signal reflection was much shorter due to the

Figure 7. Ultrasonic pulse echo analysis measurement at unconsolidated concrete location.

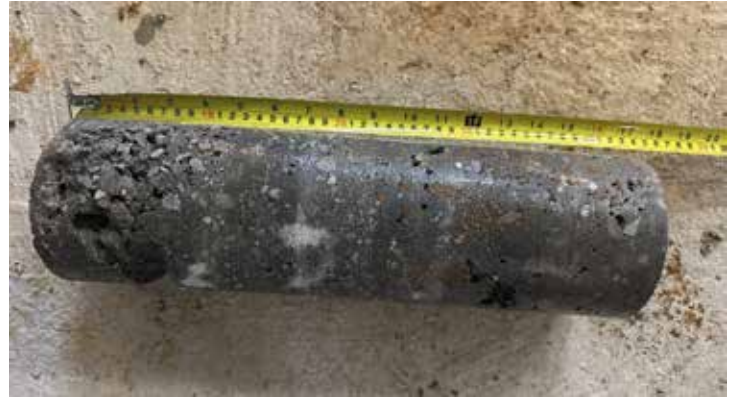
Following the coring process, it was confirmed that the membrane had adhesion issues. This appears to have been caused by shotcrete overspray, unconsolidated concrete (voids) and material bonding issues with the dryer mix of the shotcrete. What we did not expect to find was that the shotcrete and liquid waterproofing materials that are used to detail tiebacks were not adhered, either. It was also discovered that one area had unconsolidated concrete at the backside of the foundation wall (Fig. 7 and 8), rebar shadowing had occurred (Fig. 9 and 10), and a waterproofing lap joint was not fully adhered (Fig. 11 and 12). The extensive water intrusion through the foundation wall was the result of several failure modes such as tieback anchors, unbonded membrane at shotcrete overspray locations, and partially bonded overlap joints. For more information on this subject please refer to my first paper published through the 16th annual Canadian Conference on Building Science and Technology titled "Lessons Learned: Moisture Ingress Protective Waterproofing Systems."

Figure 8. Extracted core from foundation wall showing unconsolidated concrete.

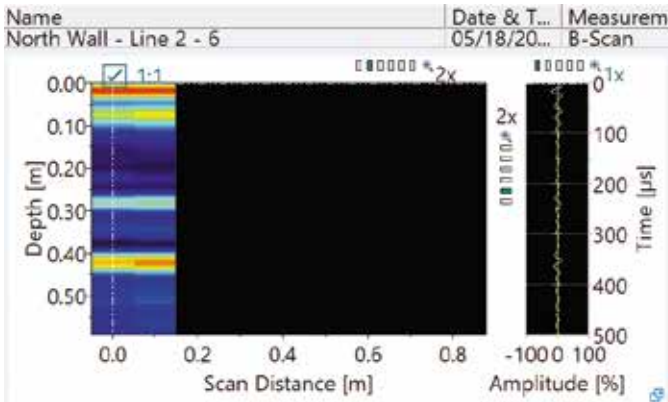
Figure 9. Ultrasonic pulse echo analysis measurement at reinforcement bar shadowing location.

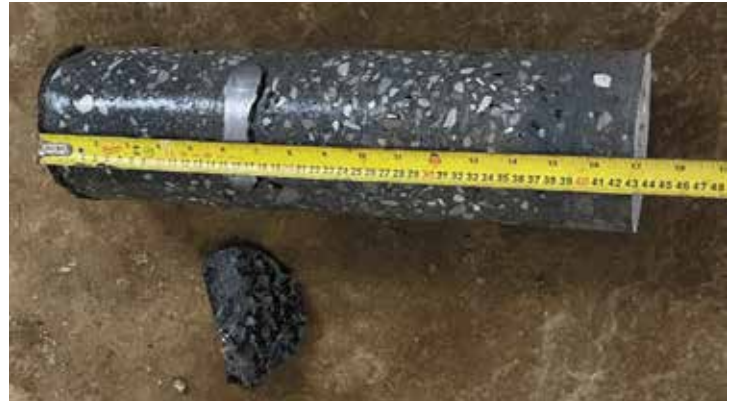
Figure 10. Extracted core from foundation wall showing reinforcement bar shadowing.

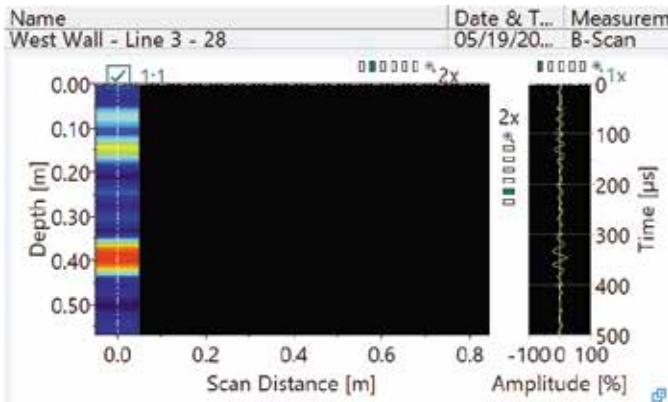
Figure 11. Ultrasonic pulse echo analysis of concrete where lap detail and waterproofing adhesion failure were found.

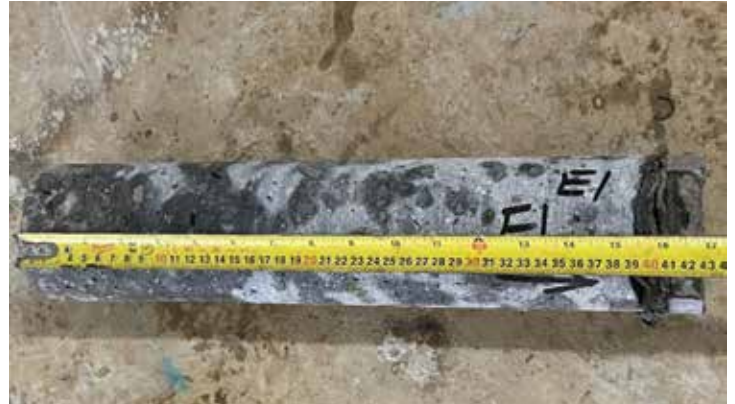
Figure 12. Extracted core of foundation wall waterproofing where the membrane was not adhered due to shotcrete overspray.

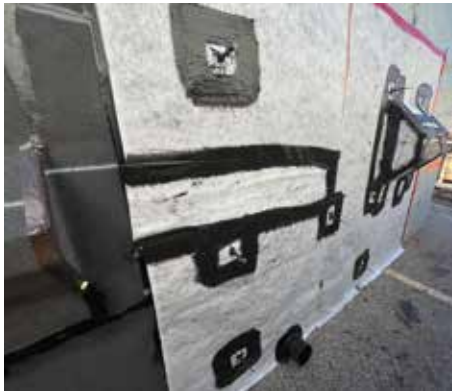
Figure 13. Elastomeric sheet waterproofing installed.

boards (**Fig. 13-16**). The intent of these mock-ups was to review the waterproofing systems following the installation of reinforcement and concrete for a 1.83 m (6 ft) high wall with details reflective of real-world construction practices (as can be reasonably duplicated). The concrete was poured using a bucket attached to a crane to drop the concrete into the forms with no protection to the overlap waterproofing material.

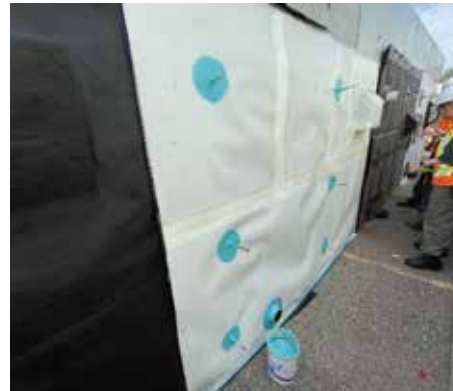
Figure 14. High-density polyethylene sheet waterproofing installed.

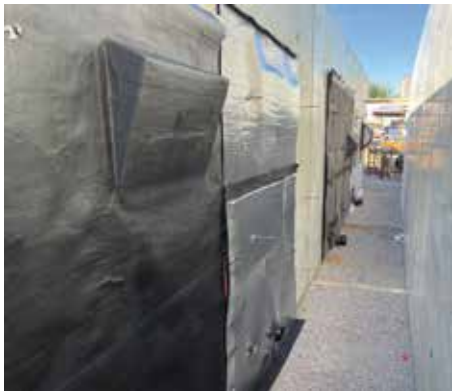
Figure 15. Elastomeric spray applied waterproofing installed.

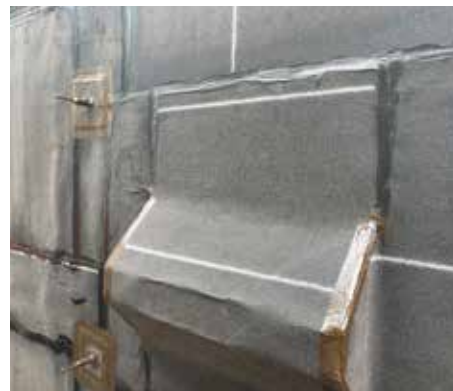
Figure 16. Styrene butadiene styrene modified bitumen waterproofing installed.

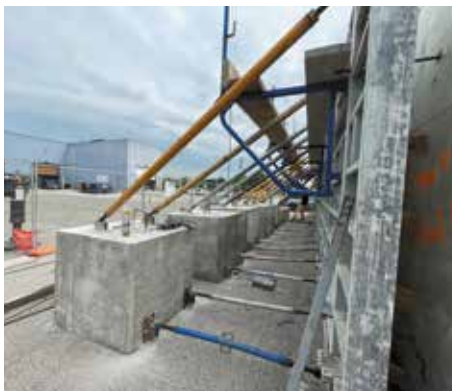
Figure 17. Formwork in place for pouring of concrete from bucket.

Once the concrete reached acceptable structural capacity (confirmed using concrete cylinders cast for each wall) the backside of the forms where the waterproofing was installed against were removed (**Fig. 17**). This exposed the waterproofing material which was bonded against the exterior face of the foundation wall mock-up. Following the exposure of the waterproofing materials, we removed the drainage boards where possible (some of the systems the drainage board are bonded to the membrane as part of the installation process) to expose the membrane at these drainboard locations. A visual and tactile review of the membranes took place to identify possible areas of debonding. Areas that were suspected of debonding were checked by completing a field adhesion test (the membrane was cut with a knife in a rectangle around the suspected area and grabbing the top of the cut section and attempting to remove by pulling perpendicular to the wall). A majority of the suspected areas were unbonded with some membranes performing better than others. A contributing factor to the unbonded waterproofing appears to be due to consolidation issues of the concrete (vibration was inadequate). During the visual review we also noted that the top of the waterproof membranes were covered in concrete splatter from the installation of the concrete (**Fig. 18**). Based on these findings the details and material selection are not the only major requirements but also the installation of concrete and the placement of the reinforcement within the foundation walls.

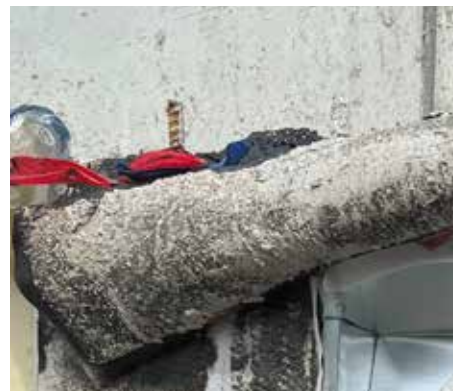
Figure 18. Concrete splatter is found on overlap joint above the concrete pour.
