# Impact Resistance of Roof Coverings

By Stephen Patterson, F-IIBEC, RRC, PE, and Jordan D. Beckner, RRC, PE

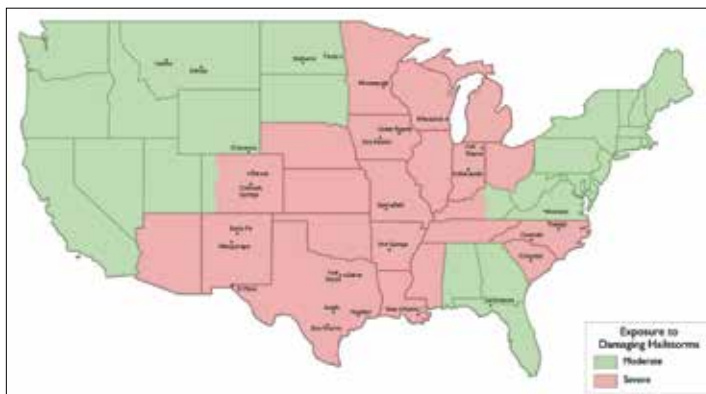
**Figure 2.** A map showing the approximate areas of the US where severe hail and moderate hail could be expected in 2009.

In conjunction with changes to the maps in 2009 and 2014, there were also changes to the hail resistance rating required for each of the very severe, severe, and moderate hail exposure risks that correspond to the map in **Fig. 2** and **3**, respectively.

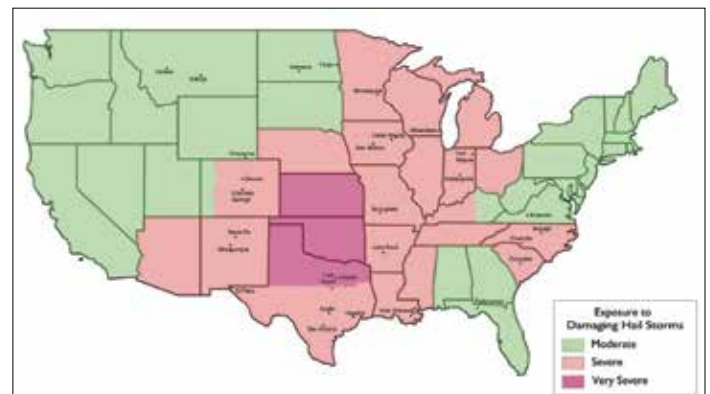
**Figure 3.** A map showing the approximate areas of the US at risk for very severe hail, severe hail, and moderate hail in 2014.

In 2014, FM DS 1-34 revised the hail hazard map to include an area of very severe hail that generally represented the historical hail belt shown in **Fig. 1**. **Figure 3** shows the approximate areas at risk for very severe hail, severe hail, and moderate hail in 2014.

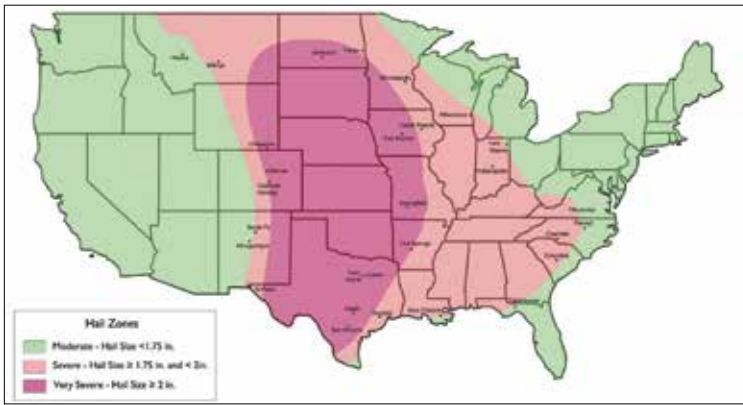
**Figure 4.** In 2018, FM revised their Hailstone Hazards Map, enlarging the area where very severe and severe hail can be expected.

In 2018, FM once again revised the Hailstone Hazards Map, enlarging the area where very severe and severe hail can be expected, as shown in **Fig. 4**.

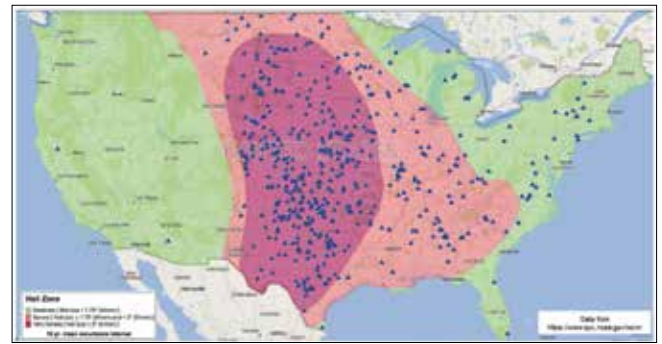
**Figure 5.** In 2022, FM DS 1-34 revised the map showing the areas where hail with diameters greater than or equal to 3 in. (76 mm) and greater than 4 in. (102 mm) fell based on National Weather Service data between 2009 and 2021.

In 2022, FM DS 1-34 revised their map showing the areas where hail with diameters greater than or equal to 3 in. (76 mm) and greater than 4 in. (102 mm) fell based on National Weather Service data between 2009 and 2021. The FM map shown in **Fig. 5** generally correlates to the maps produced

by the National Oceanic and Atmospheric Administration (NOAA) that are shown in **Fig. 6**.<sup>16</sup> The important difference is that FM assigns hail-resistant classifications to their maps. The FM hail-resistant classifications are based on industry standard testing protocols that roofing manufacturers and others rely on.

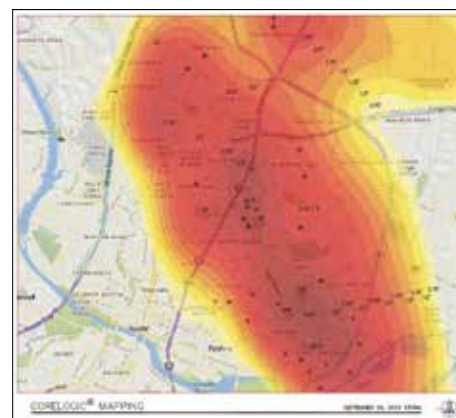
**Figure 9.** This map shows the estimated maximum hail size occurring in Austin on September 24, 2023. The map is based on a proprietary evaluation of the meteorological data. The 38 locations inspected are shown on the map.

On one project in 2023, Rooftech inspected 38 buildings in Austin, Texas, that had been impacted by hail ranging in size from 1.75 in. (44 mm) to more than 3 in. (76 mm) in diameter.

Many of the roofs were thermoplastic, typically TPO, single-ply roof membranes over dense cover boards that met FM's criteria for severe and very severe hail ratings. Most of the roofs with hail 2 in. (51 mm) or larger were damaged and had been installed over a soft substrate. None of the roofs installed over dense cover boards were damaged by hail, even from hail in the 3 in. range. The use of hail-resistant roofs over dense cover boards saved millions of dollars. **Figure 9** shows a map of the estimated maximum hail size occurring in Austin on September 24, 2023. The map is based on a proprietary evaluation of the meteorological data. The 38 locations inspected are shown on the map.

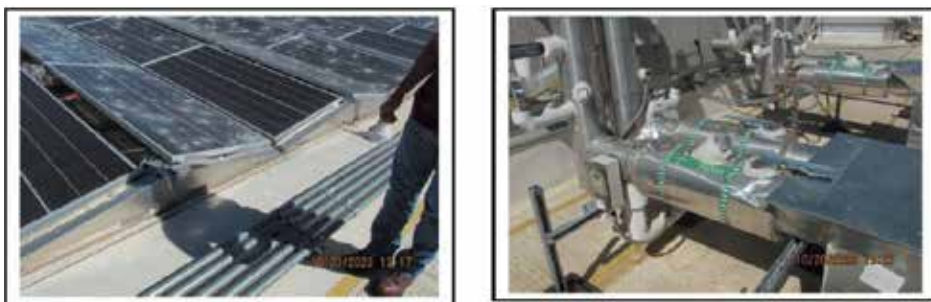
**Figure 11.** The solar panels were destroyed by hail, and the fractures in the panels were in the 2.5 in. (64 mm) to 3 in. (76 mm) range.

**Figure 11** shows some of the collateral damage. The solar panels were literally destroyed, and the fractures in the panels were in the 2.5 in. (64 mm) to 3 in. (76 mm) range. The conclusion was that the installation of hail-resistant roof systems prevents hail damage from the vast majority of hail events.

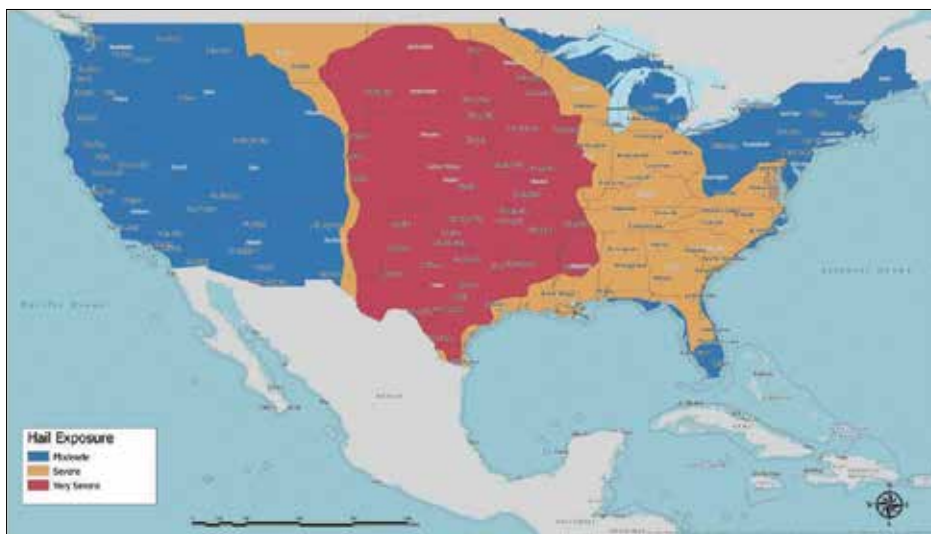
**Figure 12.** This map shows hail resistance exposure.

**1504.7 Impact resistance.** Roof coverings installed on low-slope roofs in accordance with Section 1507 shall resist impact damage based on the results of tests conducted in accordance with the Hail Damage Resistance test of FM 4470 or UL 2281. Hail resistance exposure shall be determined by **Fig. 12**, which is derived from the map in FM DS 1-34.
