Best Practices for a Successful Natatorium Enclosure

By Jonathan Smegal, MAsC, PEng;
John Straube, PhD, PEng; Chris Schumacher,
MAsC, BAsC, BTech, BECxP, CxA+BE; and
Aaron Grin, MAsC, PEng

*This paper was presented at the 2024 IIBEC/
OBEC BES.*

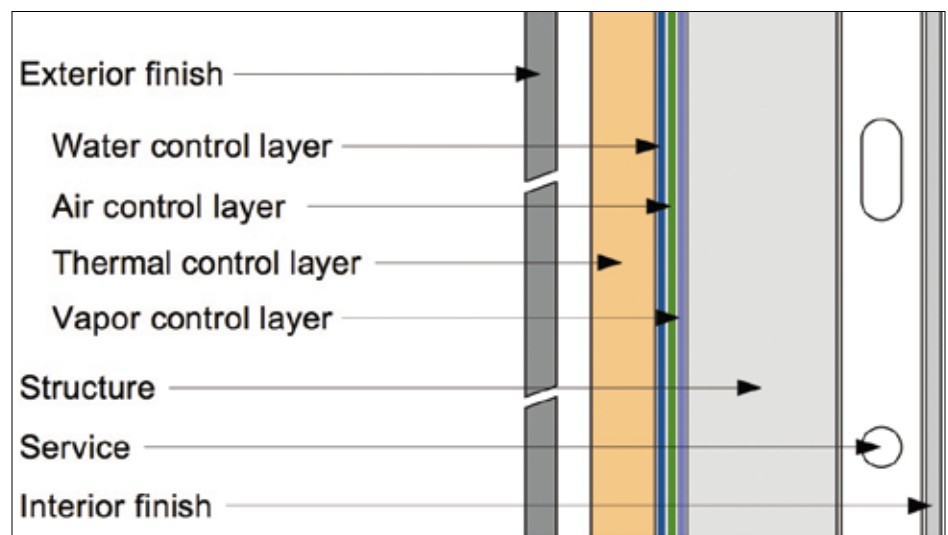
Figure 1. Schematic for an exterior insulated enclosure wall assembly.

A conceptual representation of an ideal exterior insulation strategy is illustrated in **Fig. 1**. The image shows a schematic identifying the structural, finish, and control layers in the enclosure. The structure (concrete masonry unit [CMU], steel, wood, insulated concrete form, mass timber, etc.) is covered with continuous water, air, and vapor control layers, which are all covered by continuous exterior insulation. The insulation could be rigid foam, semi-rigid stone wool, or medium-density (i.e., 32 kg/m³ or 2 pcf) closed-cell spray polyurethane foam (ccSPF). This strategy ensures the air barrier system is well supported by the structure and protected from temperature fluctuations and ultraviolet light. When this strategy is used in design and the structure is well constructed, issues with the wall assembly are rare because of the continuity of the control layers. However, as is typical with enclosure issues, the problems often occur at penetrations and transitions, which is why it is critical for the designer to provide clear, constructible details for all penetrations and transitions within the enclosure.

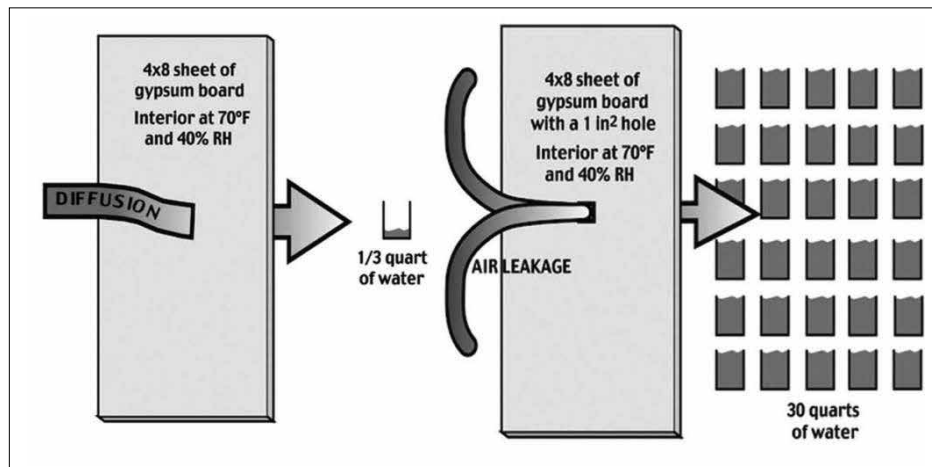
Figure 2. Illustration explaining the relative water vapor movement from vapor diffusion and air leakage. Source: *buildingscience.com*.

Fig. 2 illustrates how much more water vapor can be moved by air movement than by vapor diffusion, further emphasizing the need for a continuous air barrier membrane in the enclosure. Depending on the height of the space, stack effect can be substantial and cause continuous air leakage through the roof system.

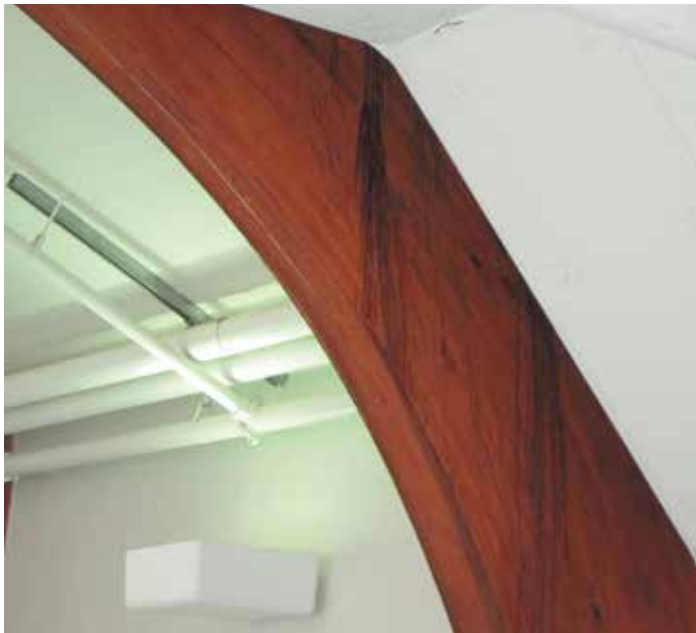
Figure 3. Staining from the roof on the interior structure.

Case Study 1 is a wood-framed pool building within a ski resort located in the northeastern US. The owners had observed some dripping and staining from the roof assembly onto the glulam structural beams of the building (**Fig. 3**), and the exterior roof surface on the north side of the building appeared to be uneven. The key issue related to enclosure durability was air leakage condensation that led to moisture accumulation in the roof and, to a lesser extent, in the walls. The panelized wood-framed roof construction was assembled on the ground as panels adjacent to the building and lifted into place onto the glulam beams. The panels themselves were constructed to be quite airtight: they were constructed with 10 in. (254 mm) engineered wood joists (e.g., TJIs) and were nearly full of ccSPF insulation. ccSPF insulation is an air and vapor barrier; however, at any joints where there is no insulation, such as panel joints, air control must be maintained. Continuity of the control layers between panels can be a challenge. In this case, when the panels were set on the glulam structure, the air barrier was not made continuous between the panels. This allowed the slow movement of moisture-laden air through the gap between the panels, which reached the cooler roof surface and then condensed. The moist conditions resulted in rot and decay of the wood materials in the roof assembly at the joints between the panels (**Fig. 4**), which slowly spread to the rest of the panel. The deterioration was greatest on the north orientation, which is to be expected due to the lower amount of solar energy available for drying. The deterioration was so widespread that there was some concern about the roof collapsing. Dark drips stained the sides of the glulam beams due to the condensate that eventually started rotting out the wood in the roof and turned the condensate a dark brown color when it drained back into the building. The glulam beams were structurally sound, just stained, so the remediation involved replacing the roof with panelized wood-framed construction. The replacement required careful air barrier continuity detail at the joints, as shown in **Fig. 5**, and a completely exterior insulated roof assembly.

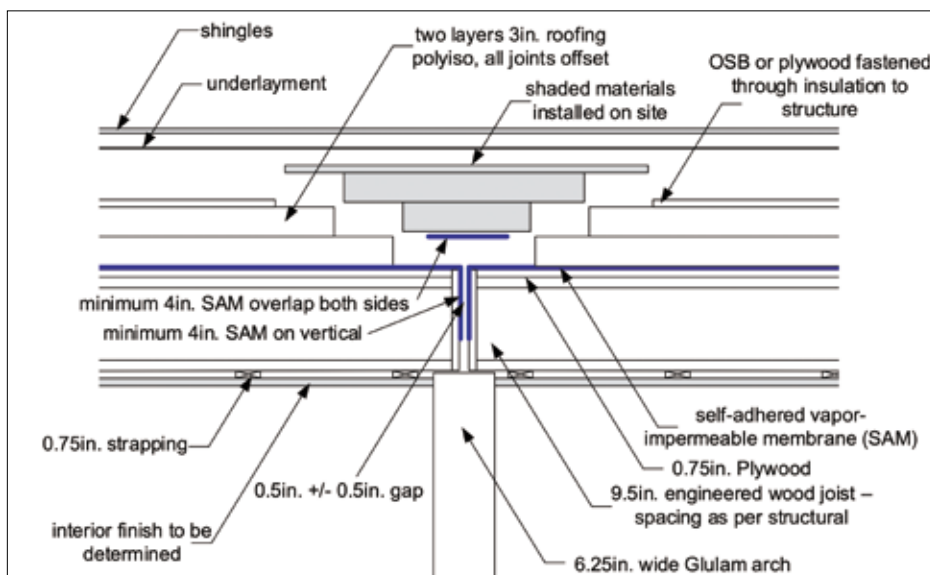
Figure 5. Schematic of the roof repair ensuring the air barrier continuity on the warm side of the insulation.

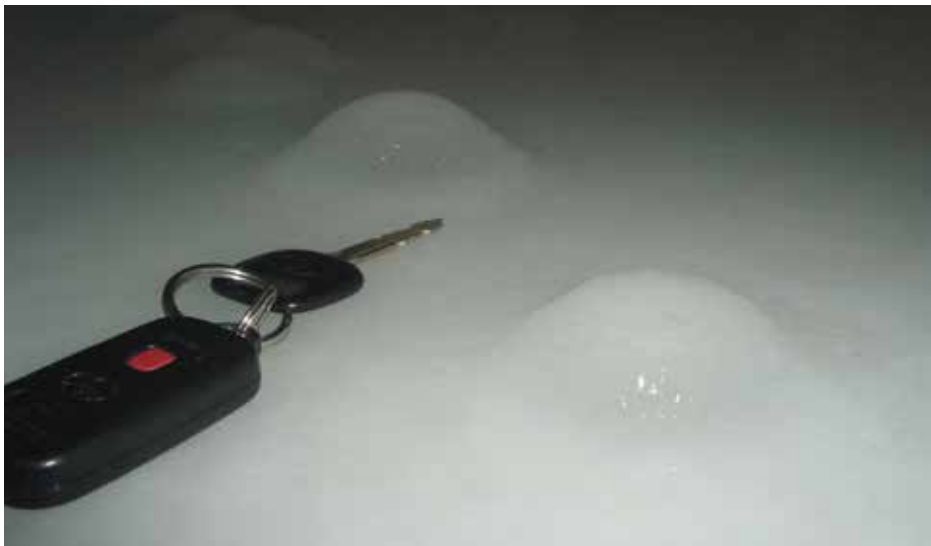
Figure 6. Mounding on ice formed when air leaked from the common areas and the pool leaked into the ceiling above the ice rink, condensed, and dripped onto the ice.

Case Study 3 was a project in 2006 at a community center north of Toronto that included a pool and ice rinks in the same building, separated by a foyer space. The issue at this building was mounding on the rink ice overnight (**Fig. 6**). The ice mounding was greatest at the end of the rink closest to the foyer and pool and diminished with distance from the foyer. Our investigation determined that air leakage pathways were created on the interior near the roof of the building where the partition walls were not air-sealed to the underside of the roof. These pathways allowed

moisture from the pool space and foyer area to pass through the common space and into the roof assembly above the ice rink. It condensed and dripped onto the ice through the joints of the interior finish, resulting in mounds that formed every night.

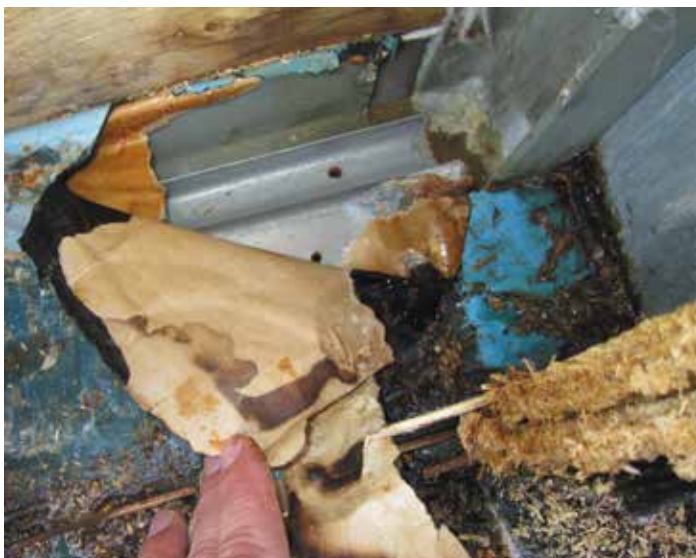
Figure 7. Water accumulation and damage in the parapet, and the backer observed on the Blueskin air barrier.

However, when the parapet and adjacent roof were opened, it was discovered that the backer had not been peeled from the self-adhered membrane (**Fig. 7**). The membrane was not adhered, and further, there were structural penetrations through the membrane that were not sealed. This resulted in air leakage pathways into the parapet from the interior space. The schematic in **Fig. 9** shows the air leakage pathway along the structural connection to the parapet. Condensation on the underside of the roof membrane was guiding water directly to the roofing assembly and saturating the coverboard and roofing insulation. Condensation was also draining back to the interior of the building, staining window mullions and the pool deck (**Fig. 8**).

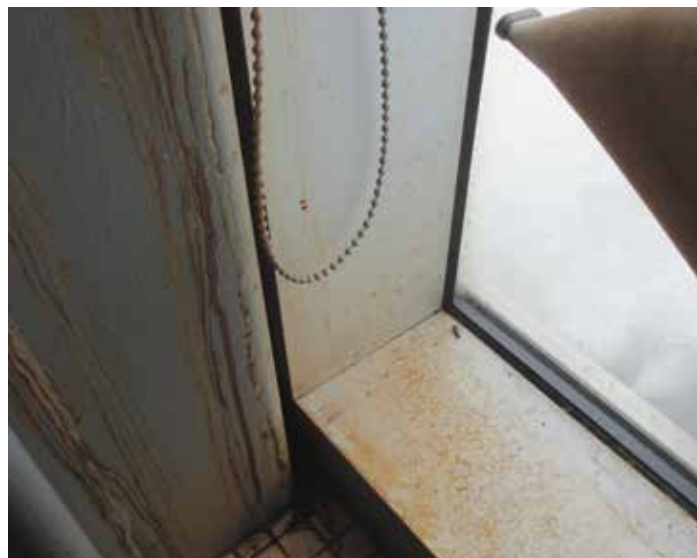
Figure 8. Staining inside the pool area running down steel columns from the parapet.

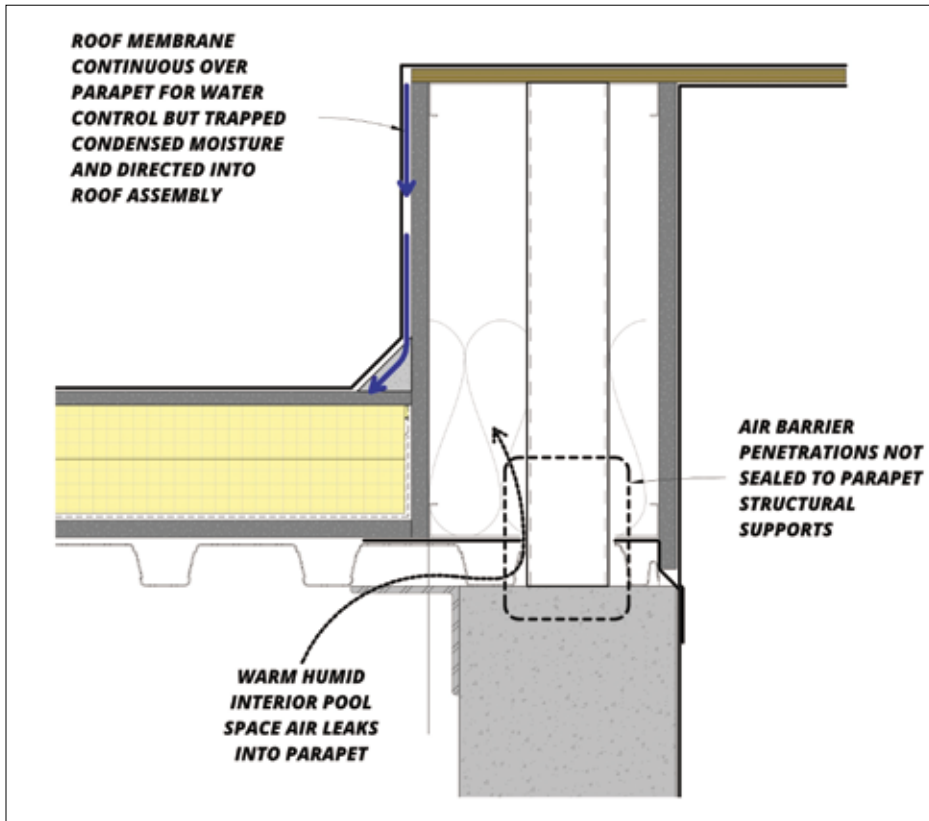
Figure 9. Schematic of the air leakage pathway and condensation that saturated a large percentage of the roofing insulation in the roof assembly.

Case Study 5 is a pool in Chicago that had issues with both air leakage and thermal bridging from the hollow structural section (HSS) that connected to the structure on the interior of the enclosure while also supporting the soffit. Significant condensation and dripping on the interior of the enclosure at this HSS was a result of a combination of thermal bridging and air infiltration. The infiltrating air combined with thermal bridging cooled the interior steel surfaces sufficiently in the wintertime that interior air condensed on the surfaces. The initial design was for the entire soffit to be wrapped airtight in self-adhered membrane

and connected to both the roof and the wall, but the air barrier layer was not continuous. Air flowed into the soffit through deficiencies in the air barrier, and then into the building through the hollow HSS. Fortunately, the pool had been operating correctly under negative pressure (as discussed later in the paper) since it was constructed; otherwise, there would have been

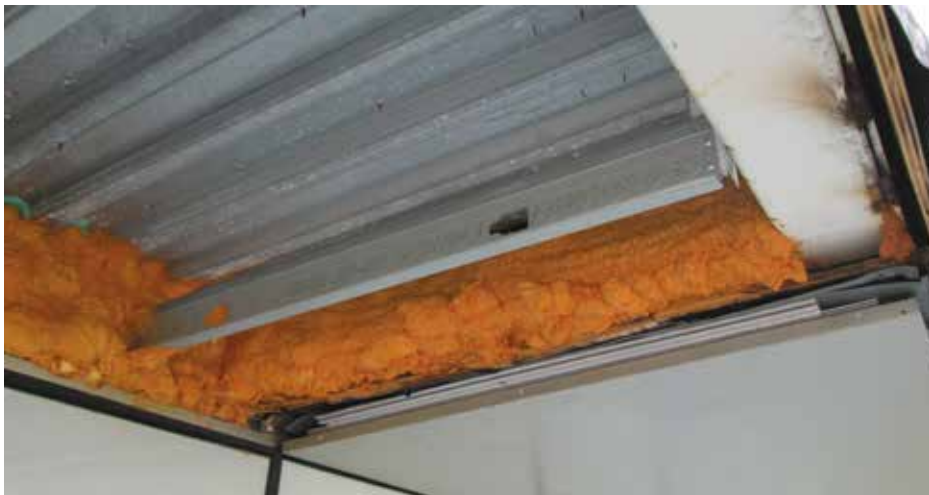
Figure 10. Closed-cell spray polyurethane foam (ccSPF) was installed above the windows at the transition between the metal roof deck and the enclosure over the green fluid-applied air and water barrier. ccSPF was also installed around the entire length of the HSS supporting the soffit and connected to the interior structure to minimize thermal bridging.

significant moisture damage to the soffit space. The recommended fix for this issue (**Fig. 10**) was to ensure the air barrier was continuous at the plane of the enclosure with a fluid-applied membrane (green coating showing past the ccSPF on the roof deck) and spray foam on the wall and in the metal deck flutes, and to entirely wrap the soffit HSS structural members in ccSPF.

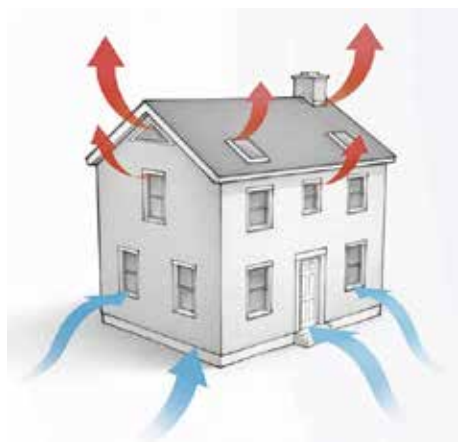
Figure 11. Illustration of wintertime stack effect with naturally occurring drawing of air in the bottom of the building and exhausting it out the top. Source: finehomebuilding.com.

Fig. 11 shows an illustration of typically occurring stack effect pressures during the winter months in a cold climate. Warm air is more buoyant; it rises to the top of the building and finds its way out through holes in the air barrier system. Replacement air is then drawn in at the bottom of the building. Positive air pressures push air out on the top of the building, while negative pressures pull air in at the bottom. The amount of pressure formed increases with building height as well as with greater temperature gradients between the interior and exterior. Stack effect pressures at the top of the building are the greatest in the coldest winter months. Therefore, they need to be considered when the pressure measurements are taken to ensure that the building is negatively pressurized all year round. Pressure measurement should be done during the winter months when it is cold outside to confirm that the

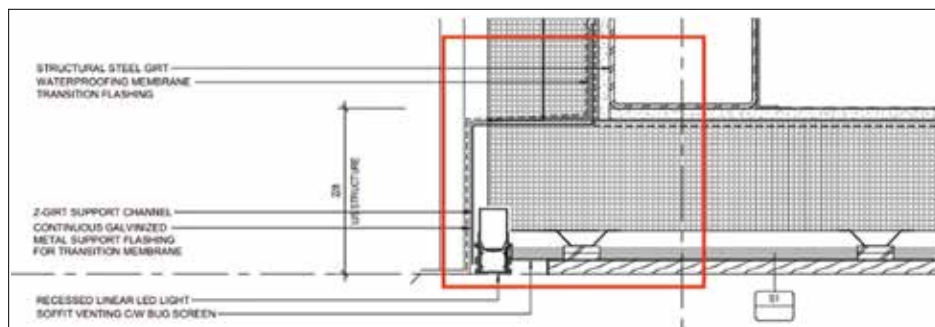
Figure 12. Many of the light fixtures at the perimeter of the soffit were filling with water and failing because of air leakage from pressurization of the building.

Case Study 7 is a newly constructed pool in Nova Scotia, completed in 2022. Lights at the perimeter of the soffit space above the entrance were filling with water and failing. Unfortunately, due to COVID-19, we were unable to travel to the site to do the investigation ourselves. Instead, we assisted remotely with the investigation. The conditioned soffit was part of the interior space and wrapped in self-adhered membrane as well as continuous exterior insulation (**Fig. 12**). The lights were well protected from driving rain events, and there was no correlation between rain events and water in the light fixtures. The accumulated water was most likely a result of warm, moist interior air being pushed along the electrical wiring pathway through the air barrier discontinuity into the light fixtures, resulting in condensation and moisture accumulation. **Fig. 12** shows a section of the exterior edge of the soffit with the membranes on the gypsum sheathing, and over the flashing, and thick layers of continuous exterior insulation.

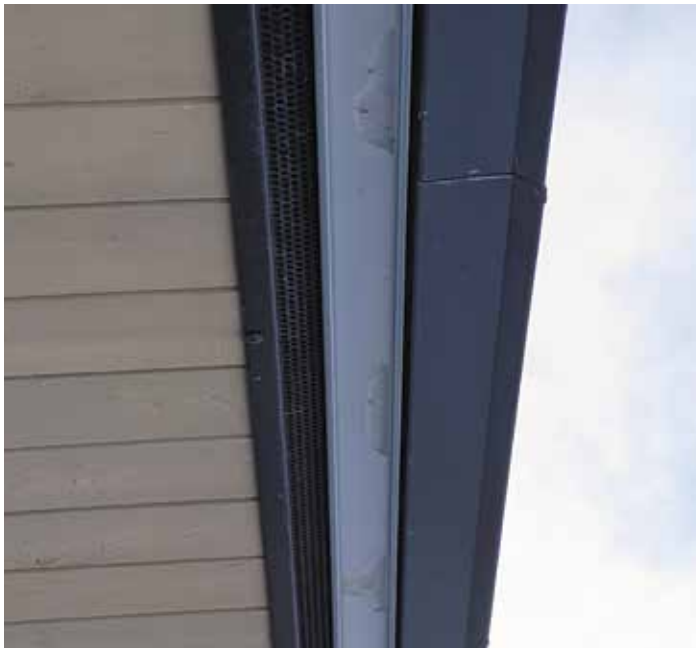
Figure 13. Photograph of water within the light fixtures at the edge of the soffit.

Fig. 13 shows a photograph of water accumulated in the light fixture at the edge of the soffit.

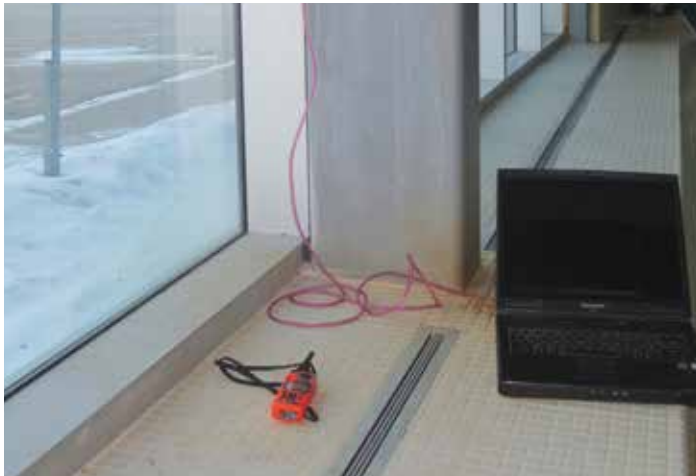
Figure 15. Linear grilles adjacent to the windows are designed to apply airflow to the window area, reducing condensation.

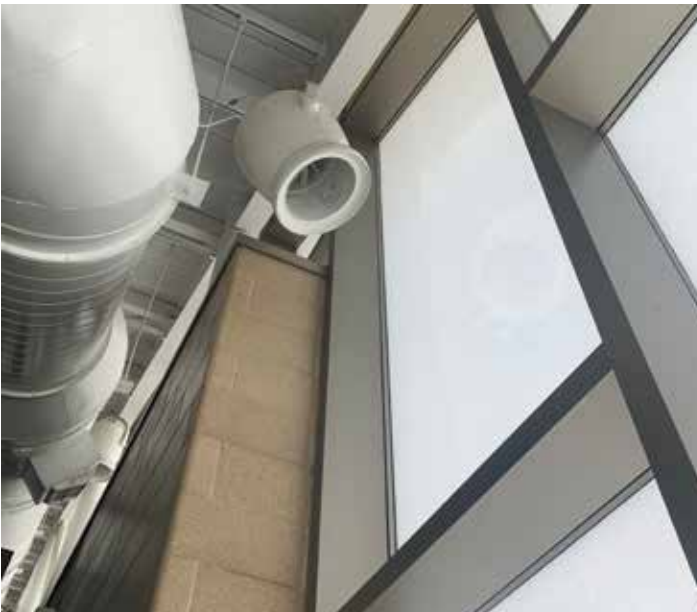
Figure 14. Fans were added during the building repairs to blow air directly over the windows to reduce condensation on the interior surfaces of the windows.

Case Study 5 in Chicago, previously discussed because of the thermal bridging and air leakage at the soffit, also had issues with condensation on the windows. The lack of air distribution from the mechanical system over the windows and the deep interior mullions disrupted the airflow, promoting condensation. As part of the repair strategy for the building, additional fans, separate from the HVAC supply ducts, were installed specifically to blow air over the windows (**Fig. 14**).

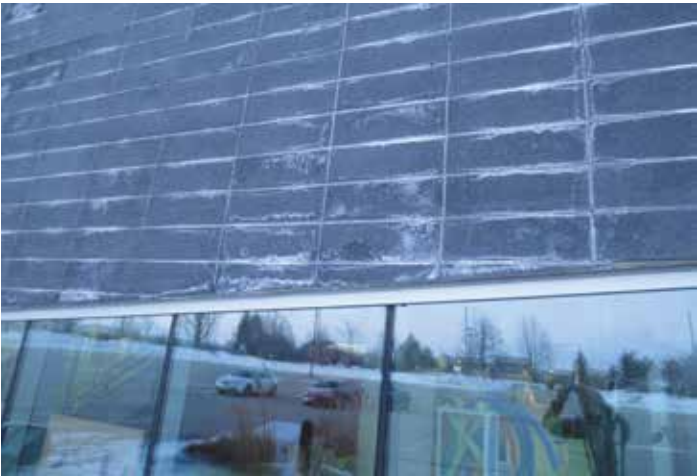
Figure 16. Around the windows, there was greater mortar damage and efflorescence as a result of the lack of deficient air barrier details.

behind the masonry. The air coming out of the gap was humid and smelled of chlorine. The high humidity air in the masonry veneer cavity resulted in icicles and moisture accumulation at the top of the wall under the parapet flashing during the wintertime (**Fig. 17**). The masonry wall issue was the result of a combination of factors, including, most importantly, the lack of air barrier continuity. However, it also involved installation deficiencies in the HVAC ductwork, since in some locations, the air from the ductwork was blown directly into the brick veneer cavity, resulting in premature failure of the masonry on the building. The building repairs included air barrier replacement and improvements to control airflow and eliminate air exfiltration.

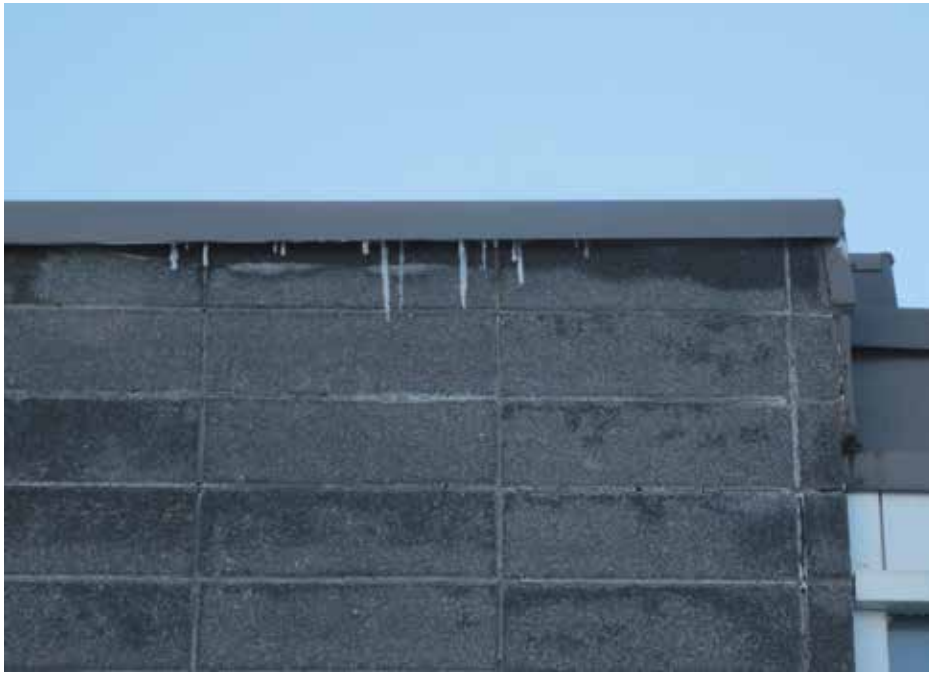
Figure 17. At the top of the wall, icicles, wetting, efflorescence, and mortar damage were all present as a result of air leakage.

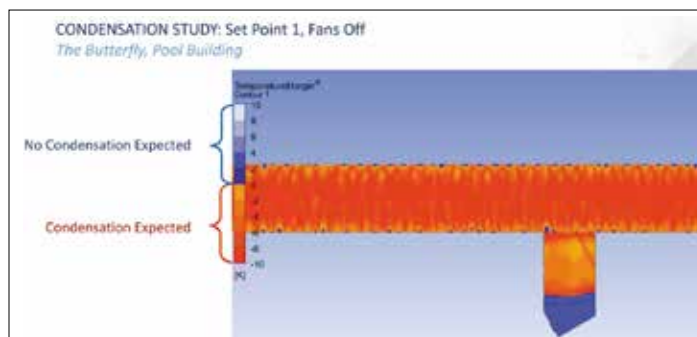
Figure 18. The predicted temperature margin and condensation risk on the skylights of the pool without any fans indicates that the other ceiling will be covered in condensation.

two of the simulations shown here. **Fig. 18** shows the model output for the plan view of the roof. The entire roof/skylight area is red, indicating condensation is expected to cover the entire skylight/ceiling assembly. **Fig. 19** shows the predicted surface temperature and condensation results with a higher temperature set point as well as additional fans blowing air over the glazing surfaces. This approach significantly reduced the predicted condensation risk over most of the skylight/ceiling of the pool space, as indicated by the mostly blue and white coloration of the surfaces.

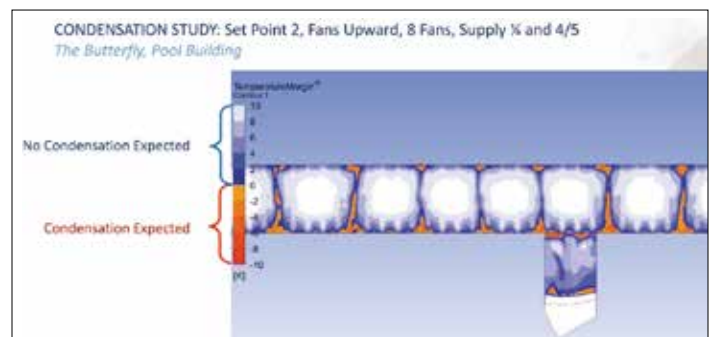
Figure 19. The predicted temperature margin and condensation risk on the skylights of the pool with a higher temperature setpoint and additional fans shows a significantly decreased risk of condensation.
