2025 BUILDING ENCLOSURE
SYMPOSIUM

**IIBEC**
INTERNATIONAL INSTITUTE OF
BUILDING ENCLOSURE CONSULTANTS

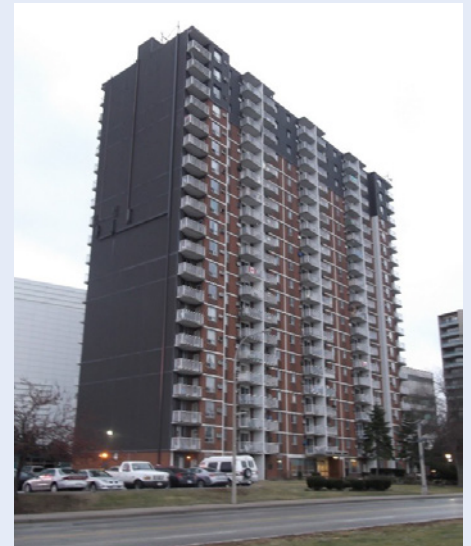
FIGURE 1. 255 Riverside Drive (Raymond Desmarais Manor) before the deep energy retrofit.

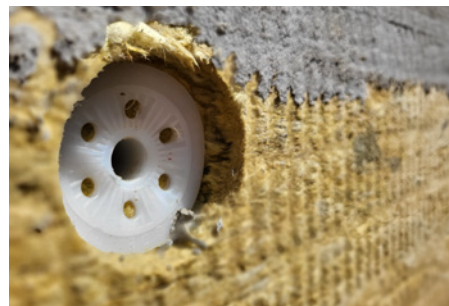
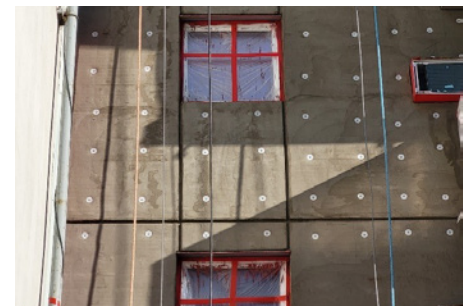
FIGURES 4 & 5. Stage 1 fastener through mineral wool insulation, countersunk to allow for insulation plug and stage 2 fasteners installed over the fully cured base coat.

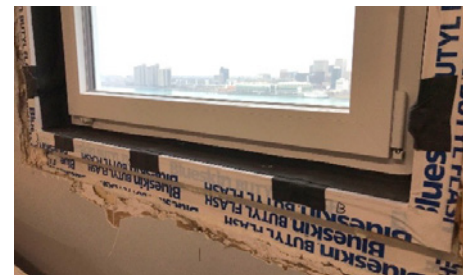
FIGURE 12. Supplemental interior air barrier application at window perimeter.

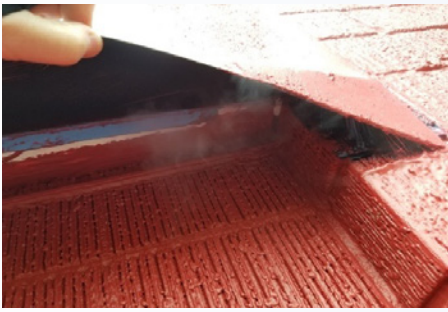
FIGURE 13. Poorly bonded transition membrane, with tracer gas leak during diagnostic airtightness testing.

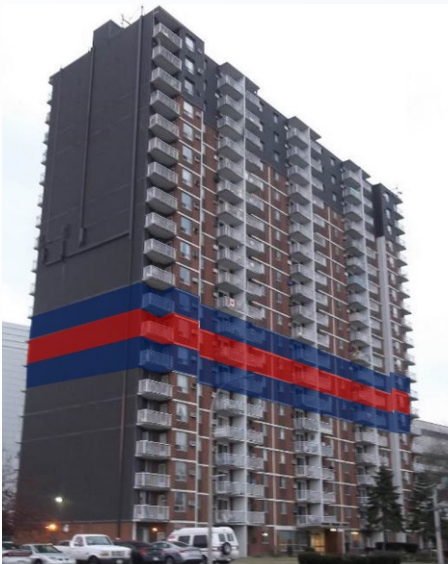
FIGURE 14. Sample of guarding for a whole-floor test, with the test floor in red and the guards in blue.

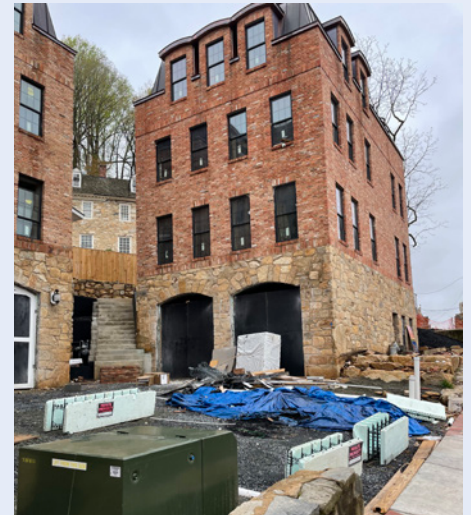
FIGURE 1. Overall view of the subject property during construction.

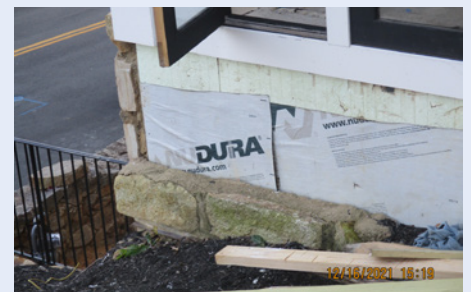
FIGURE 2. Waterproofing was applied without primer or termination bars.

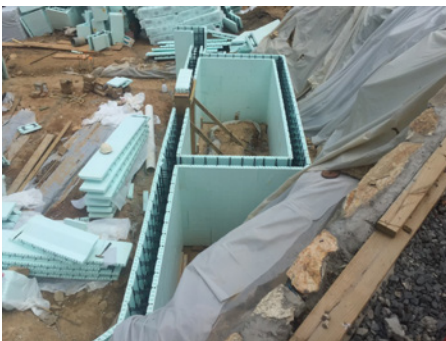
FIGURE 5. The insulated concrete form panels have continuous insulation.

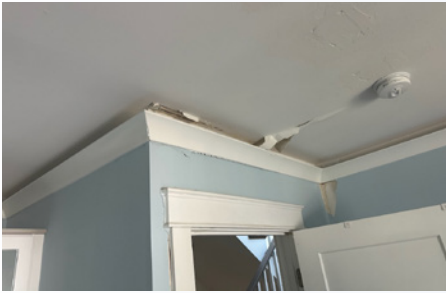
FIGURE 6. Water leaks appeared immediately.

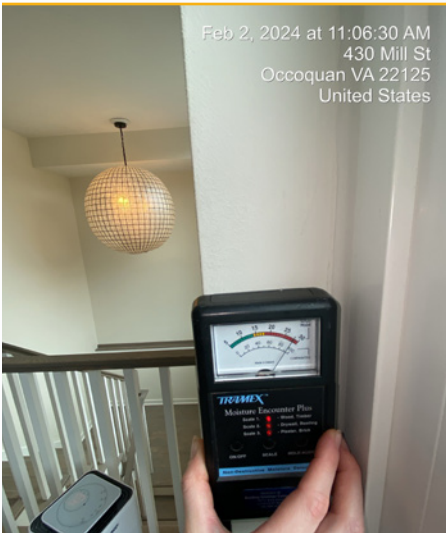
FIGURE 7. Nondestructive testing revealed many wet locations on the walls and floors.

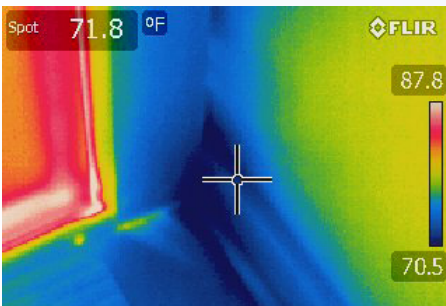
FIGURE 8. Blower door with infrared showed many locations of air infiltration.

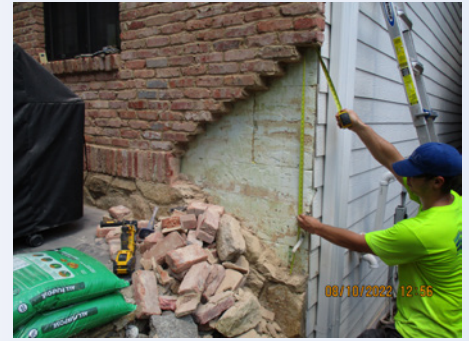
FIGURE 9. Destructive testing was performed to document concealed conditions.

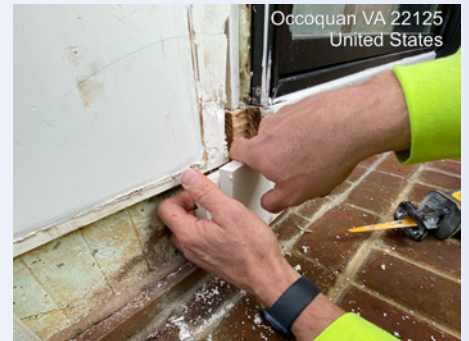
FIGURE 10. No flashing or waterproofing was present at the windows, as expected.

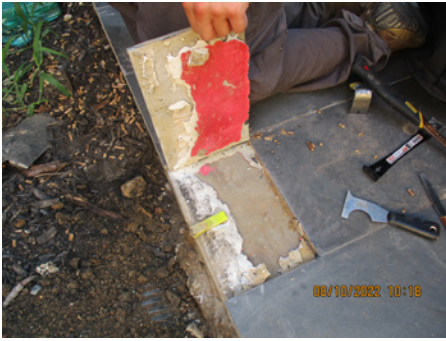
FIGURE 11. The patio waterproofing failed and was not tied into the wall or foundation.

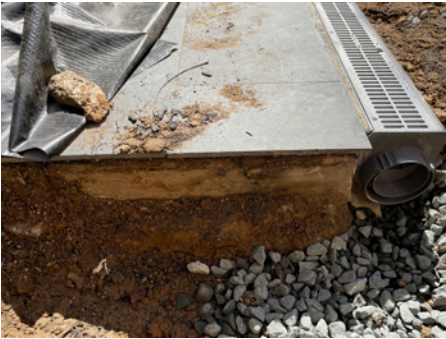
FIGURE 12. The foundation waterproofing did not extend to the top of the foundation walls.

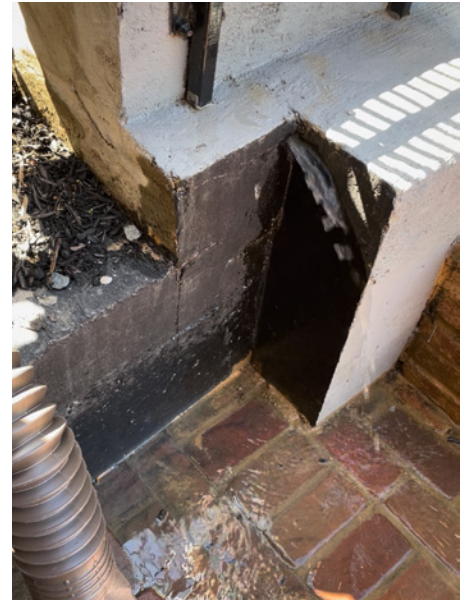
FIGURE 13. Photo of water “squirting” out of the retaining wall under hydrostatic pressure.

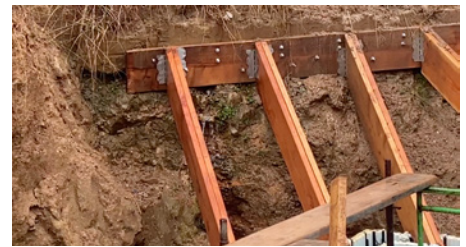
FIGURE 14. The excavation had to be reinforced due to constant water movement below the concrete retaining wall .

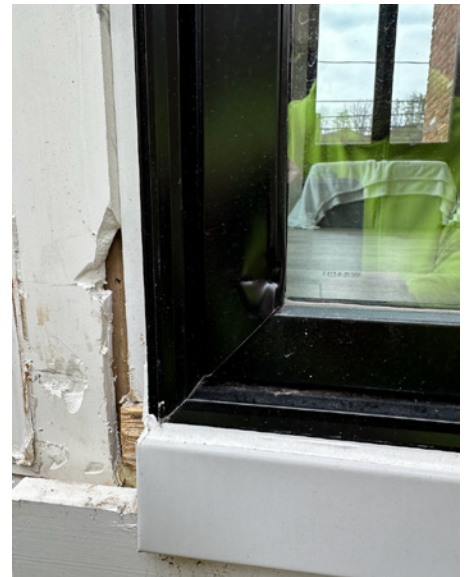
FIGURE 15. A window installer replaced the kitchen windows and doors, but did not add flashing and did not eliminate the water intrusion.

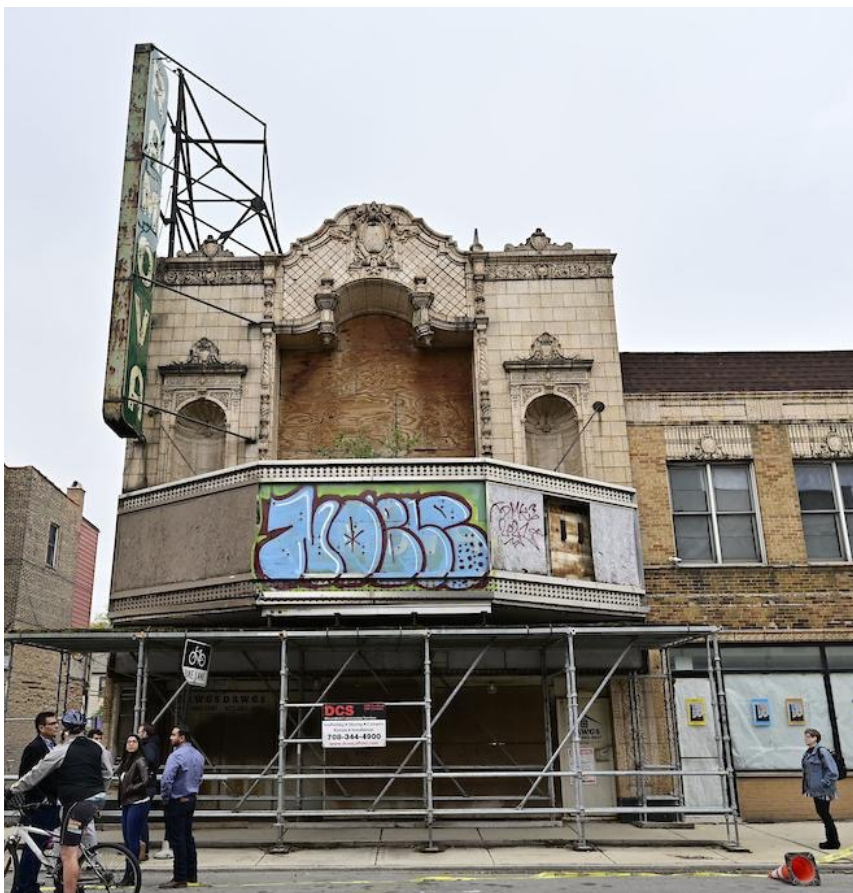
FIGURE 2. View of existing conditions of the east facade elements (terra-cotta, marquee and blade signs, and monumental window) of the Ramova Theatre in spring 2021.

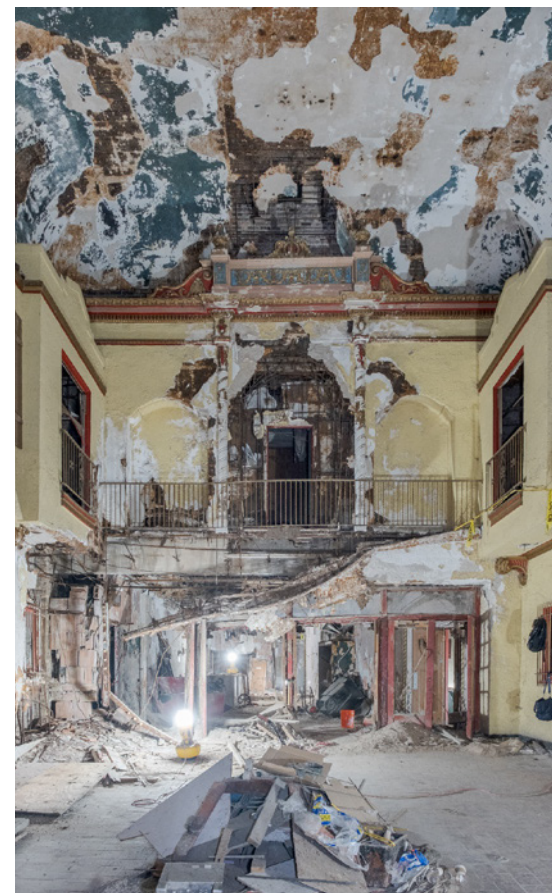
FIGURE 3. Interior view (from main entrance) of the existing plaster conditions of the lobby space.

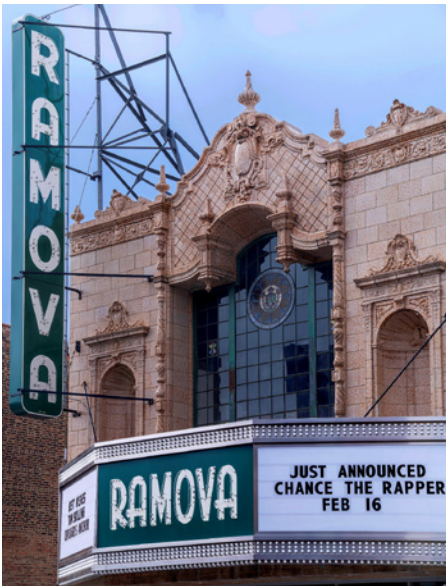
FIGURE 4. View of restored facade elements (terra-cotta, marquee and blade signs, and monumental window) of the Ramova Theatre in winter 2024. *Photo credit: Eric Laignel.*

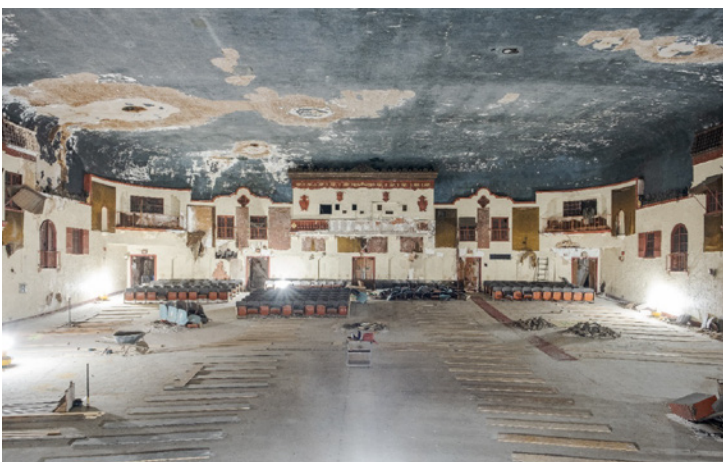
FIGURE 5. Interior view (from the stage) of the theater space showing the plaster conditions of the auditorium. *Photo credit: Danielle Campbell.*

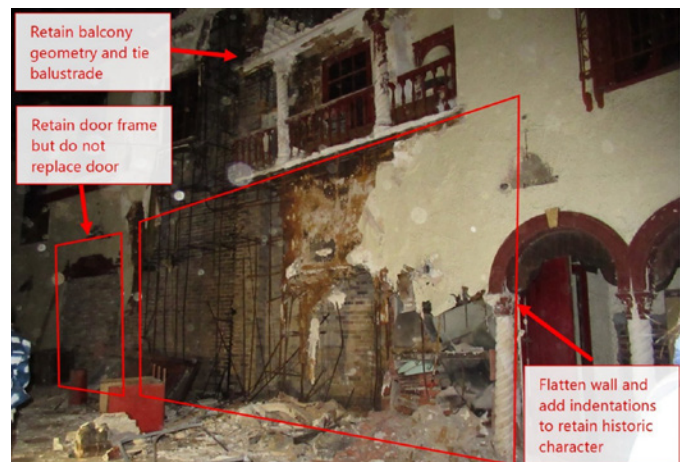
FIGURE 6. Interior view of the theater space showing the plaster conditions of the auditorium prior to repairs, highlighting repair scope.

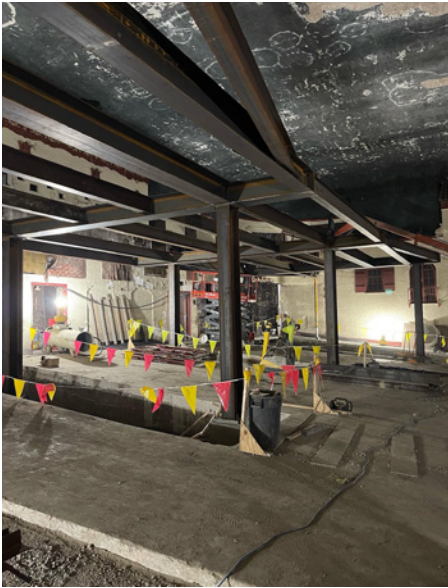
FIGURE 7. View during construction, showing new support steel structure for balcony, including footing repairs and interface with interior plaster.

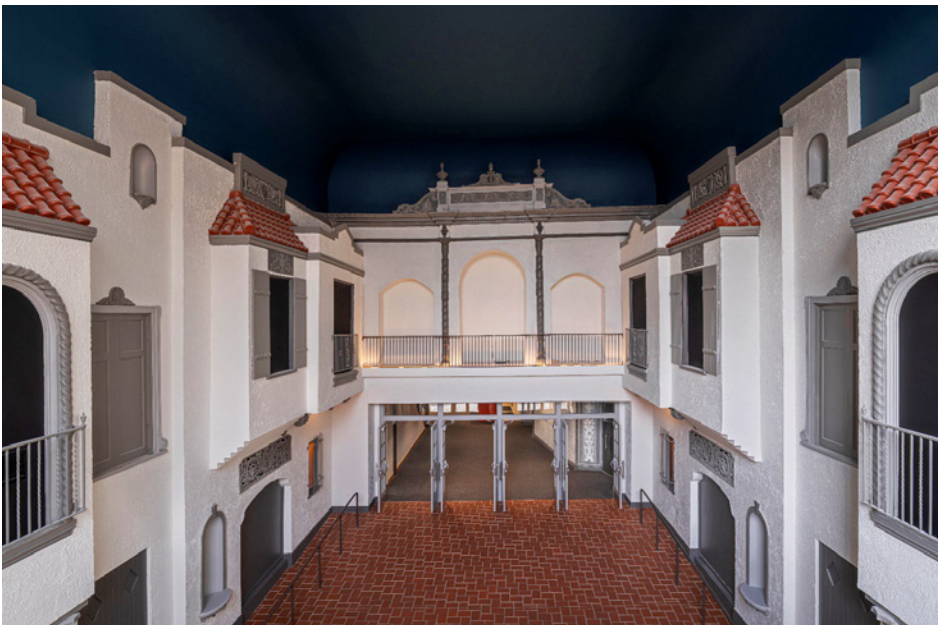
FIGURE 8. Interior view (from main entrance) of the restored plaster conditions of the lobby space. Photo credit: Eric Laignel.

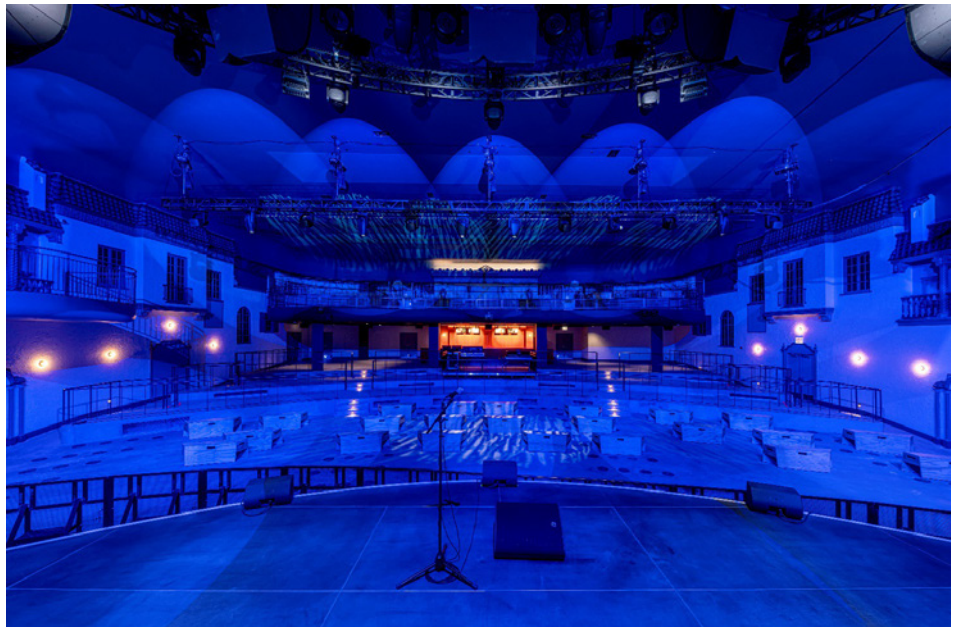
FIGURE 9. Interior view (from the stage) of the theater space showing the restored plaster conditions of the auditorium following completion of the project. *Photo credit: Eric Laignel.*

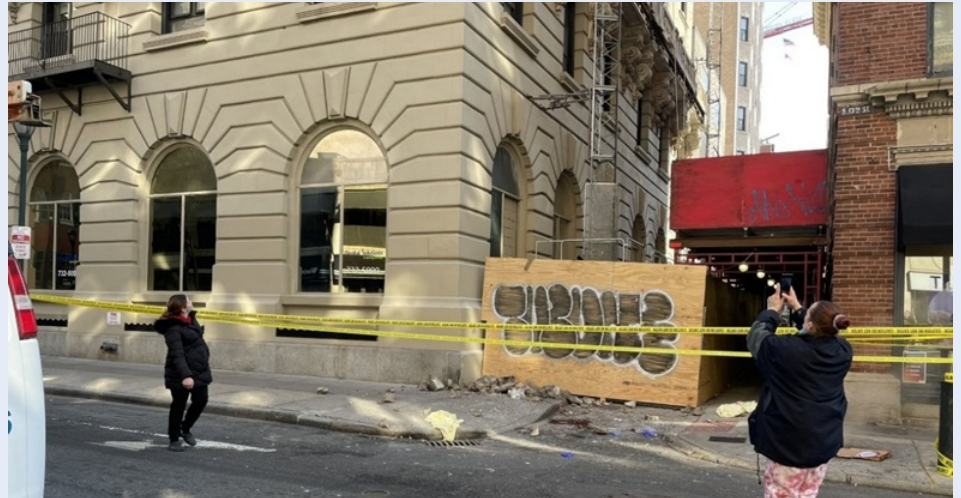
FIGURE 1. View of 2023 facade collapse debris in Philadelphia's Center City district. Image courtesy of 6ABC.²

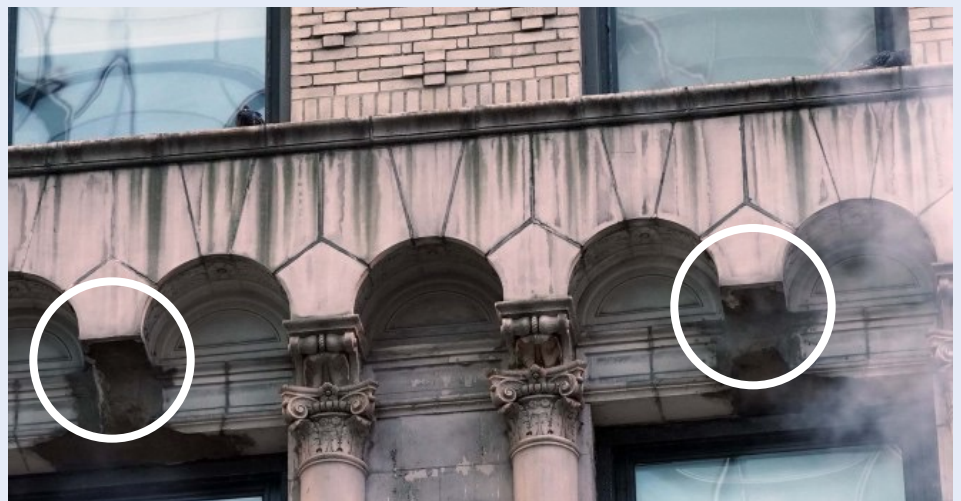
FIGURE 2. Close-up view of terra-cotta failure that led to fatality in New York City, 2019. Image courtesy of the New York Post.⁴ Annotations by Mike Lopez.

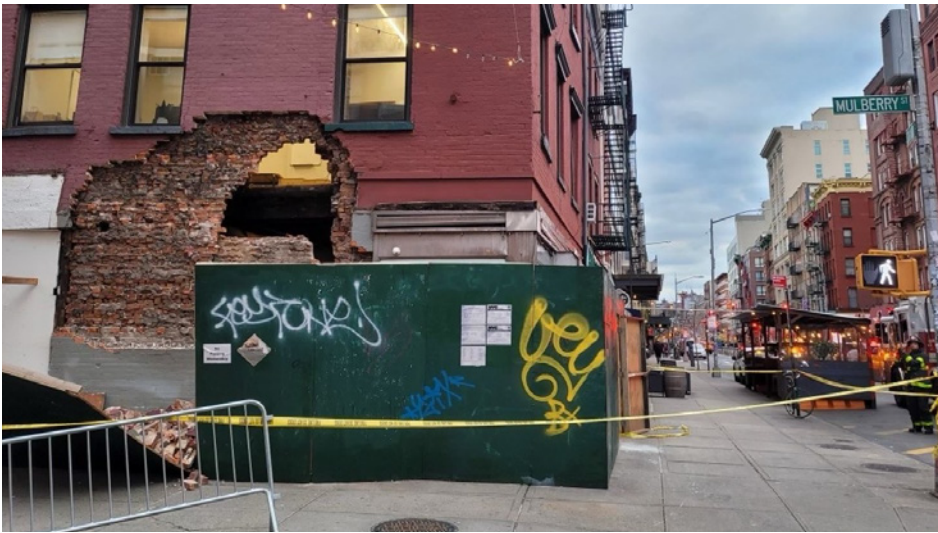
FIGURE 3. Facade collapse in New York City’s Little Italy neighborhood. *Image courtesy of The Structural Engineer.*⁷

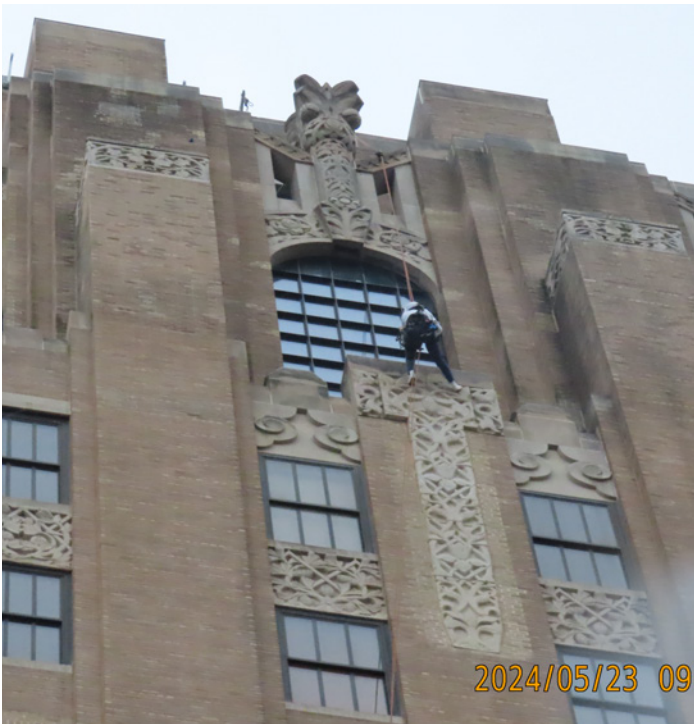
FIGURE 6. Inspector performing facade inspection via industrial rope access. Photograph by Mike Lopez, May 23, 2024. Rimkus.

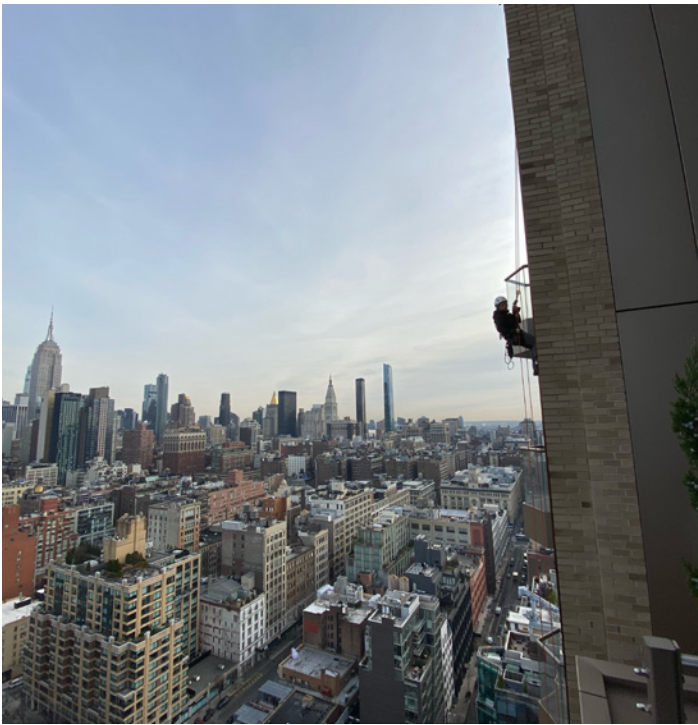
FIGURE 7. Inspector performing facade inspection via industrial rope access. Photograph by Mike Lopez, January 25, 2022. Rimkus.

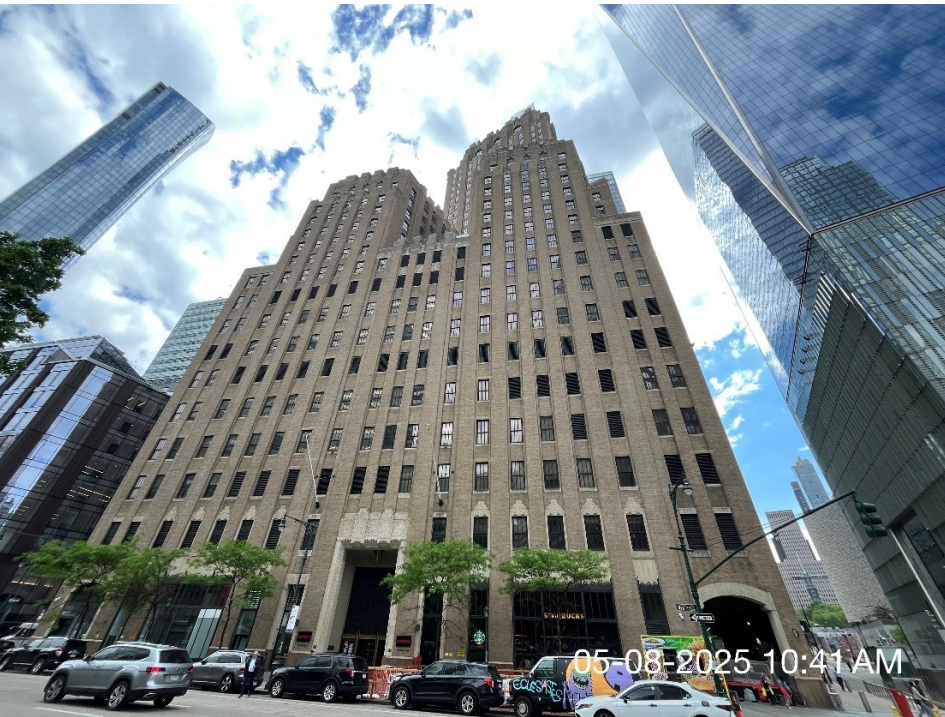
FIGURE 8. The Barclay-Vesey Building at 140 West Street. Photograph by Mike Lopez, May 08, 2024. Rimkus.

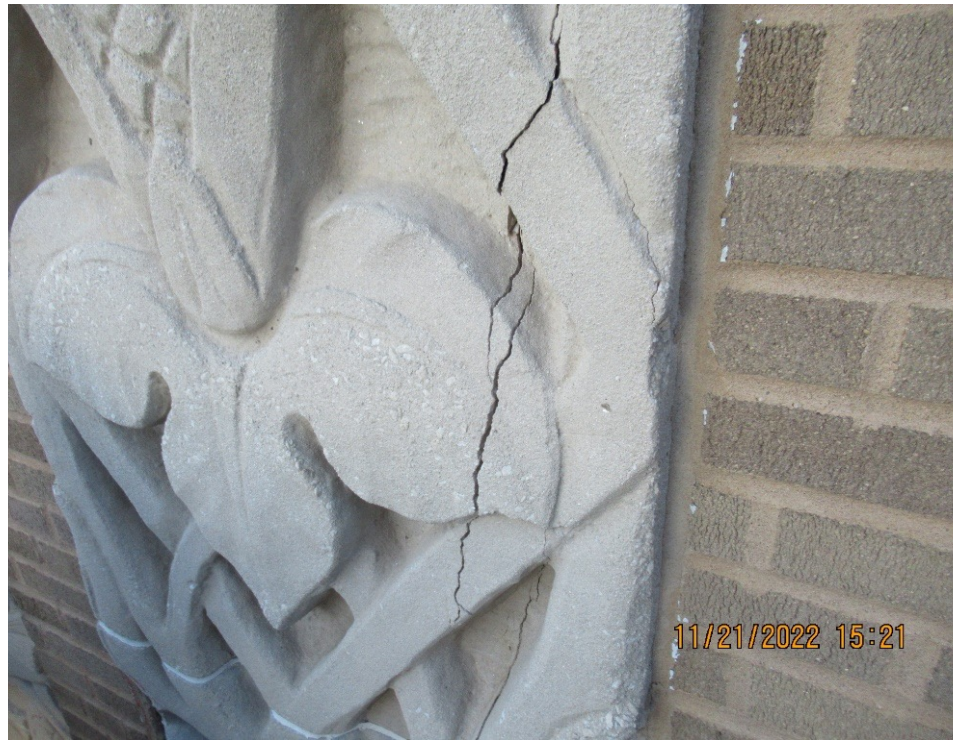
FIGURE 9. Close up view of cracked decorative stone at the Barclay-Vesey Building at 140 West Street. Photograph by Mike Lopez, November 21, 2022. Rimkus.

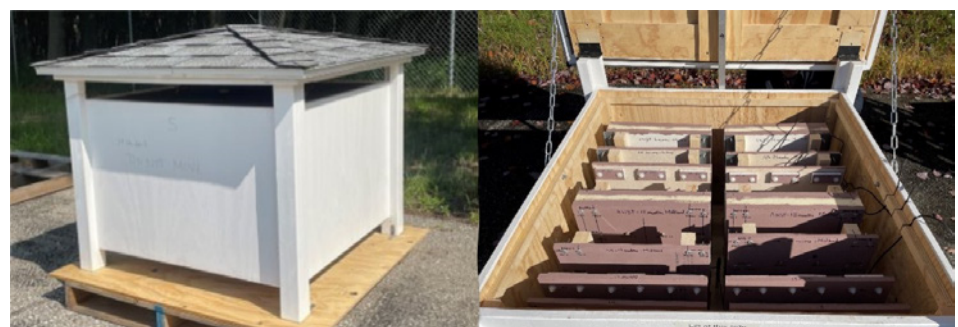
FIGURE 1. Small test hut used to house various panel configurations containing magnesium oxide boards and expose them to local ambient conditions without direct exposure to rain, such as might be experienced in a vented air gap behind typical claddings. The bottom and top of the enclosure are open to allow airflow through the enclosure (left image), with a hinged roof assembly allowing access to the samples evenly spaced within the enclosure (right image).

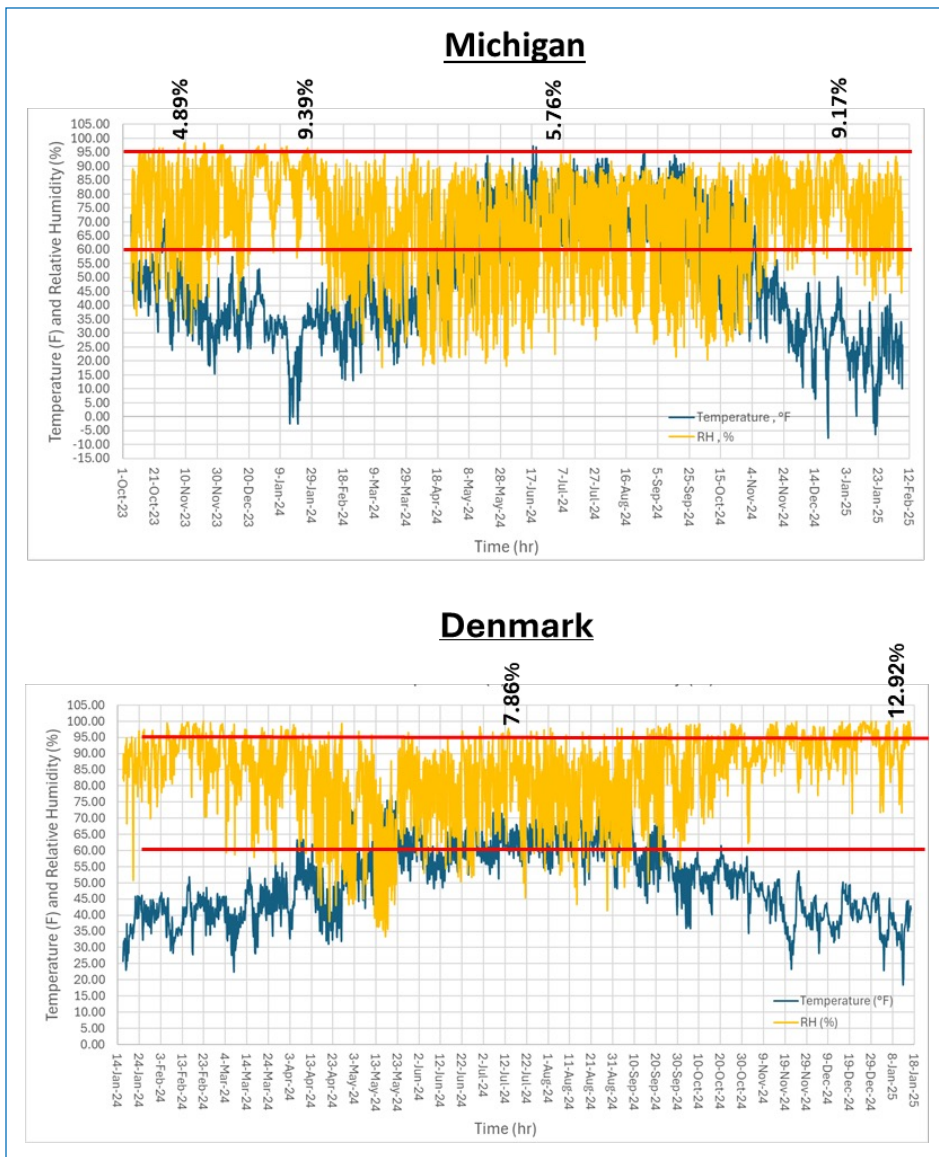
FIGURE 2. Plots of temperature (blue) and relative humidity (orange) recorded within the small test huts at two locations: Midland, Michigan (top), and Jyllinge, Denmark (bottom), over the course of 12–16 months. At several points, magnesium oxide board samples with water resistive barrier were removed from the test hut to measure moisture content, which is reported above the plot. The red lines indicate 60% and 95% relative humidity.

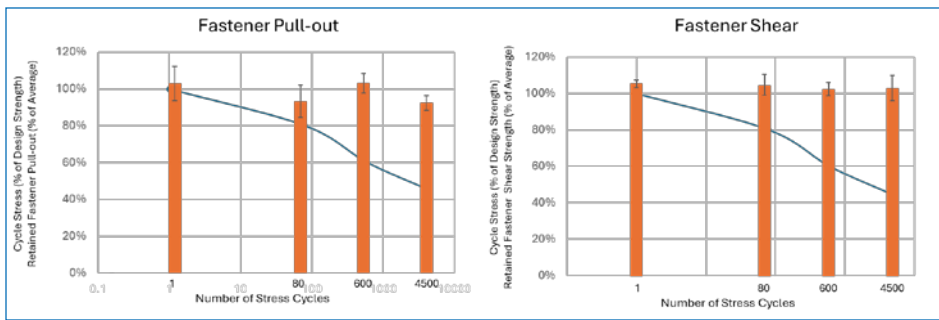
FIGURE 3. Graphs of fastener pullout (left) and fastener shear (right) as a function of the number of load cycles, shown as orange bars and reported as a percentage of the average control prior to cycling. Also shown on the graph is an x-y plot of the cycling load value (calculated as a percentage of the minimum spec value) versus the number of cycles. Read together, each orange bar represents the relative peak pullout strength when tested to failure after cycling the indicated number of times, at the percent load indicated by the blue line.

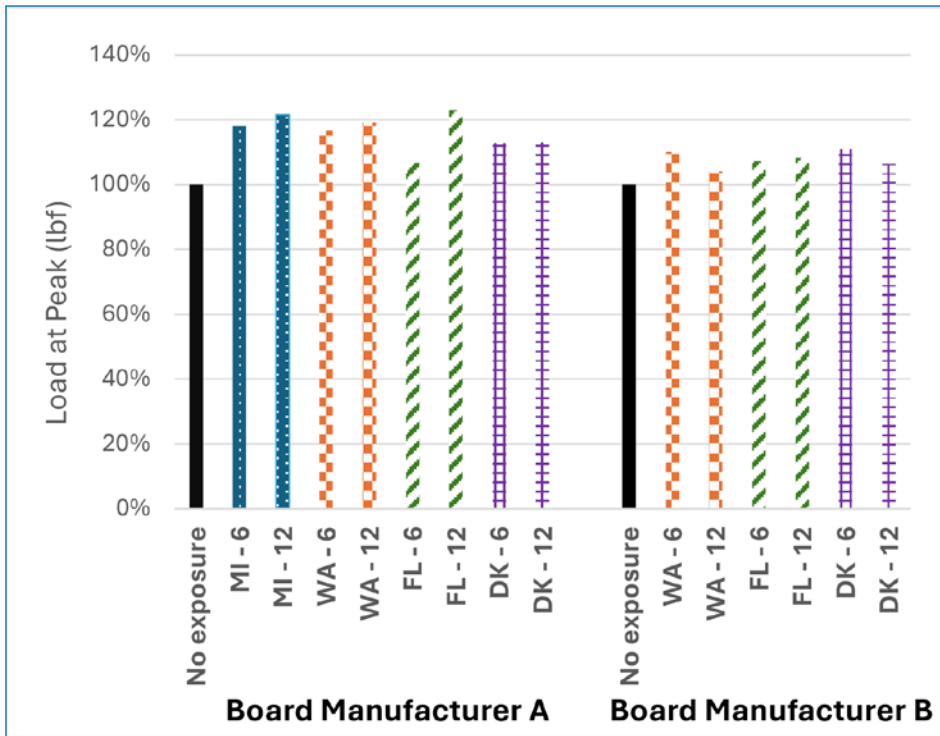
FIGURE 4. Graph of peak load measurements from ASTM fastener pull-out testing for two board manufacturers. Samples of each board were evaluated after 6 and 12 months in each of the tested locations, as indicated (Michigan [MI], Washington [WA], Florida [FL], and Denmark [DK]); the “no exposure” data points reflect the long-term average test measurement for boards as received from the respective manufacturer.

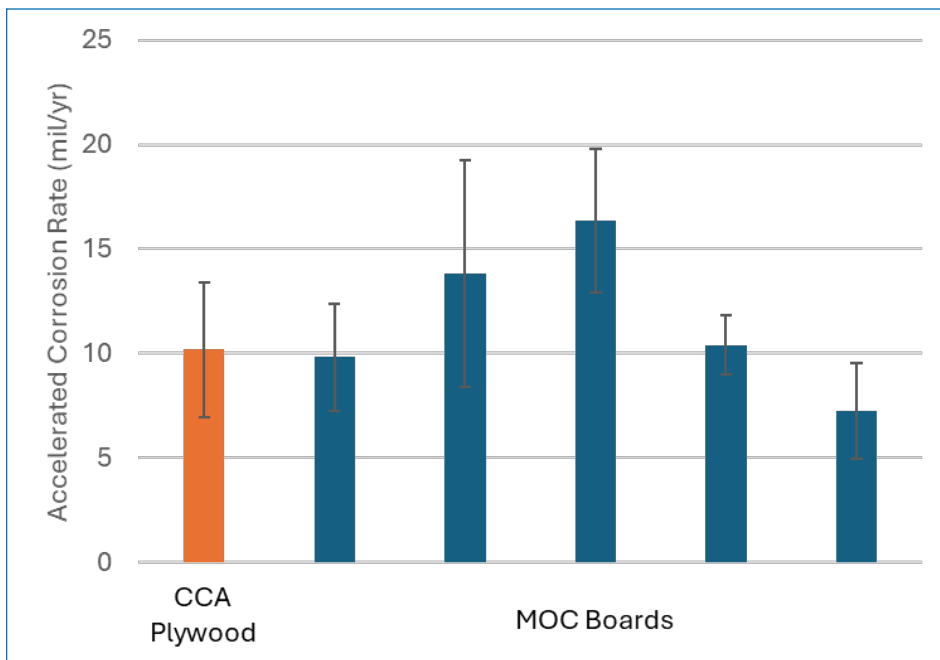
FIGURE 5. Plot of annualized corrosion rate for chromated copper arsenate (CCA)-treated plywood (orange) and magnesium oxide (MgO) boards (blue) in contact with low-carbon steel for five different lots of boards from two manufacturers. The corrosion test was run at 50°C and 90% relative humidity.

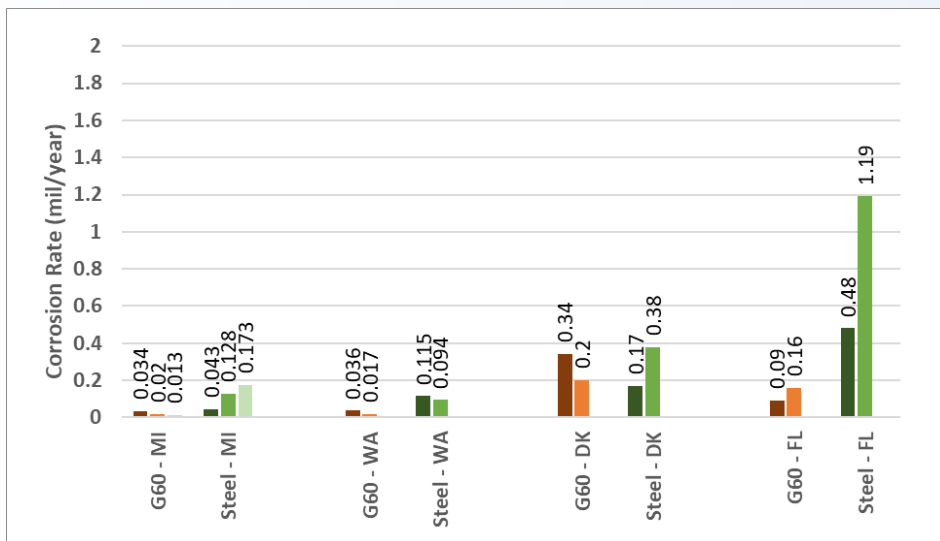
FIGURE 6. Measured annualized corrosion rate for G60 galvanized steel (orange) or carbon steel (green) coupons exposed for 6 months (dark), 12 months (medium), or 18 months (light, Michigan [MI] only) to ambient conditions in small test huts at all locations (Washington [WA], Denmark [DK], and Florida [FL]), as indicated.

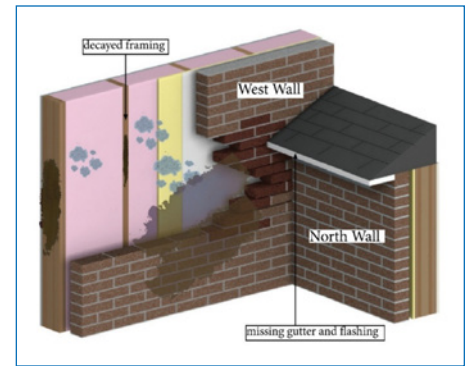
FIGURE 1. Structural damage (rotting and mould growth) on the west wall due to water deposition from the roof-wall intersection.

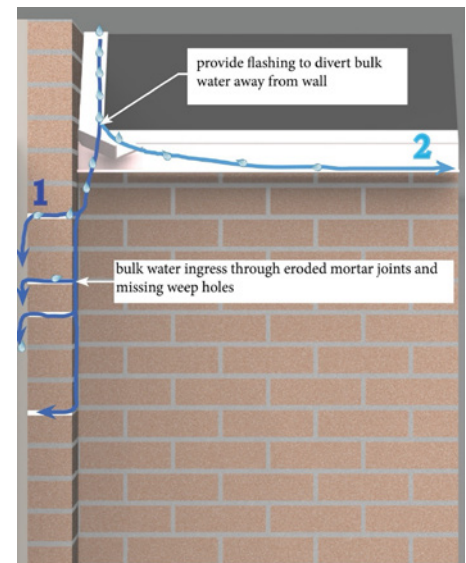
FIGURE 2. At the critical roof-wall intersection, the natural water pathway (indicated as 1 on image) needed to be diverted to a controlled route of water shedding (indicated as 2 on image).

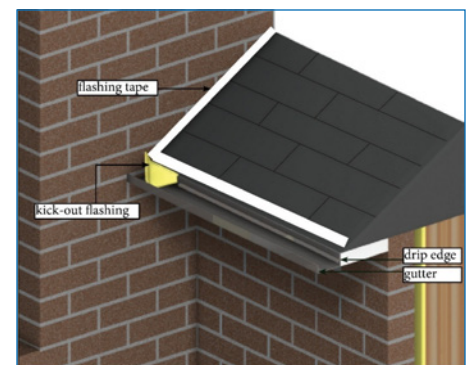
FIGURE 3. Moisture damage on the west wall could have been avoided with the inclusion of proper kick-out flashing, drip edge at the roof, and gutter specified on architectural drawings and verified during construction.

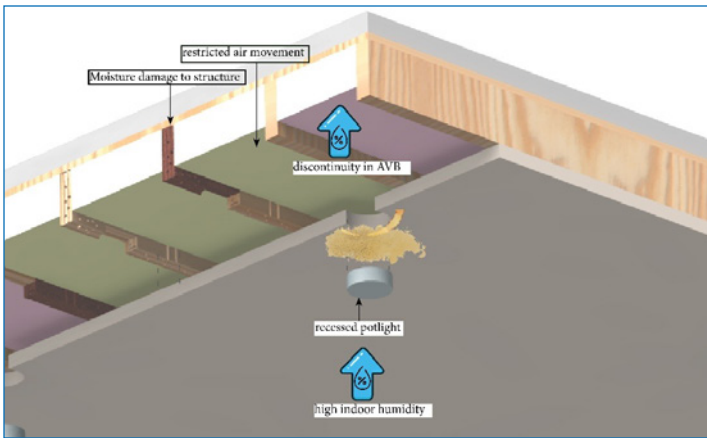
FIGURE 4. Roof structural system condensation damage due to air barrier discontinuities and inadequate attic venting.

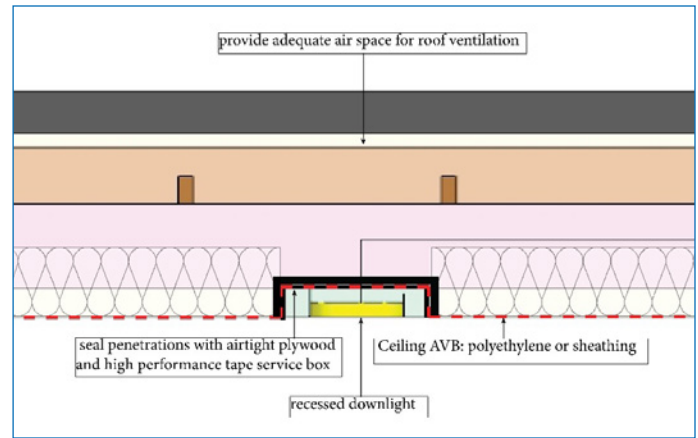
FIGURE 5. Seal penetration of recessed downlight with airtight plywood and high-performance tape service box to prevent heat and air bypass.

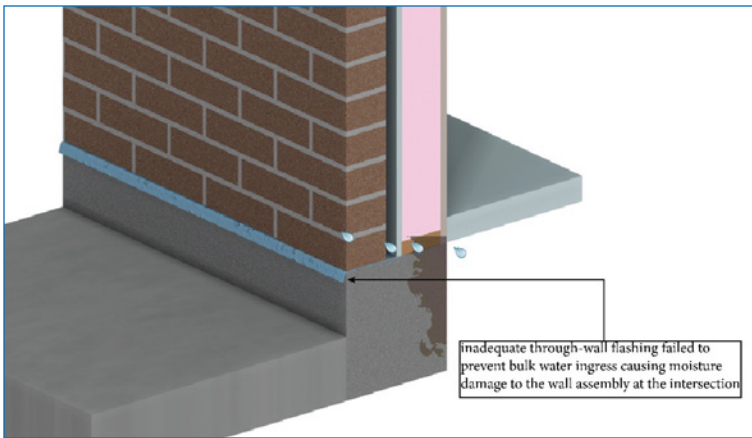
FIGURE 6. Inadequately installed through-wall flashing causing water leakage in the basement.

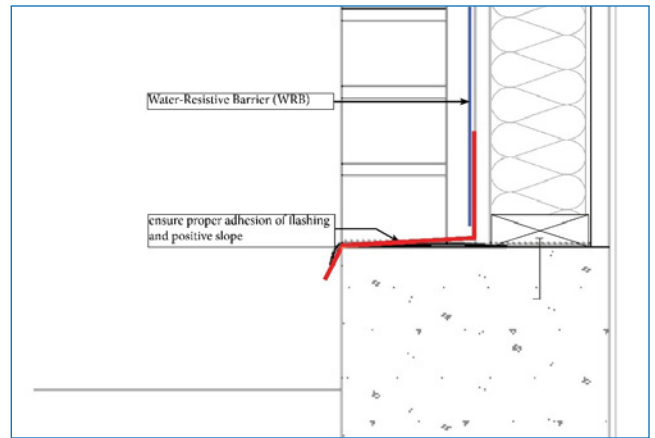
FIGURE 7. Stakeholders must ensure the water-resistive barrier is properly integrated with the flashing and the flashing is securely fastened at the transition.

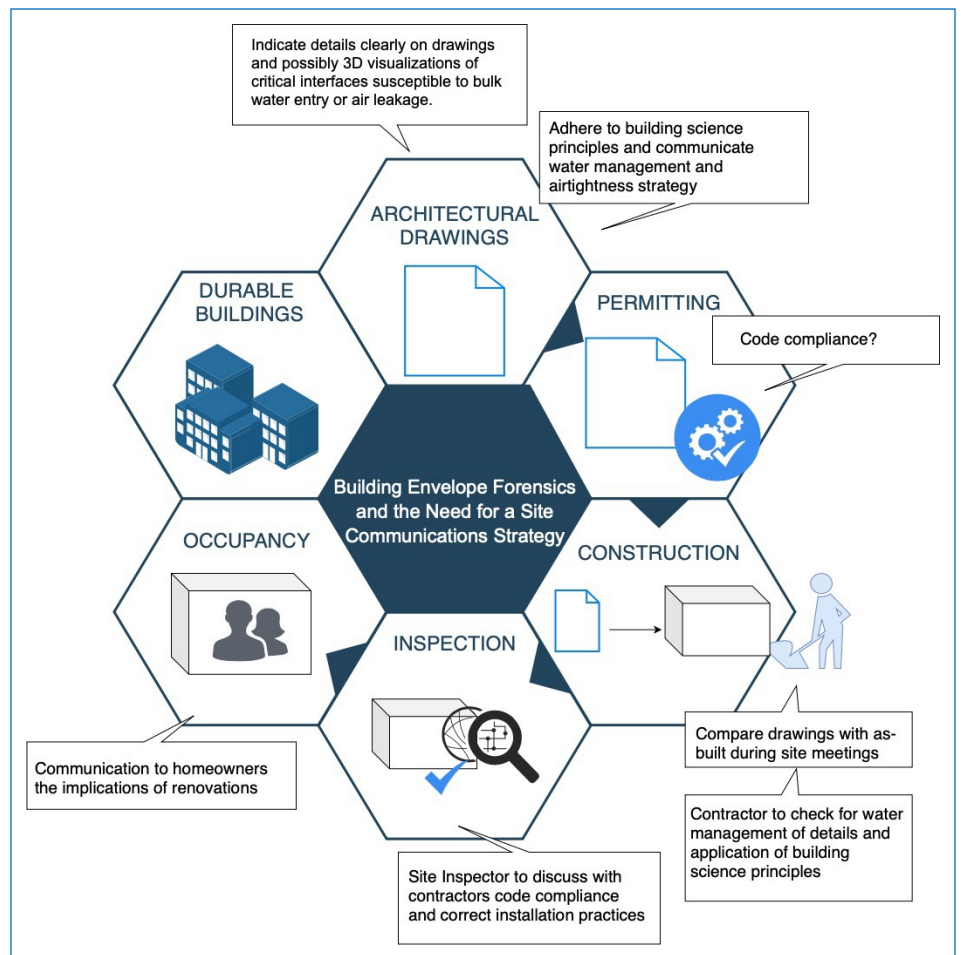
FIGURE 8. Each stage of a building’s life cycle plays a part in adhering to building science principles and ensuring the durability of building details.

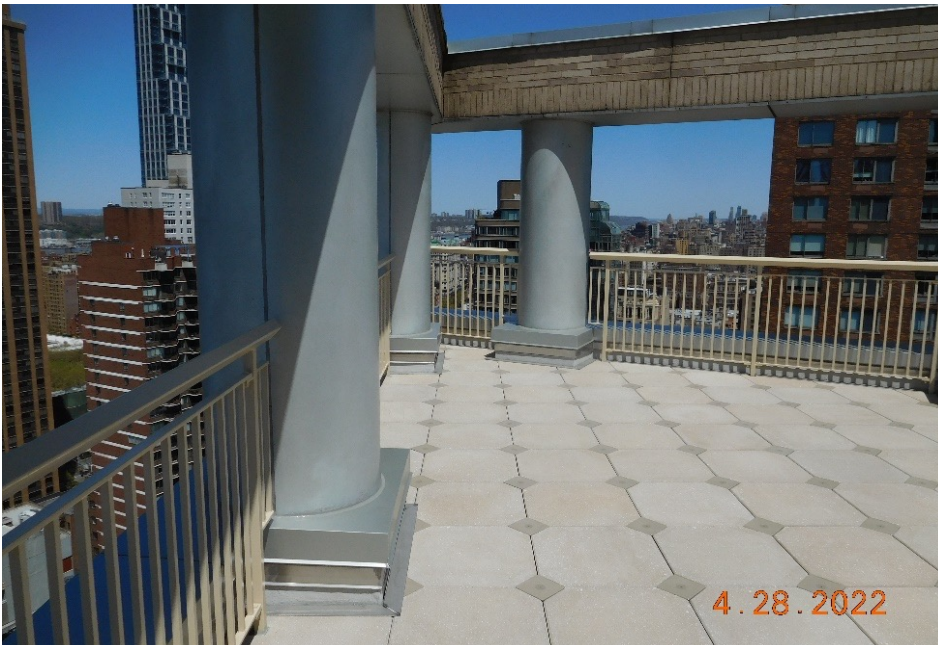
FIGURE 2. View of posted guardrail system with design that does not allow the passage of a 4 in. sphere. *Photo by author.*

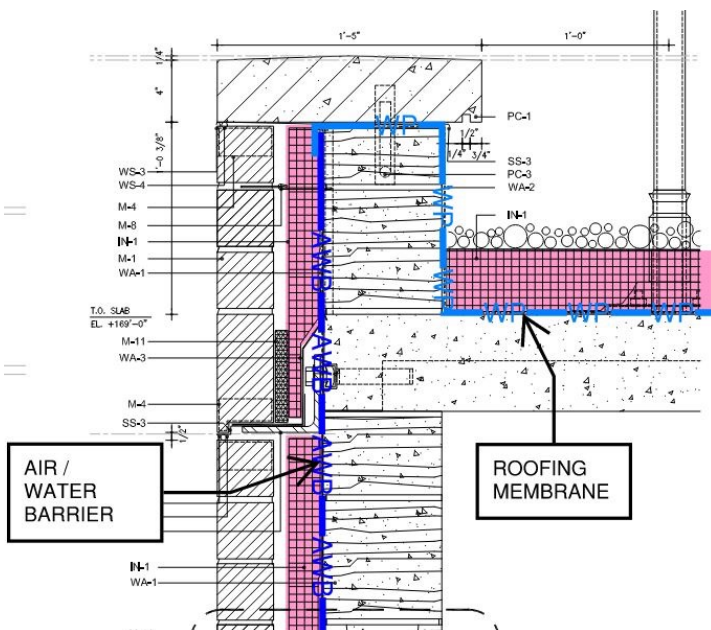
FIGURE 4. Parapet design, circa 2010, with continuity of roofing membrane with exterior wall air barrier. *Drawing by author.*

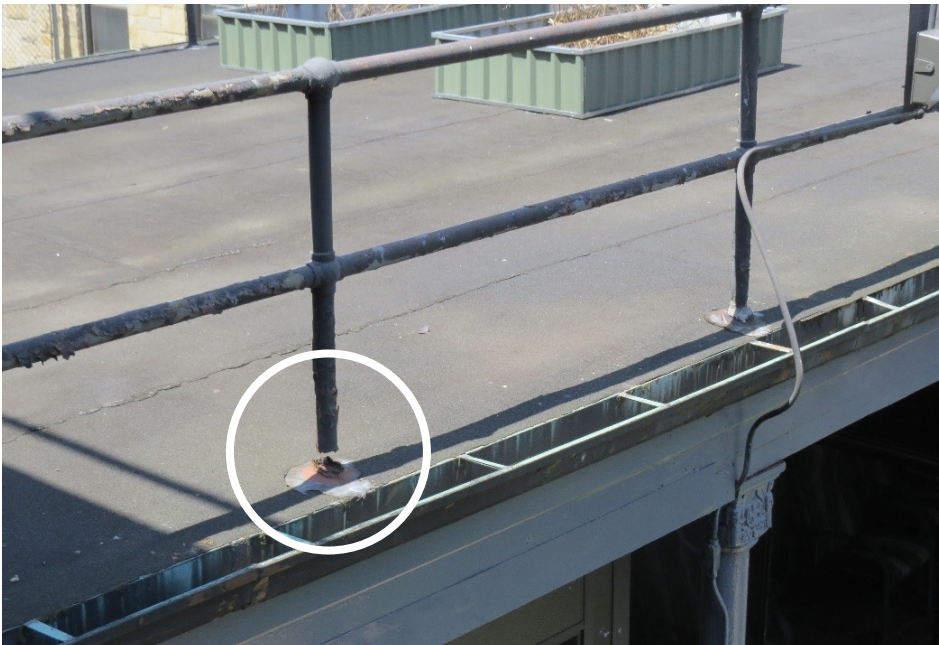
FIGURE 6. Posted guardrail completely corroded and post is left hanging. *Photo by author.*

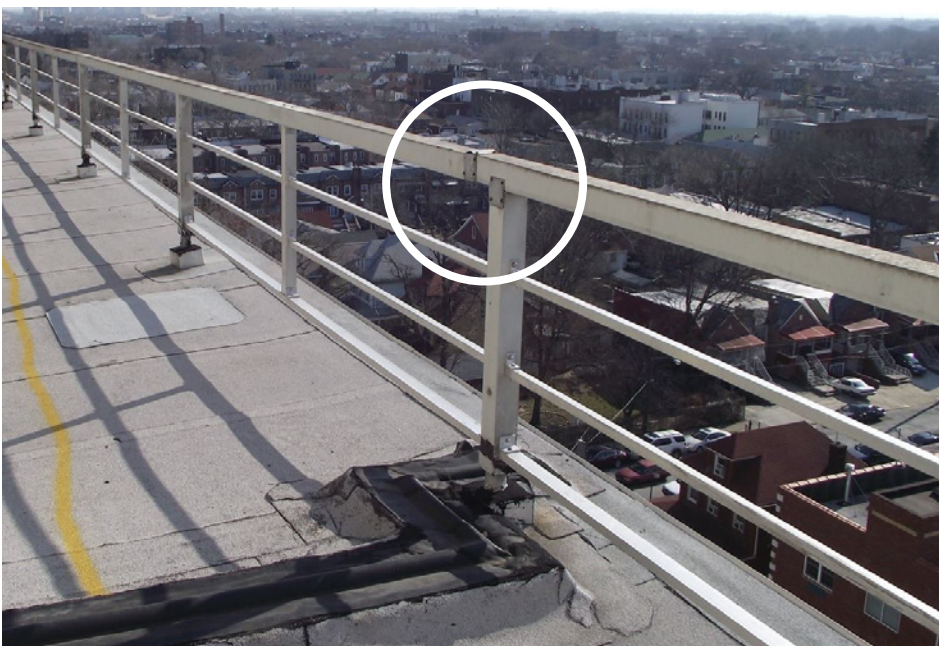
FIGURE 7. Guardrail at building expansion joint—note deformation at remedial plate at top rail. *Photo by author.*

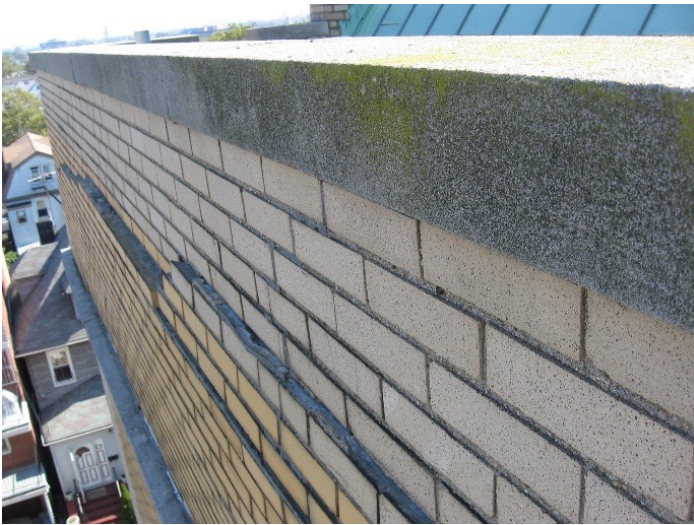
FIGURE 8. View of unsafe parapet masonry where it has shifted. *Photo by author.*

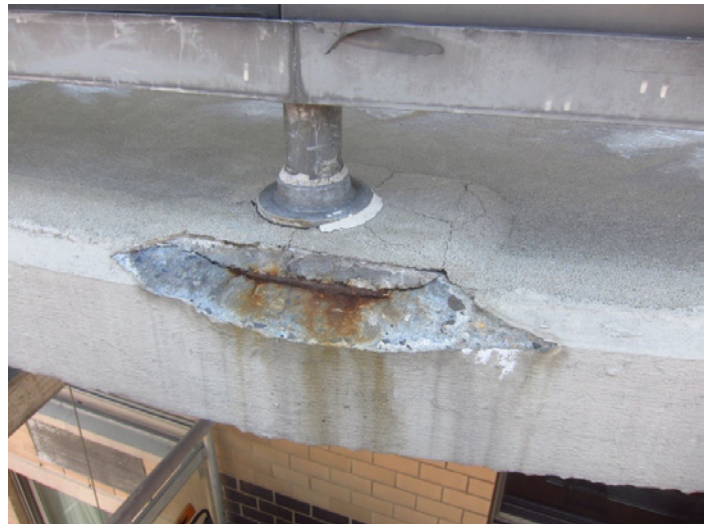
FIGURE 9. View of guardrail post base and balcony edge distress. *Photo by author.*

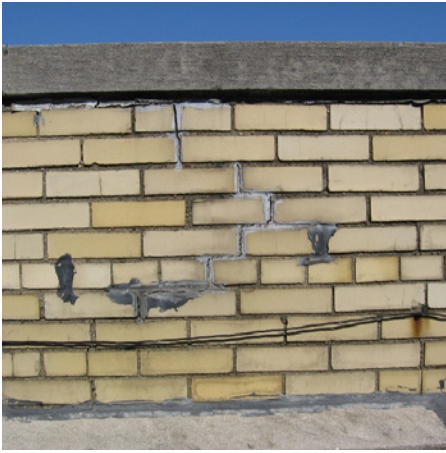
FIGURE 10. View of gap at coping stone, resulting in parapet masonry distress below. *Photo by author.*

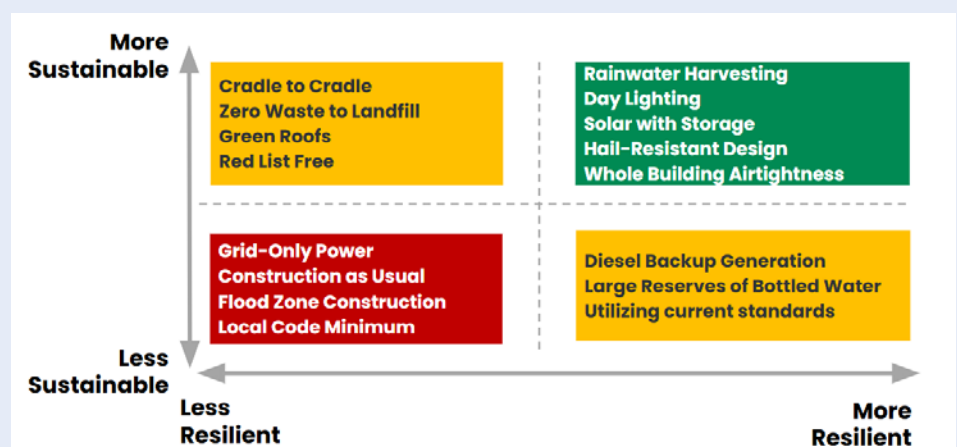
FIGURE 1. Sustainability and resilience matrix.
