2025 BUILDING ENCLOSURE
SYMPOSIUM

**IIBEC**
INTERNATIONAL INSTITUTE OF
BUILDING ENCLOSURE CONSULTANTS

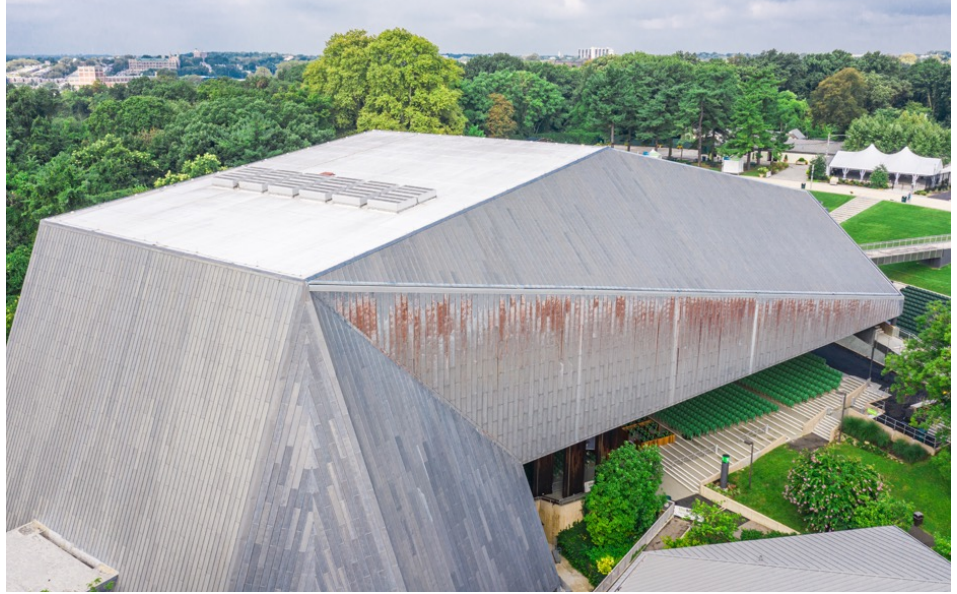
FIGURE 1. Overview of the east elevation of the Mann Center for the Performing Arts from the lawn via a drone survey performed in August 2019.

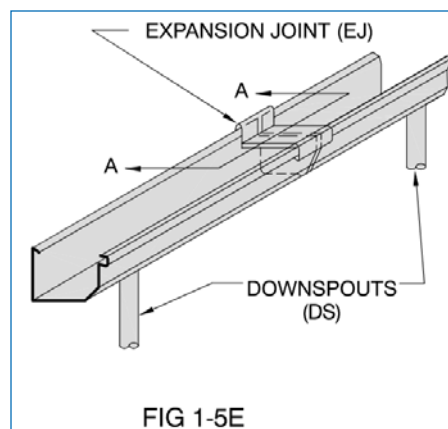
FIGURE 4. Excerpt from SMANA showing traditional expansion joint in gutters.

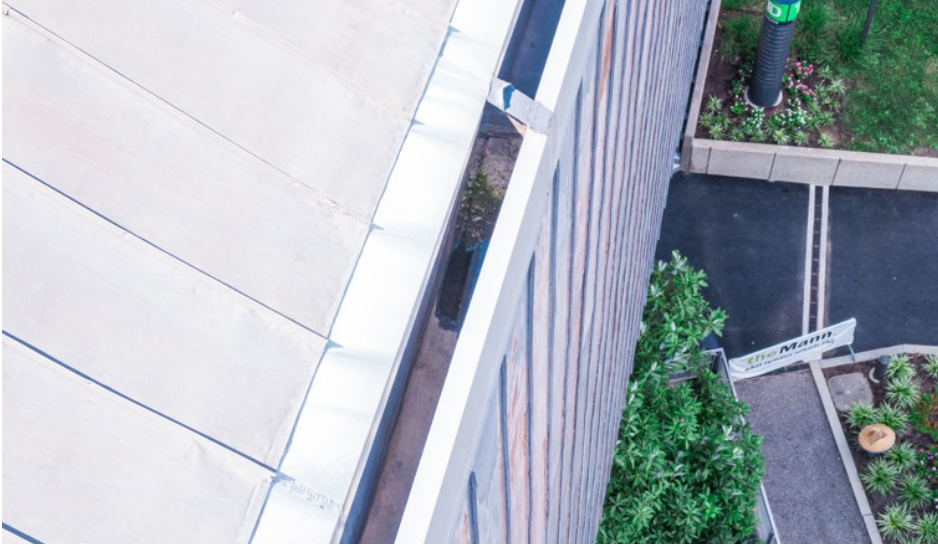
FIGURE 7. Typical blockage at representative outlet tubes due to debris accumulation.

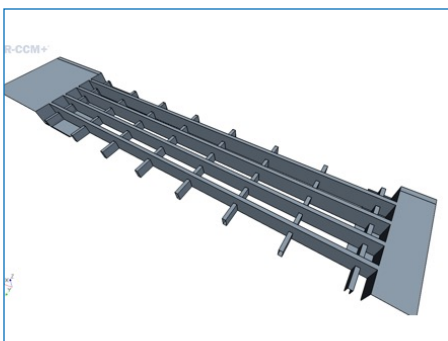
FIGURE 10. Geometry of grate at sump inlet of Modification 1.

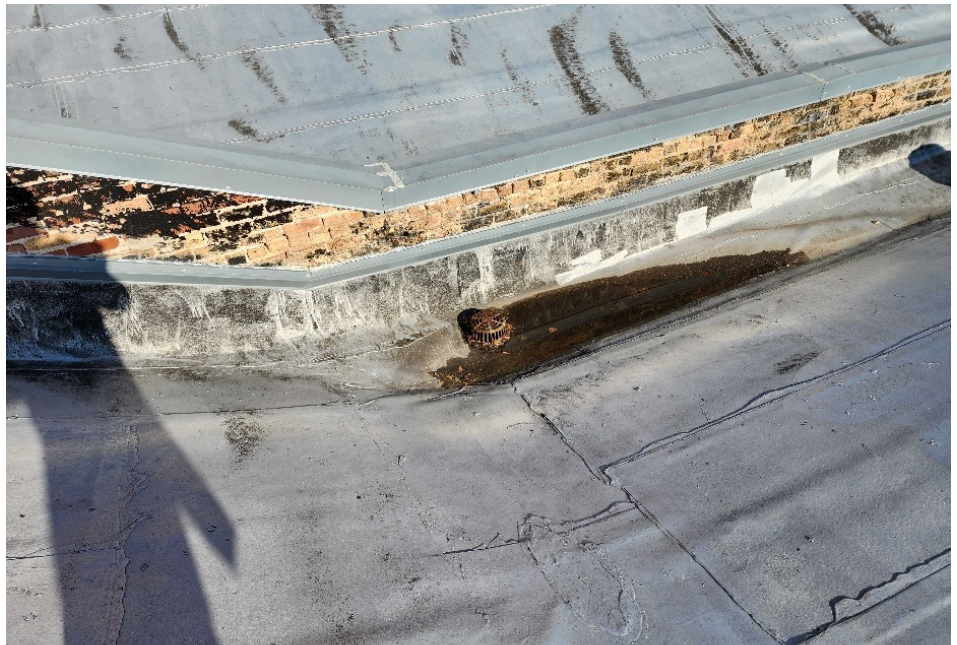
FIGURE 3. Example of a roof drain without a corresponding secondary (emergency overflow) drain or scupper.

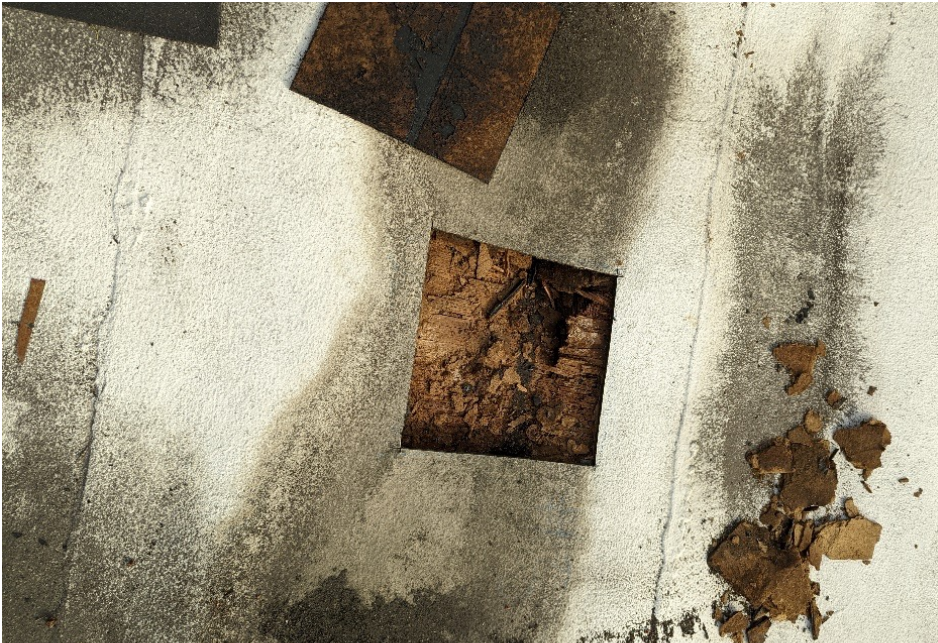
FIGURE 4. Example of condensation damage beneath a cool-roof membrane in Climate Zone 5.

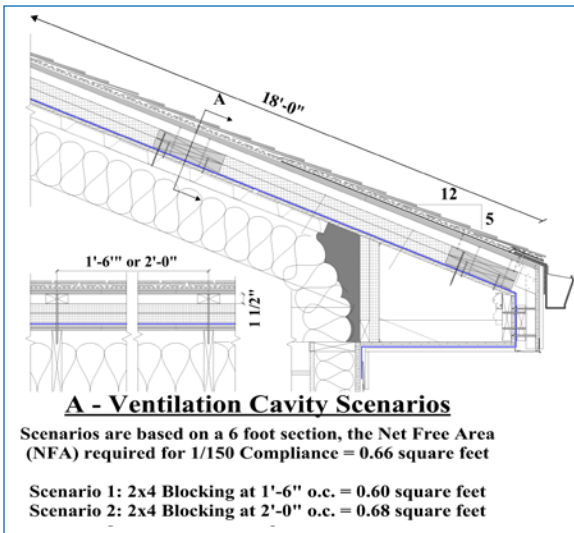
FIGURE 4. Ventilation scenarios.

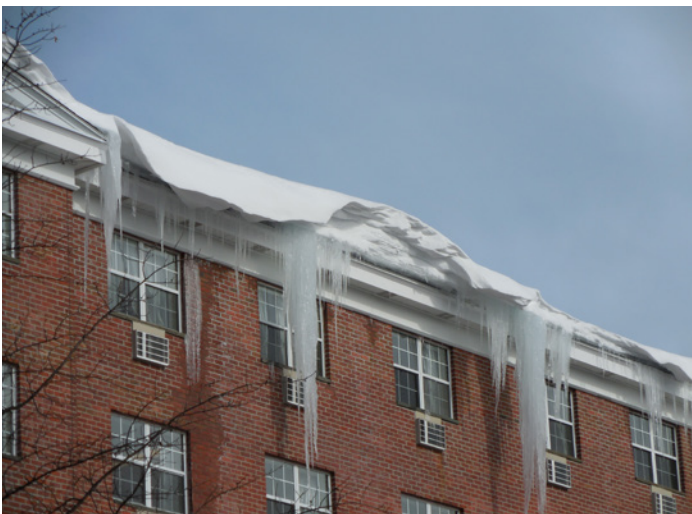
FIGURE 5. Ice dams and icicles resulting from insufficient ventilation.

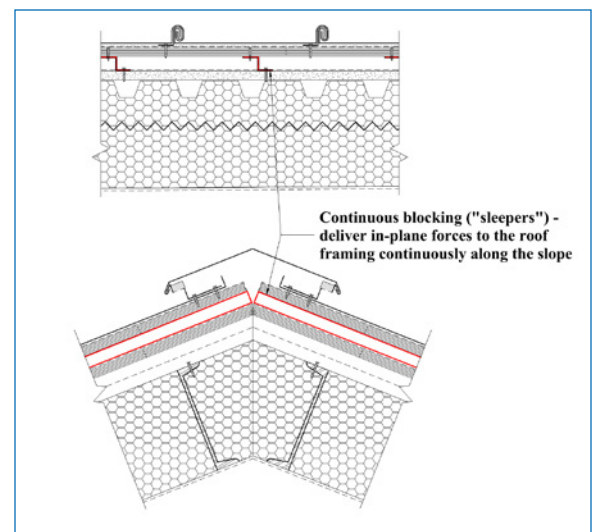
FIGURE 9. Continuous sleepers parallel to roof slope.

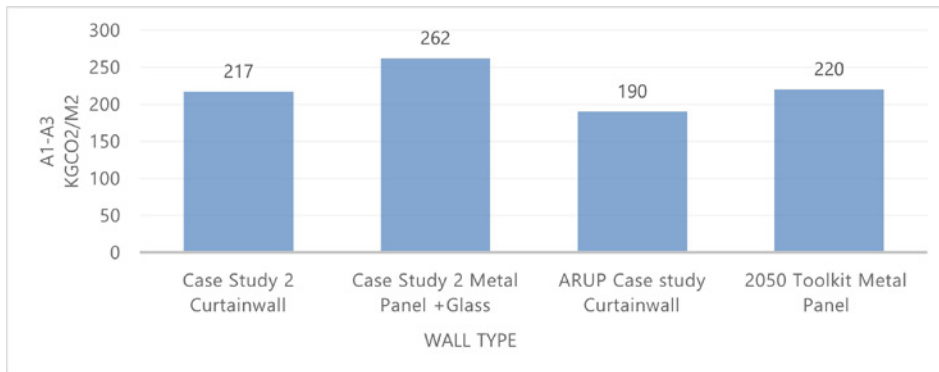
FIGURE 9. Comparison of industry baselines for embodied carbon associated with different wall types in modules A1, A2, and A3.¹⁰

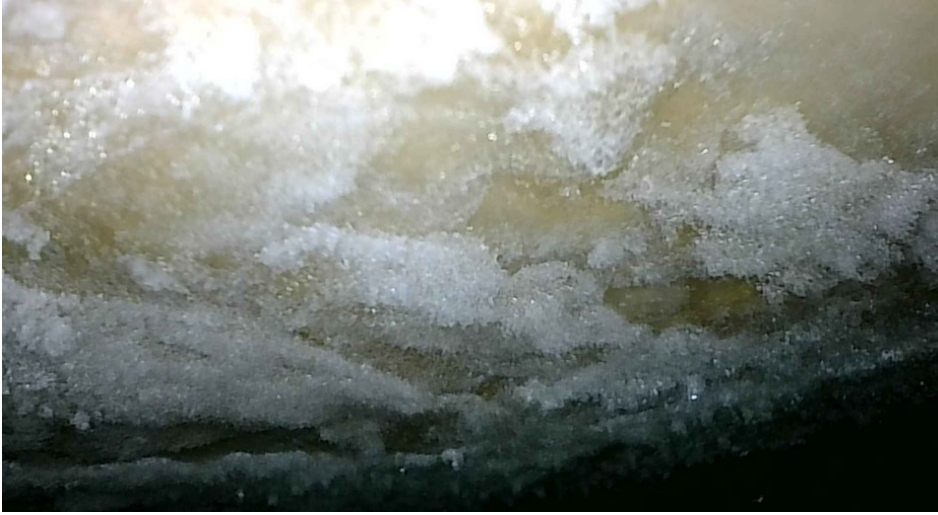
FIGURE 1. Frost buildup on the interior face of precast concrete.

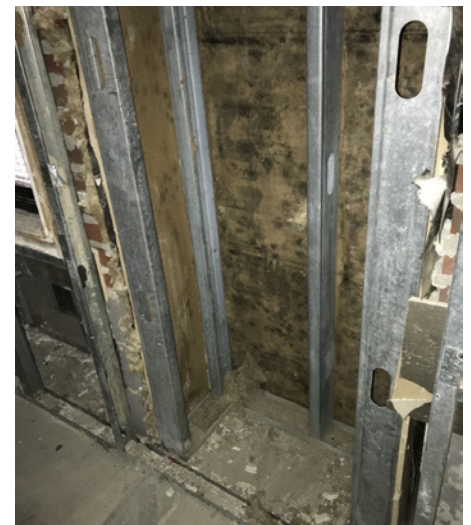
FIGURE 2. Organic growth at the interior face of the exterior sheathing within a neonatal intensive care unit space.

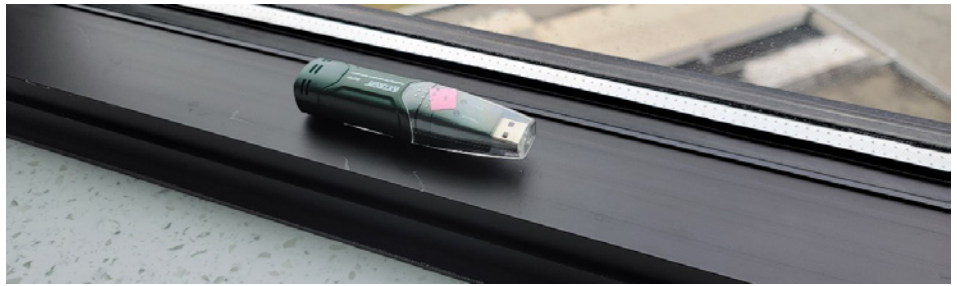
FIGURE 3. Temperature and humidity datalogger on a windowsill.

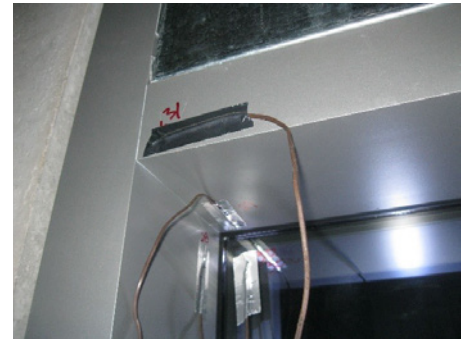
FIGURE 4. Thermocouple datalogger leads at the surfaces of an insulated glass unit and mullions.

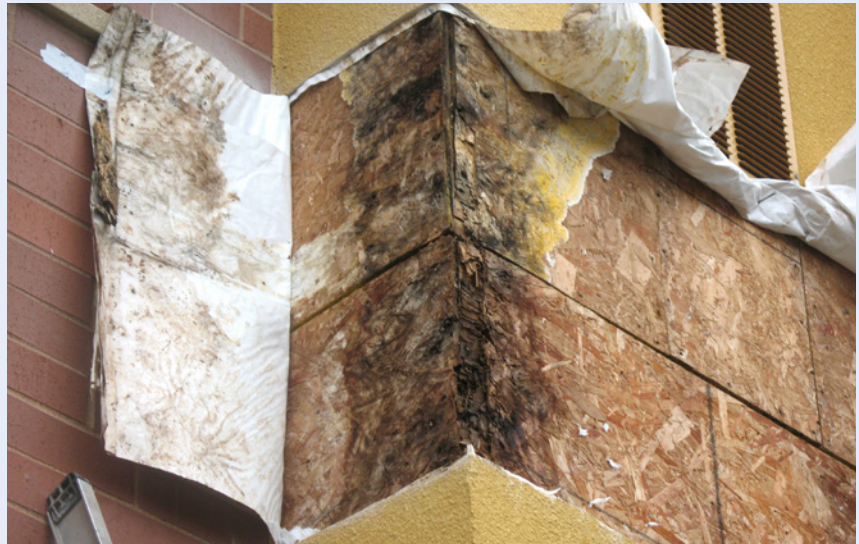
FIGURE 1. Material degradation due to cladding leaks and poor drainage.

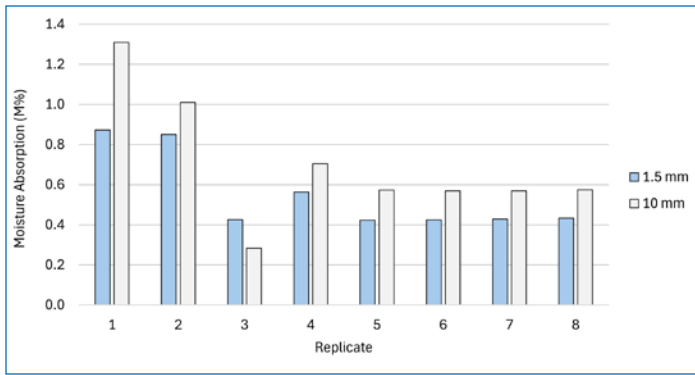
FIGURE 7. Water absorption by fiber cement panels. Note: 1 mm = 0.0394 in.

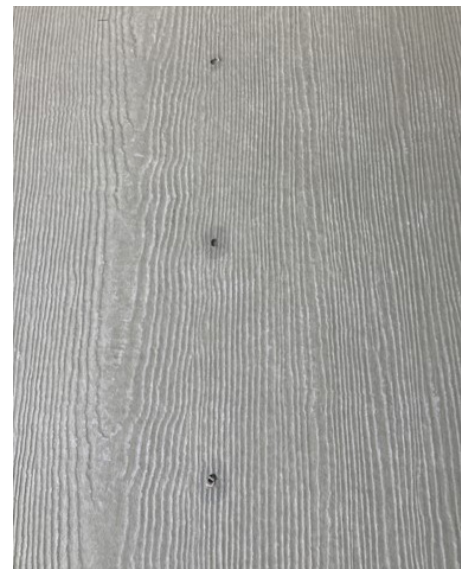
FIGURE 8. Water absorption at fastener penetrations.

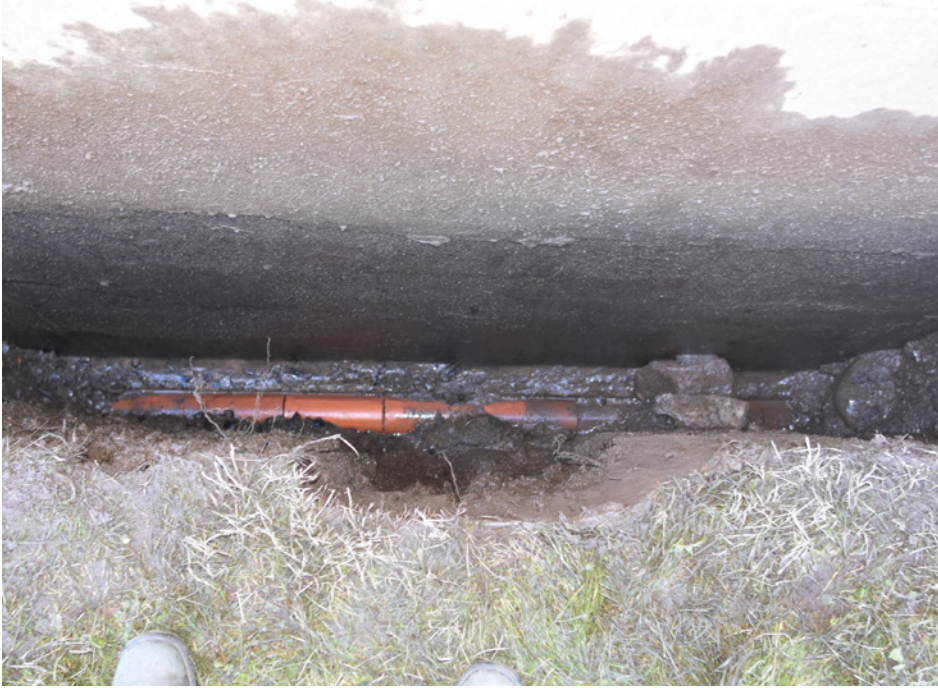
FIGURE 2. Hydrovac trench example.

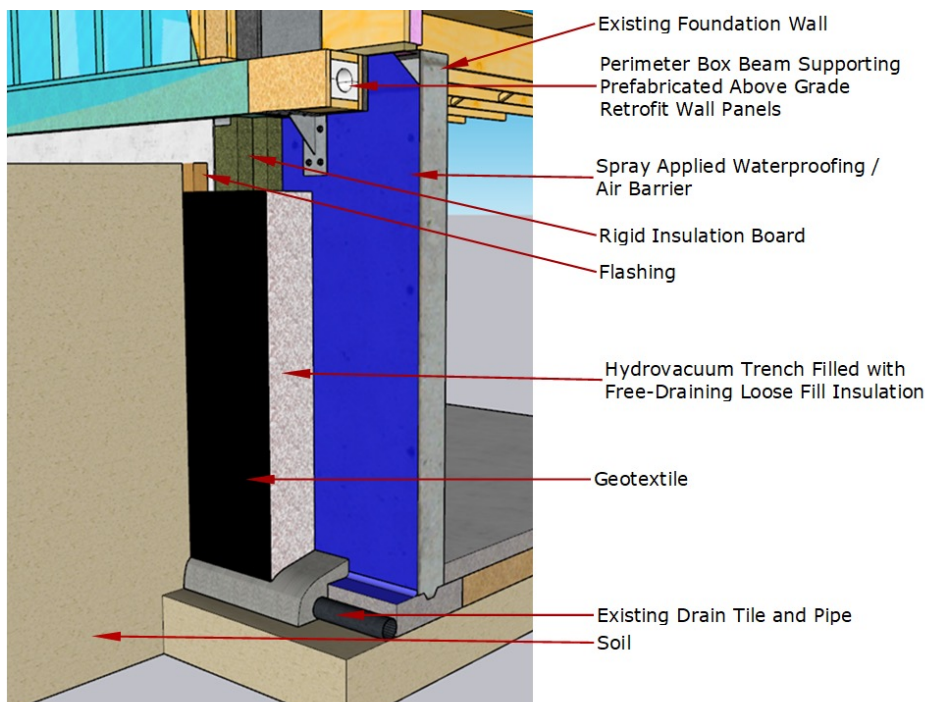
FIGURE 3. Novel foundation retrofit approach.

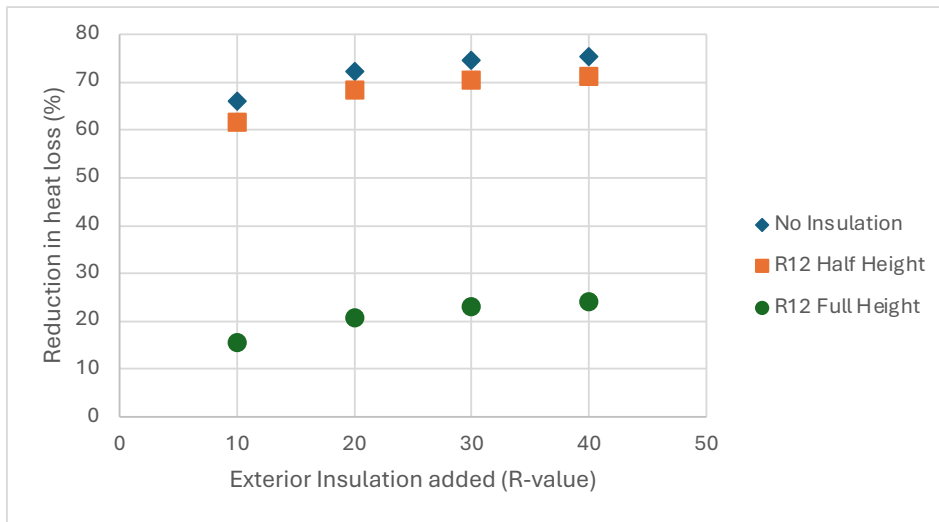
FIGURE 4. Heat loss reduction through exterior insulation.

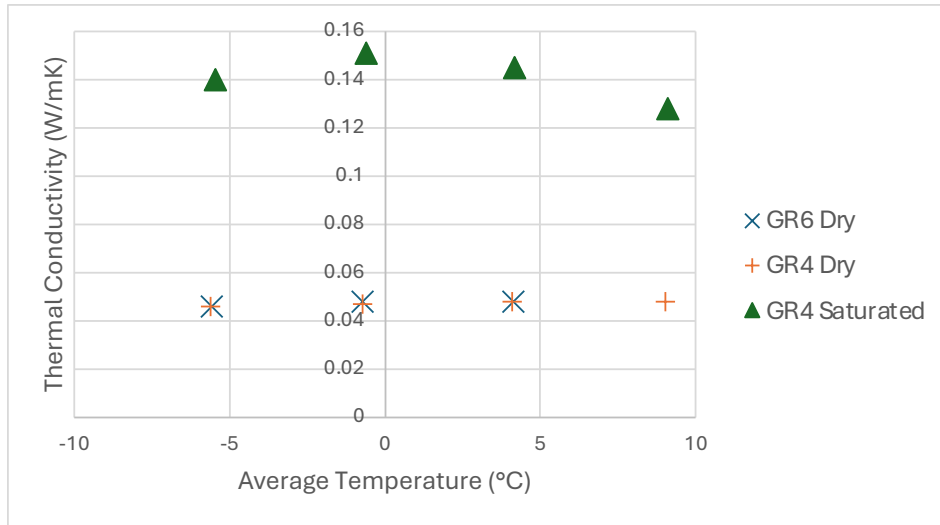
FIGURE 5. Thermal conductivity of perlite with respect to temperature.

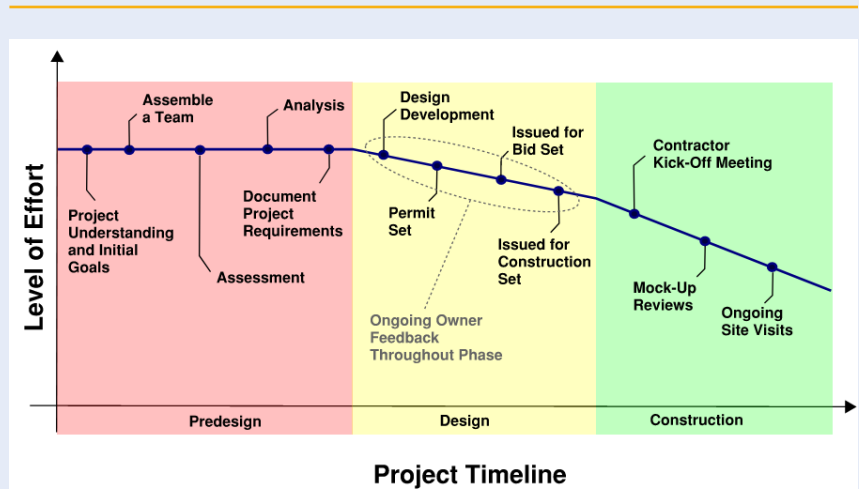
FIGURE 1. Proposed project approach demonstrating early predesign phase effort to maximize project value.

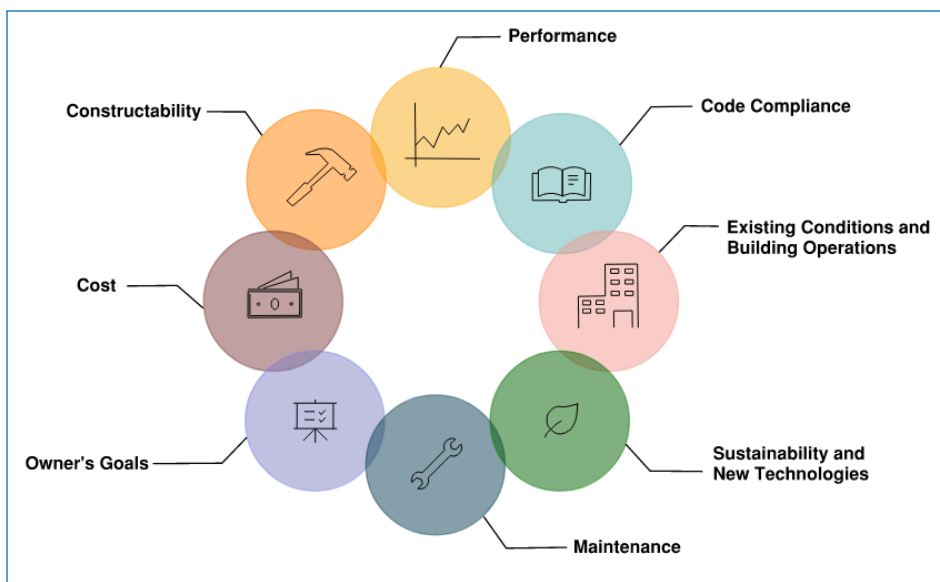
FIGURE 2. Diagram showing potential considerations during a project rehabilitation project. Considerations should be reconciled based on the project requirements to align the project scope with the owner's vision

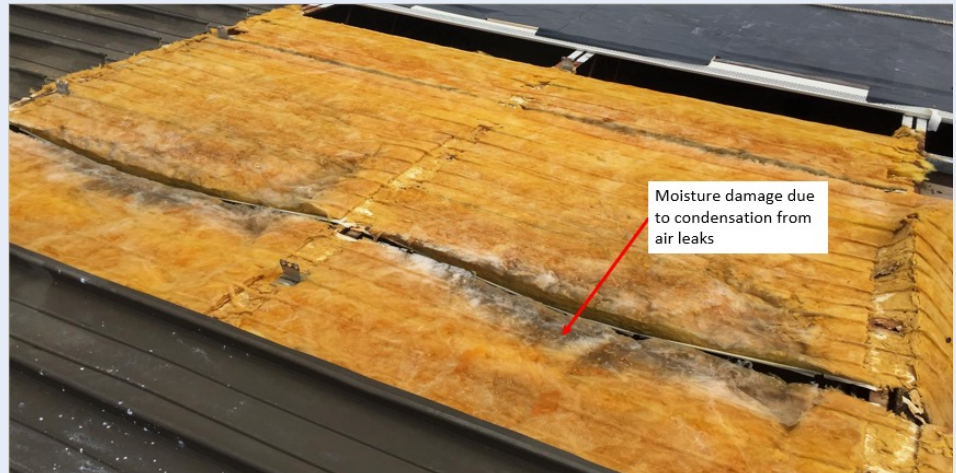
FIGURE 1. Natatorium roof enclosure failure.

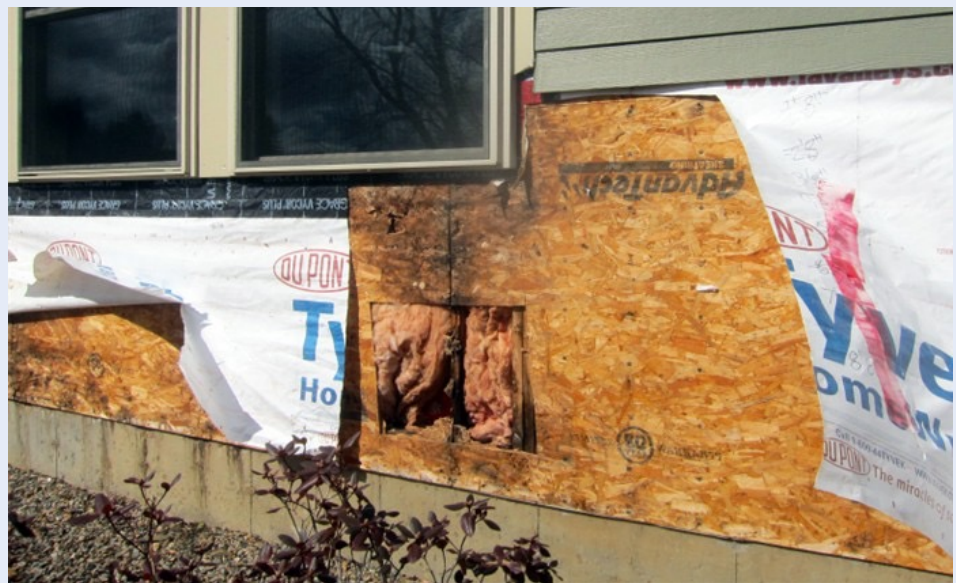
FIGURE 2. Natatorium wall failure.

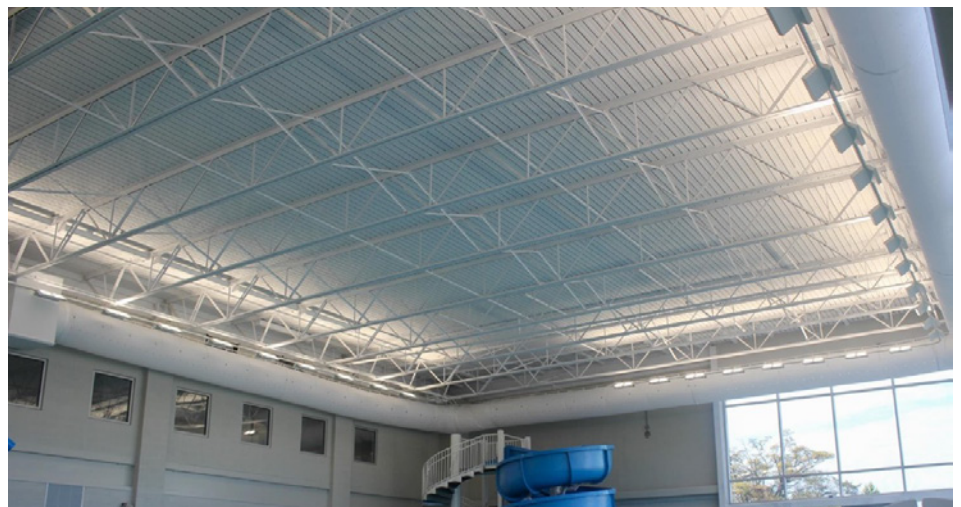
FIGURE 4. Three-coat metal deck system.

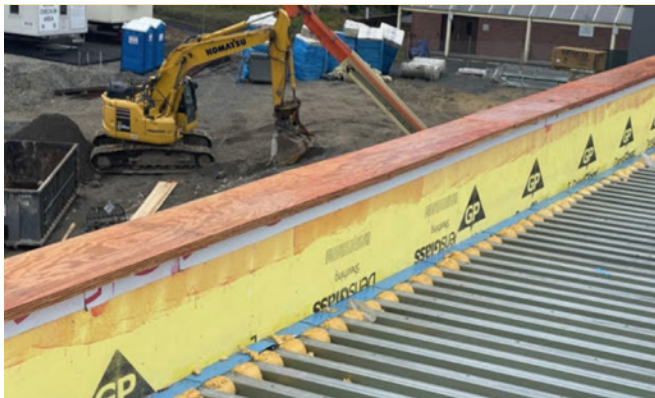
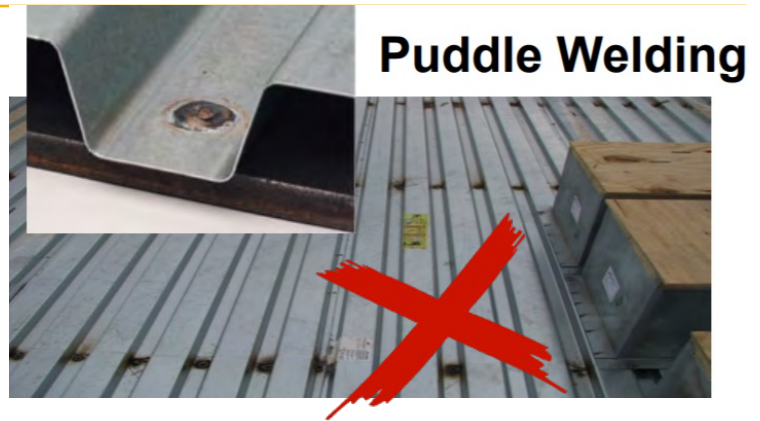
FIGURE 6. Examples of inappropriate sealing and attachment systems.

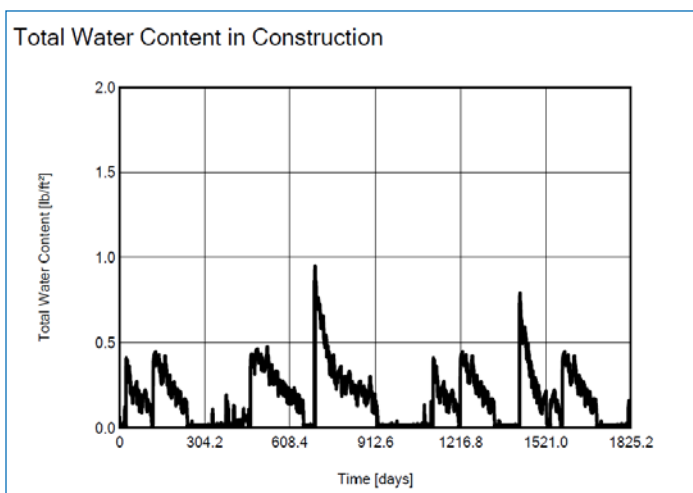
FIGURE 8. Assembly 1 and 2 model output: typical accumulated moisture in outer gypsum board.

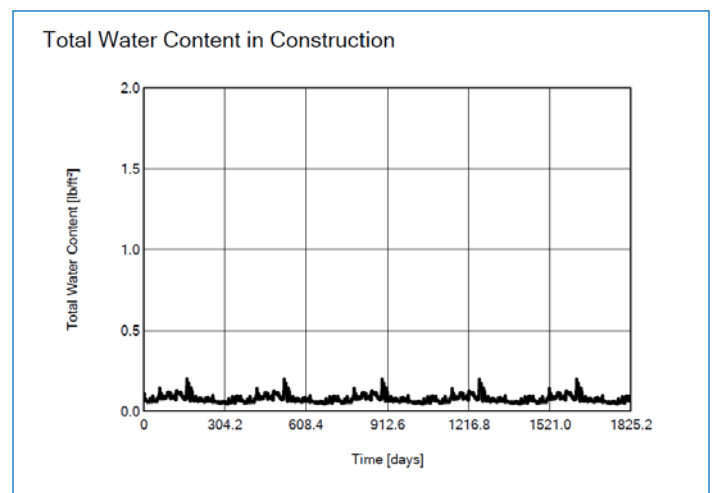
FIGURE 9. Assembly 4 model output: typical accumulated moisture in outer gypsum board.

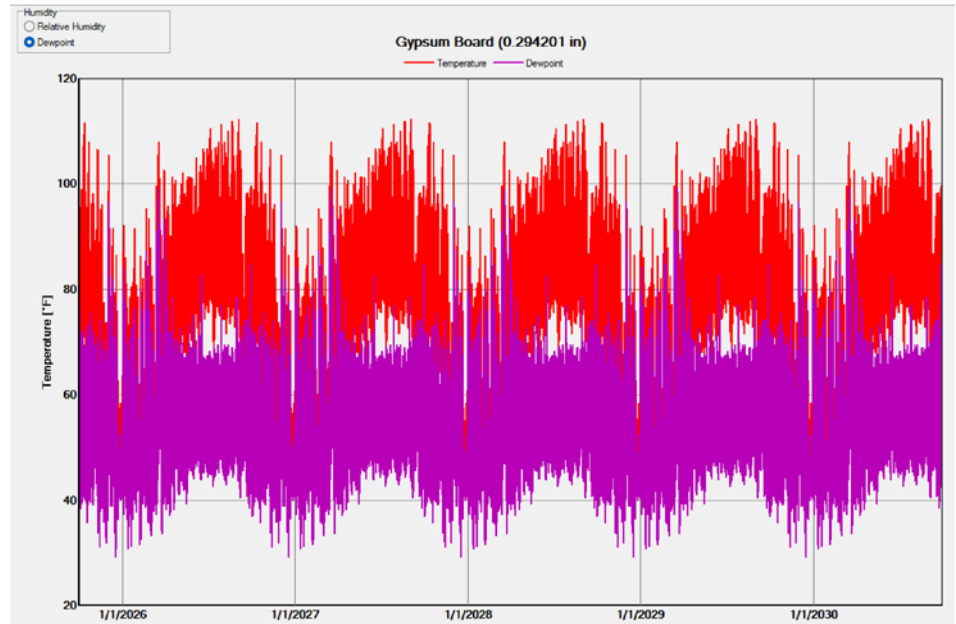
FIGURE 10. Assembly 1 and 2 model output: temperature versus dewpoint.

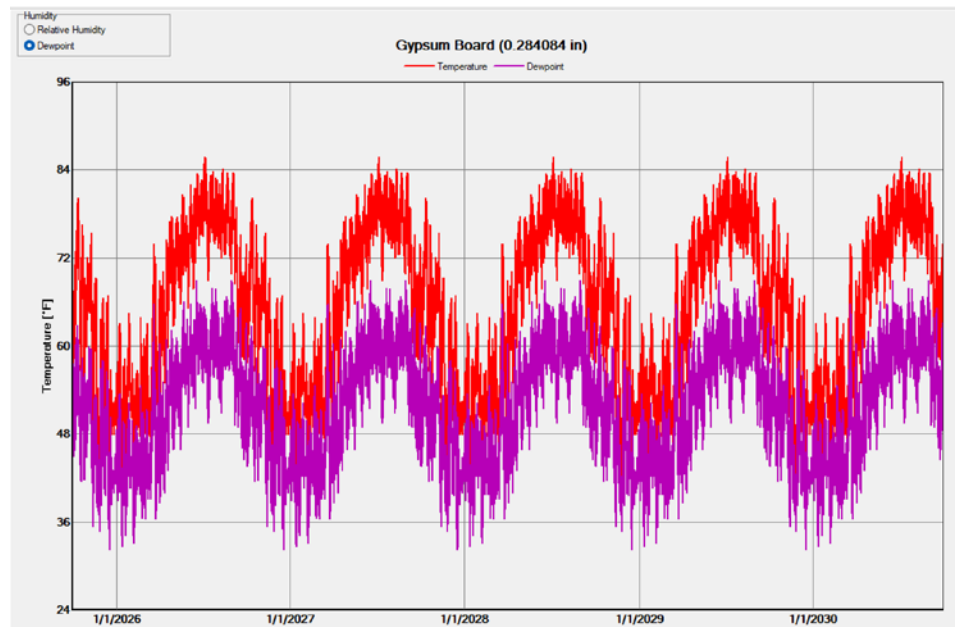
FIGURE 11. Assembly 3 model output: temperature versus dewpoint.

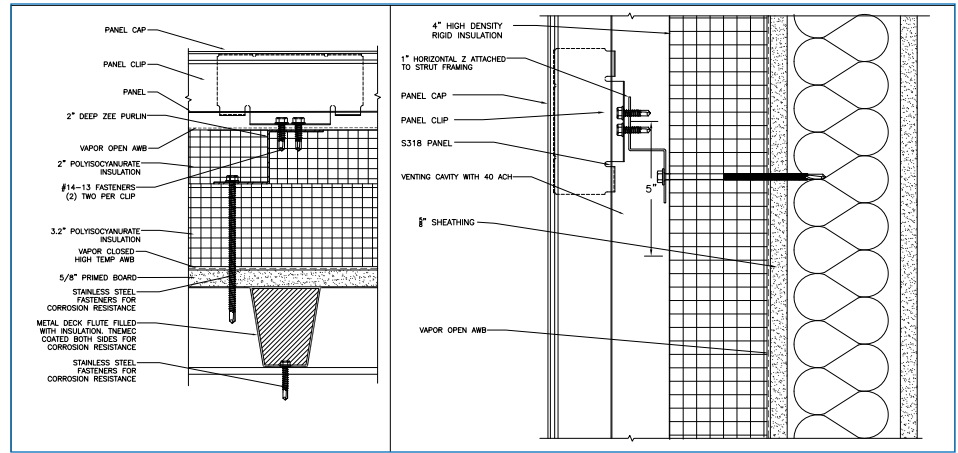
FIGURE 12. The manufacturer proposed roof and wall assemblies engineered to satisfy specified performance criteria, including hygrothermal, structural, and durability requirements.
