# Transforming 240 Markland Drive, Etobicoke: A Blueprint for Decarbonizing Multiunit Residential Buildings

By Blair Gamracy, RRO, BArchSci, and  
David De Rose, MASc, PEng, BSS

*This paper was presented at the 2024 IIBEC/  
OBEC BES.*

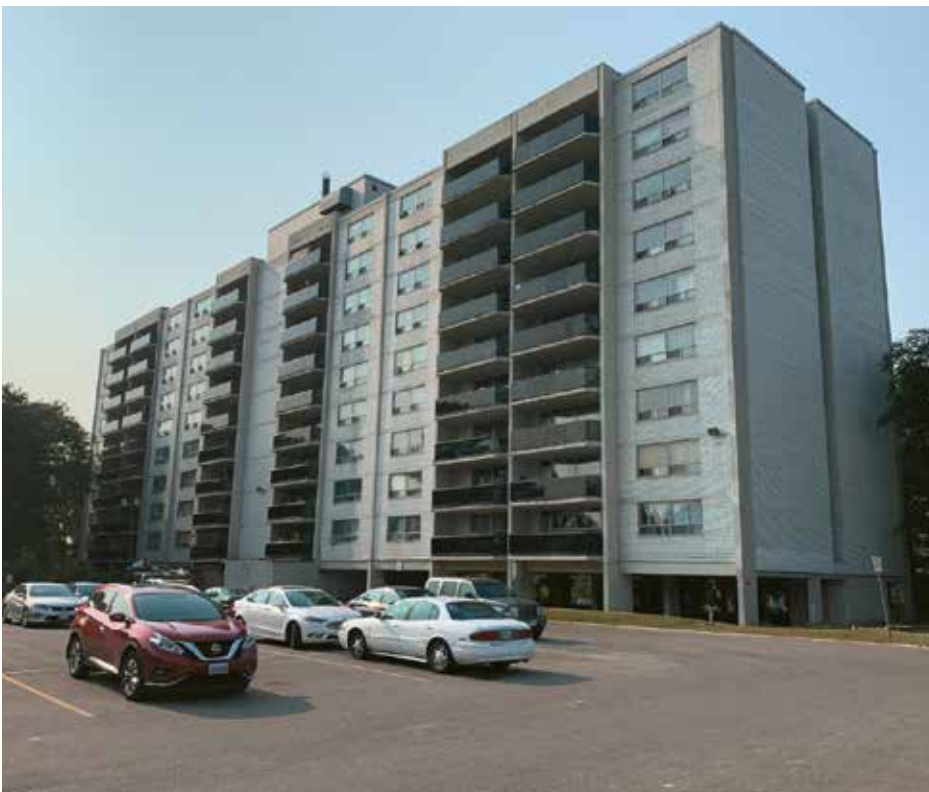
Figure 1. East elevation, preconstruction.

When the developer first laid eyes on the 1960s building (Fig. 1), the scene was far from inspiring. The building's exterior was marked by aged masonry walls, aging single-pane windows, and a failing roofing system. The mechanical systems within the building were outdated and inefficient. The lack of capital investment from the previous owner left the building aesthetically outdated and functionally deficient, presenting a challenging yet promising opportunity for revitalization.

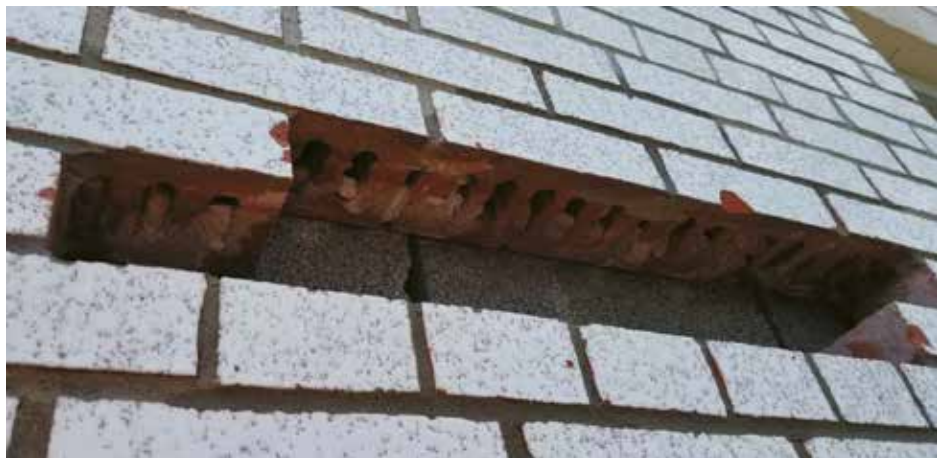
**Figure 2.** Exploratory opening in brick masonry.

The exterior walls of the building were primarily clad with white-glazed brick masonry. The construction of the wall system consists of composite masonry, where the exterior wythe of the brick masonry is bonded to the interior wythe of concrete masonry units (CMUs). The exterior brick masonry and backup CMUs rest on exposed concrete slab edges and are tied to each other by header bricks (**Fig. 2**).

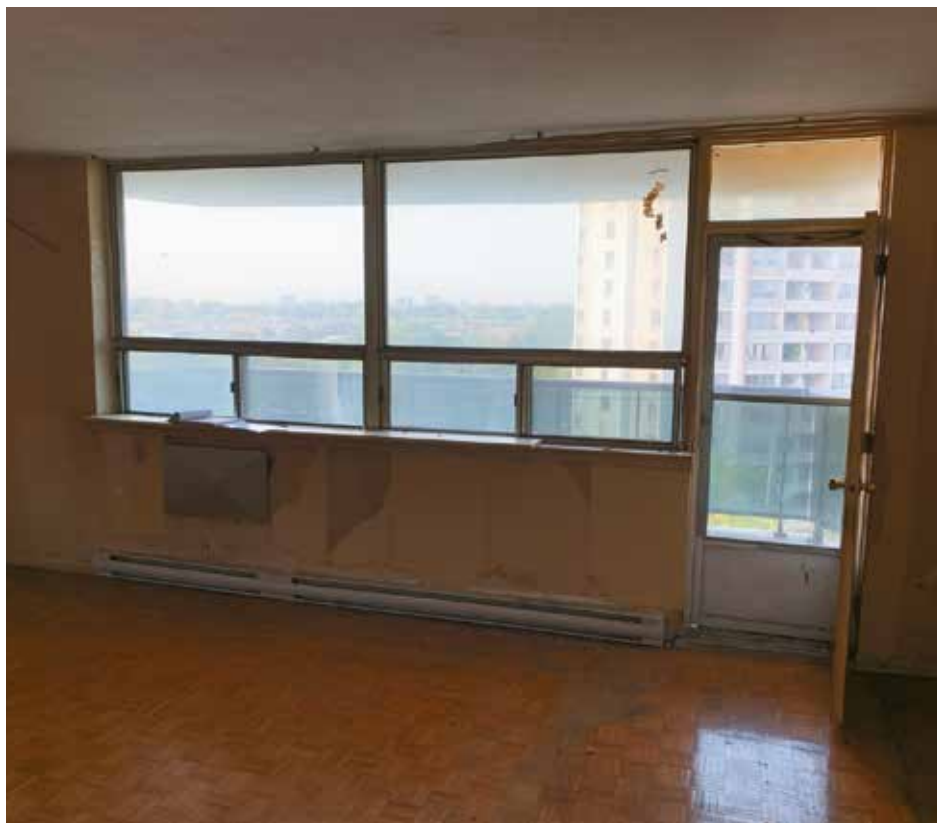
**Figure 3.** Existing in-suite windows and balcony swing doors.

The existing in-suite windows were aluminum framed with a single-pane glass lite with exterior single-pane storm windows, installed over four single-pane operable sash sliders. The existing swing door systems consisted of full-height inward-swinging wood door slabs with exterior aluminum storm doors (**Fig. 3**). The window performance was calculated to be U-0.76 (USI-4.3) with a solar heat gain coefficient (SHGC) of 0.67.<sup>1</sup>

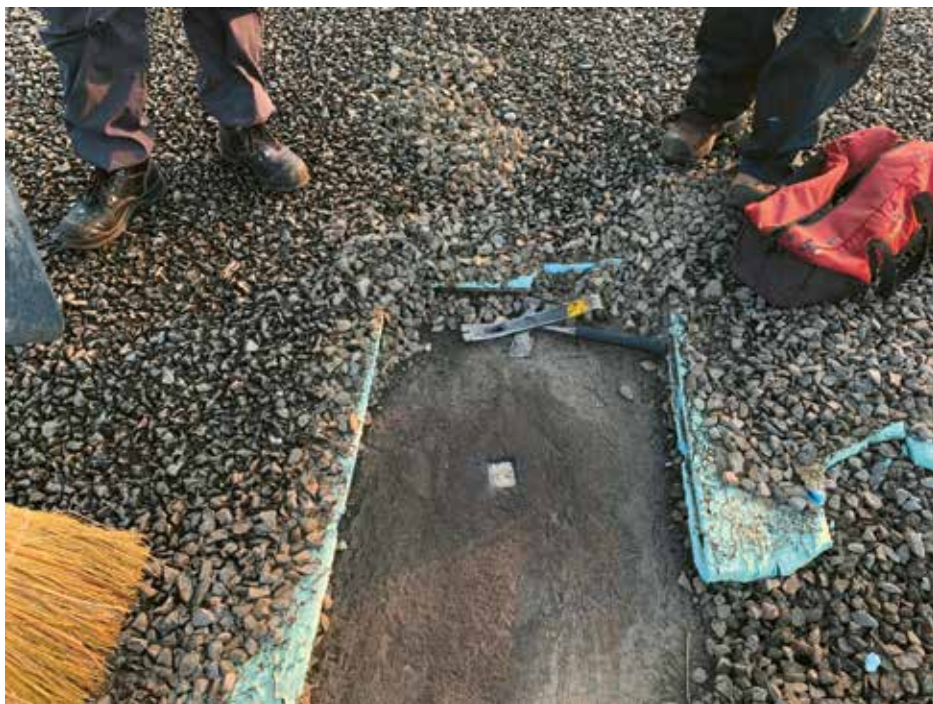
**Figure 4.** Test cut within existing roofing system.

The roof system was a protected membrane roof (PMR) system. The system was comprised of a concrete deck, four-ply asphalt and felt membrane, 1.5 in. (37.5 mm) of extruded polystyrene (XPS) insulation, and gravel ballast

(**Fig. 4**). The roof was estimated to have an overall thermal performance of approximately *R*-8 (*RSI*-1.41).<sup>1</sup> Active water leakage was reported into the mechanical penthouse and within several units directly below the roof.

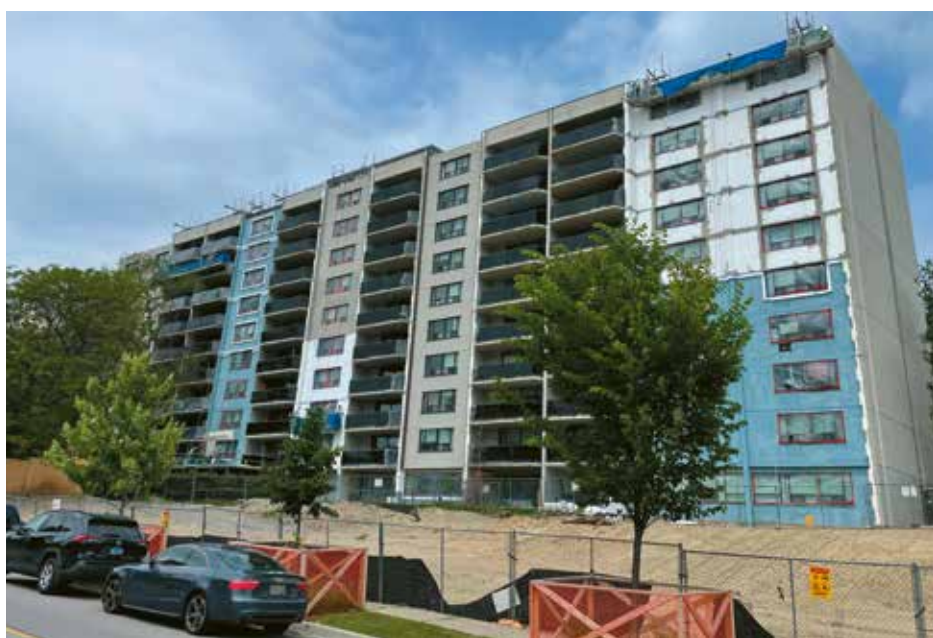
**Figure 5.** Exterior insulation and finish system installation on the west elevation.

The EIFS overclad generally consists of 3 in. (75 mm) of EPS insulation covered with a reinforced cementitious base coat and a finish coat lamina. A liquid-applied air and water-resistive barrier is applied directly over the existing brick and reinforced concrete shear walls and floor slabs (**Fig. 5**).

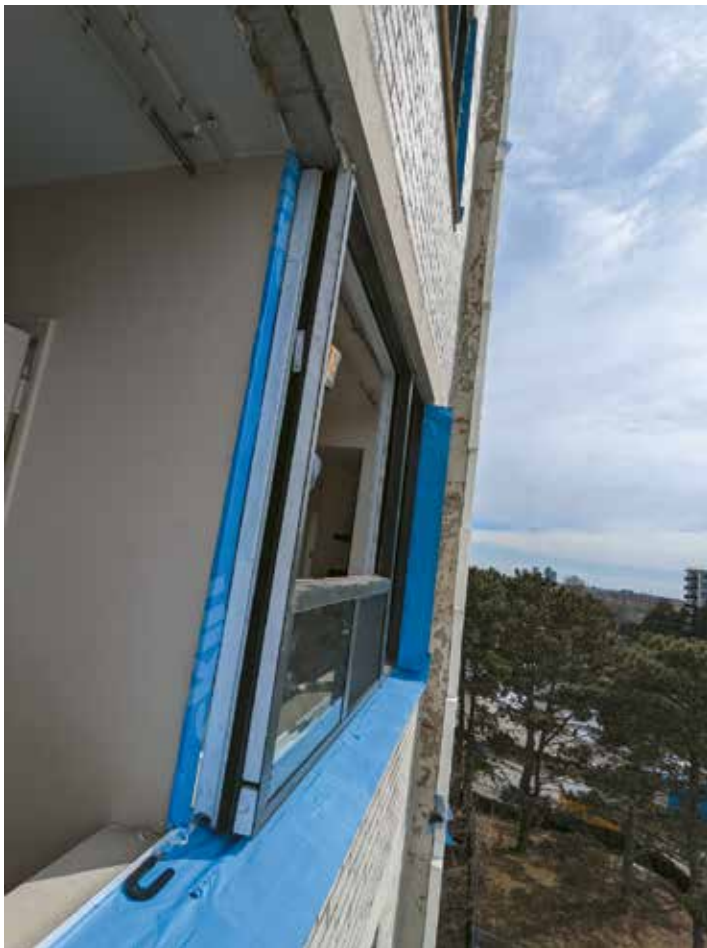
**Figure 6.** New residential window systems with subsill flashings.

All glazing systems utilize sub-sill membrane flashings (**Fig. 6**) and transition membranes for critical barrier continuity to adjacent walls. These membranes are married into the adjacent air- and water-resistive barrier of the EIFS for improved air- and water-leakage resistance and to be in line with best-practice detailing.

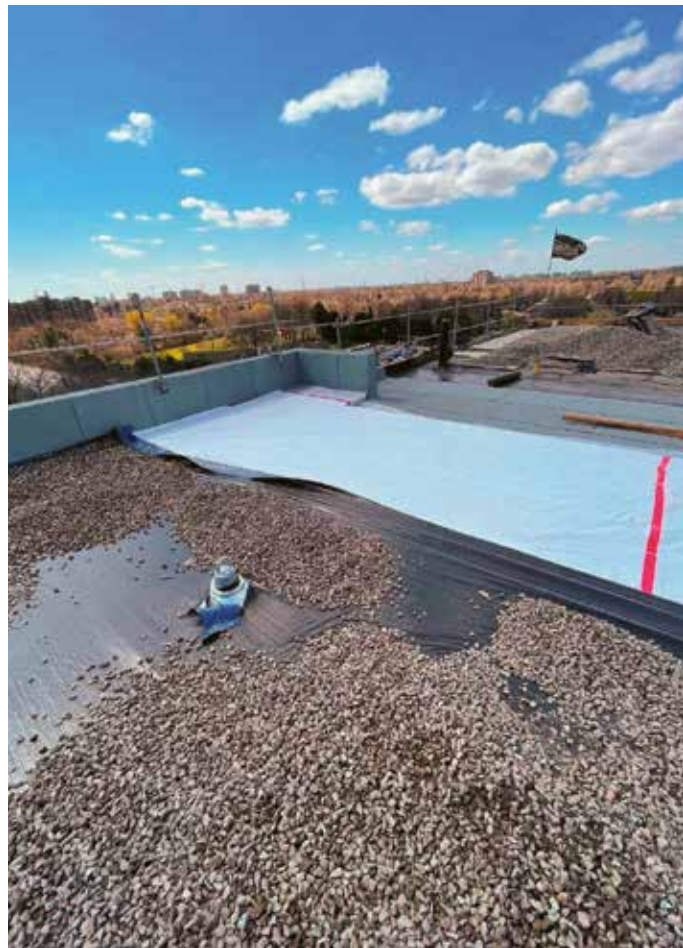
**Figure 7.** New protected membrane roof system under construction.

Although some existing components could be salvaged, the system's composition was changed to enhance performance. The existing XPS insulation, which was bonded to the existing membrane and brittle from ultraviolet exposure, was in poor condition and could not be salvaged. A two-ply modified bitumen membrane was used over the existing reinforced concrete roof deck. A 4 in. (100 mm) layer of new XPS insulation

was installed over a polyethylene separator sheet, improving the roofing system's thermal performance (**Fig. 7**). The existing gravel ballast was salvaged and supplemented with new gravel where necessary to meet wind uplift performance requirements.

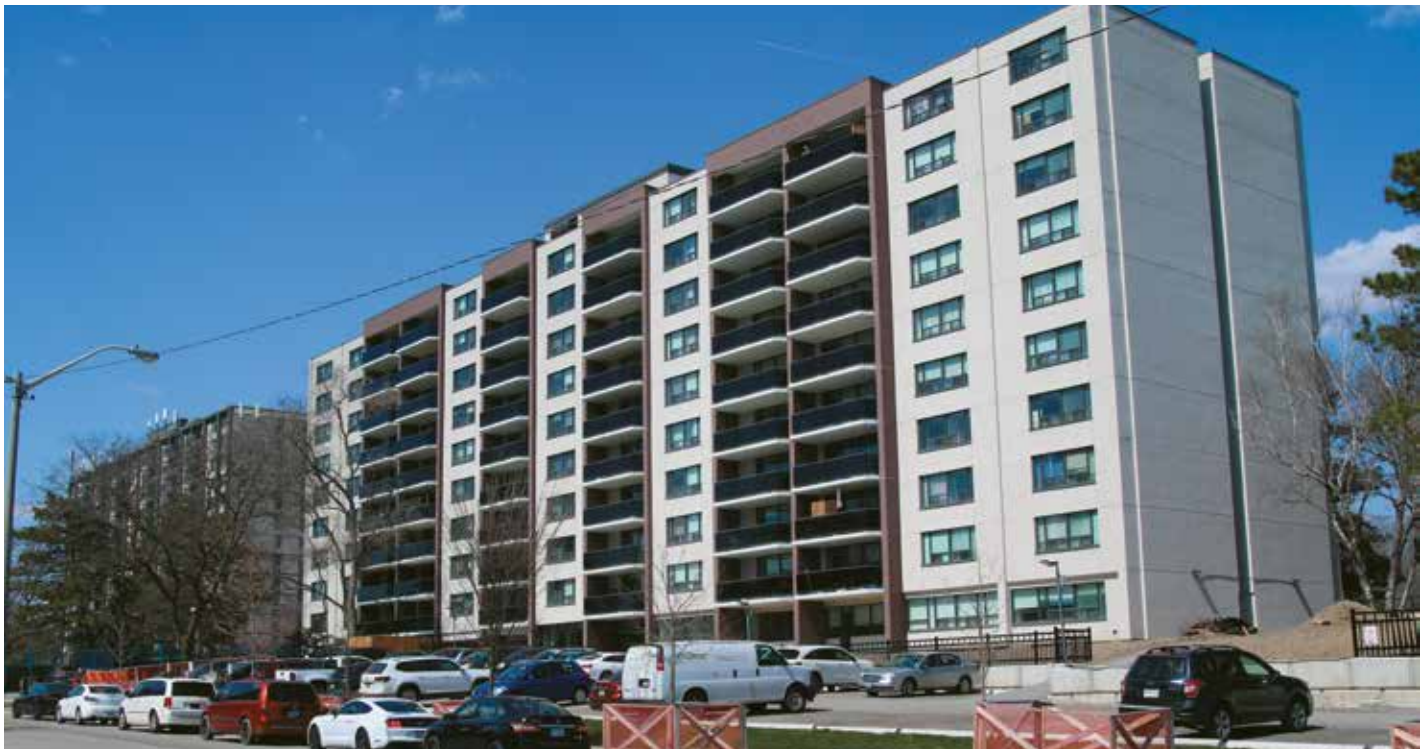
Figure 8. West elevation, post construction.

The transformation of this 1960s building is a testament to what can be achieved when vision meets innovation. From an outdated and inefficient structure, the building has been reborn as a model of sustainable design and performance (**Fig. 8**). The developer's commitment to integrating advanced technologies and sustainable practices has not
