When Sealants Meet Waterproofing: A Sticky Situation

Adhesion, Compatibility, and Discoloration of Silicone Sealant in Contact with Bituminous Waterproofing Materials

By Kelly Cronin, RWC, PE; Emmett Horton, PE; Matthew Schofield, PE; and Sang Kim, PhD

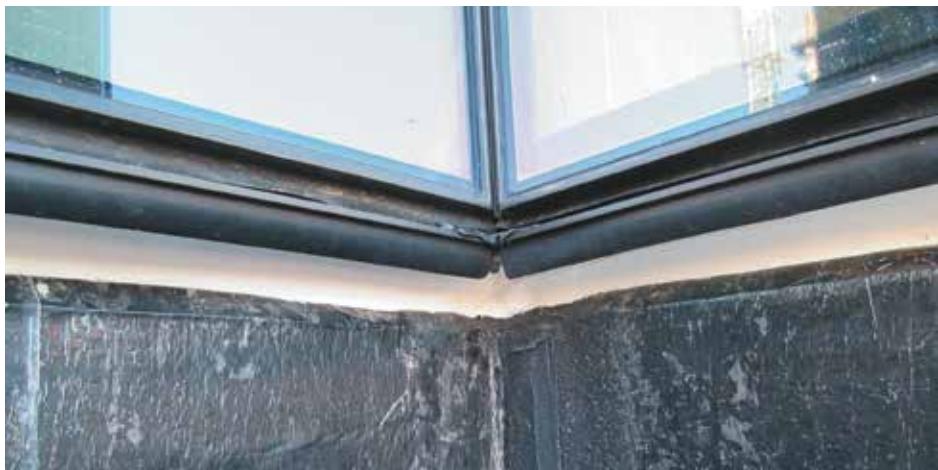
Figure 1. Example of in-service silicone sealant installed in joint between bitumen-based waterproofing and curtainwall frame.

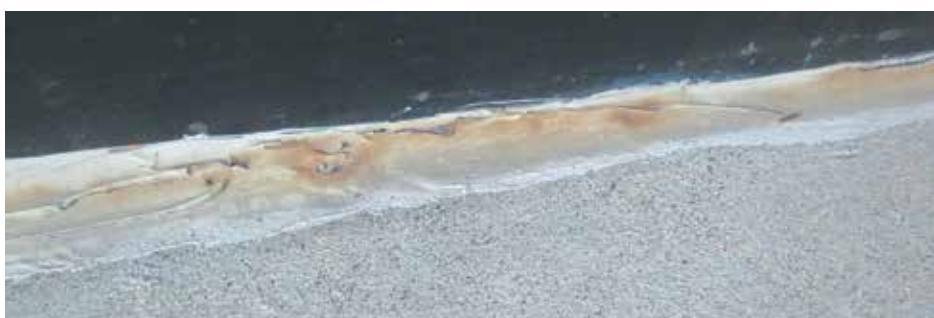
Figure 2. Example of discolored in-service silicone sealant in contact with bitumen-based waterproofing.

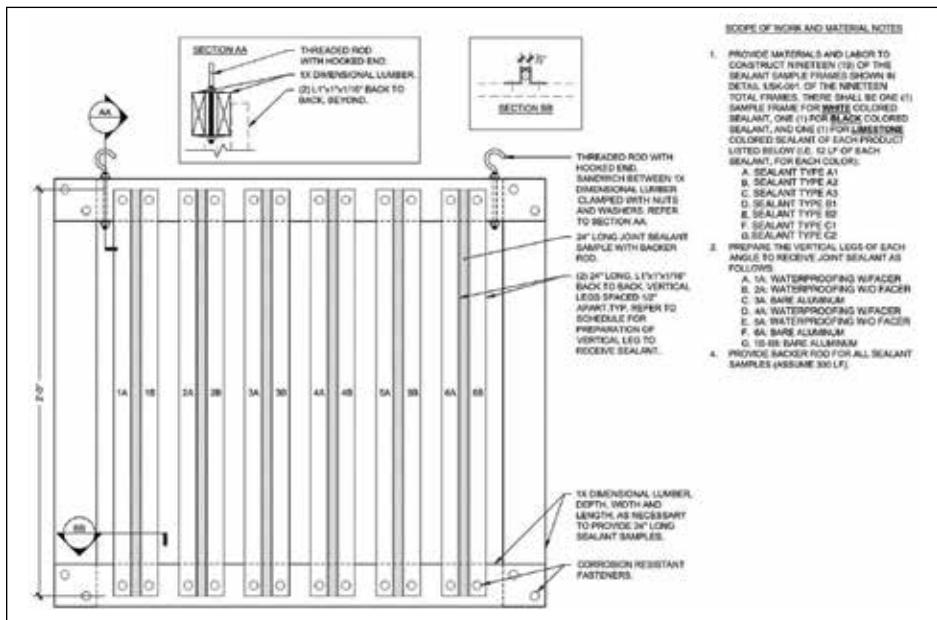
Figure 3. Schematic sketch of sealant sample frame.

Specimen construction consisted of a dimensional wood frame with intermediate 24 in. (610 mm) long anodized aluminum angles secured to and spaced evenly across the frame. Sealant was installed in the joint between back-to-back aluminum angles. The substrate at one side (A side) of each test specimen consisted of the primed anodized aluminum. The substrate on the other side (B side) of each test specimen consisted of either anodized aluminum (Control), bitumen-based self-adhering membrane with plastic facer (Condition W+F), or the same bitumen-based membrane but with the plastic facer removed (Condition W-F) to simulate a fluid-applied bitumen-based membrane. In addition, smaller (approximately 2 in. [50 mm] long) reference samples of each material were constructed and set aside in the laboratory to be used to establish the baseline chemical properties of the sealants and waterproofing. Sealant was installed over a bicellular backer rod in a 1/2 in. (13 mm) wide joint and toolled to a concave profile with a 2:1 width-to-depth ratio. Two samples of each sealant and waterproofing combination were installed on each test frame (specimen) for a total of six samples on each frame (two with control condition on the B side, two with Condition W+F on the B side, and two with Condition W-F on the B side). In total, 19 test frames, each with a unique sealant formulation and color, were constructed (**Fig. 3** and **Fig. 4**).

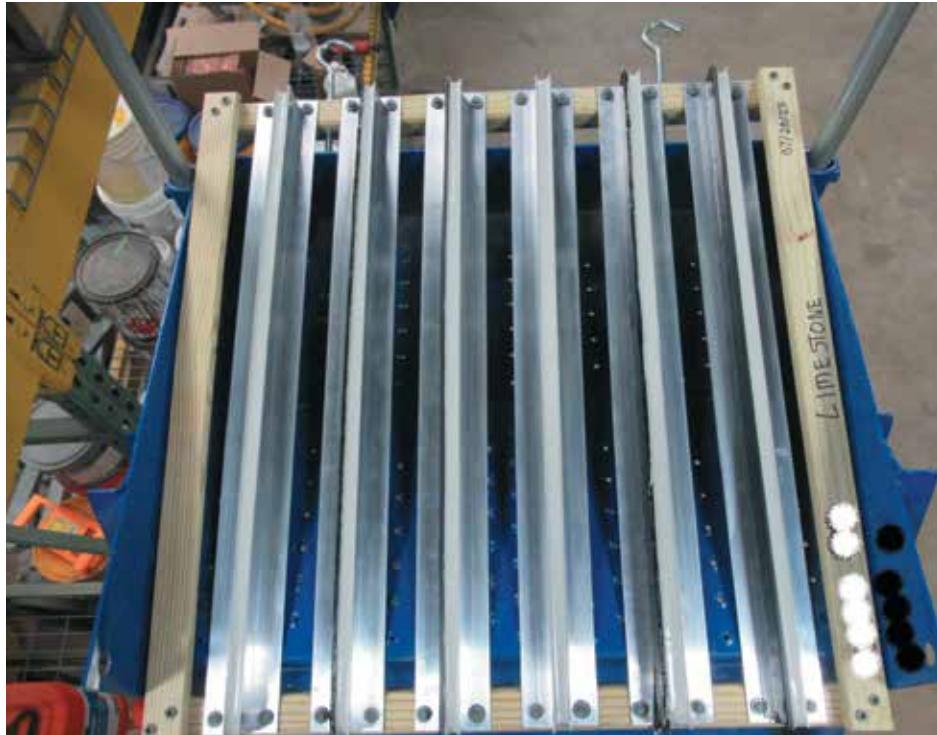
Figure 4. Example of frame shortly after fabrication.

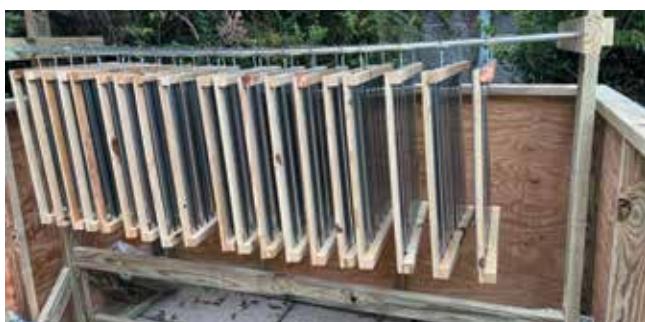
Figure 5. Frames hanging within outdoor enclosure.

After fabrication, the sealant was allowed to cure inside a conditioned warehouse for 1 month. In July 2023, the specimens were transported to an outdoor open-air enclosure located in the Washington, DC, metro area, which is in IECC Climate Zone 4A: Mixed Humid. The enclosure was partially shaded to prevent ultraviolet deterioration of the waterproofing over the course of testing/monitoring (**Fig. 5**).

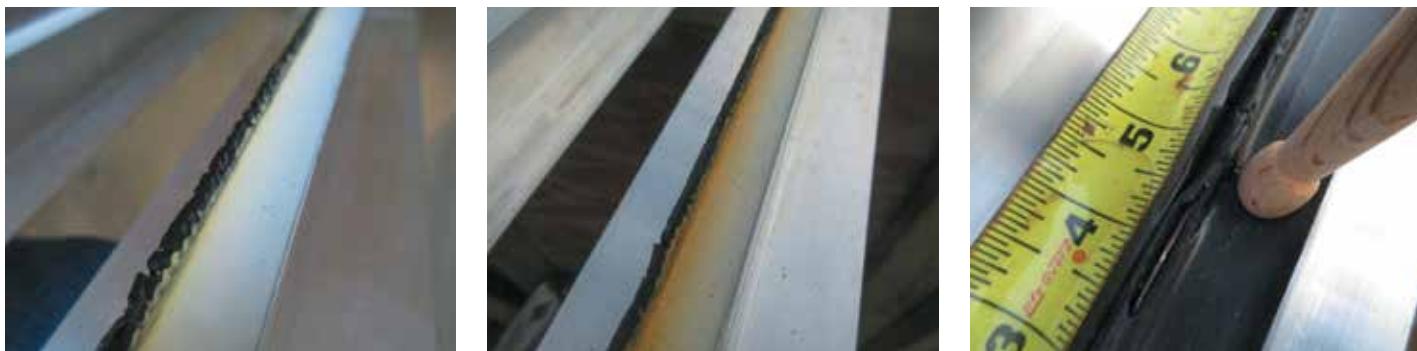
Figure 7. Photo examples of sealant at: (a) Week 6, slight yellow discoloration at Condition W-F, (b) Week 28, bright orange discoloration at Condition W-F, and (c) Week 28 with localized adhesive failure along edge in contact with bitumen-based waterproofing (Condition W-F).

- At Week 6, a slight discoloration at the edge of the sealant in direct contact with the exposed bitumen material (Condition W-F) was observed at nine specimens. A subtle yellow haze at the edge of the sealant in direct contact with the exposed bitumen material was noted at an additional three specimens (Sealant Types A1 and B1). Discoloration of some degree was noted at all white- and limestone-colored specimens. In general, discoloration was noted along the full length of the edge of the joint in direct contact with the bitumen-based material (Fig. 7[a]).

- By Week 9, a subtle haze was observed at the edge of two black-colored sealants (Types C1 and C2).
- By Week 11, three of the specimens developed a bright orange discoloration at the edge of the sealant in direct contact with the exposed bitumen material; the discoloration lightened across the width of the joint (Fig. 7[b]).

- At Week 28, localized adhesion failure was noted at the edge of Sealant Type C1 at both black-colored samples (Fig. 7[c]).
- At Week 52, only two samples (Sealant Types A2 and B1, both black colored) did not have visible discoloration to some degree.

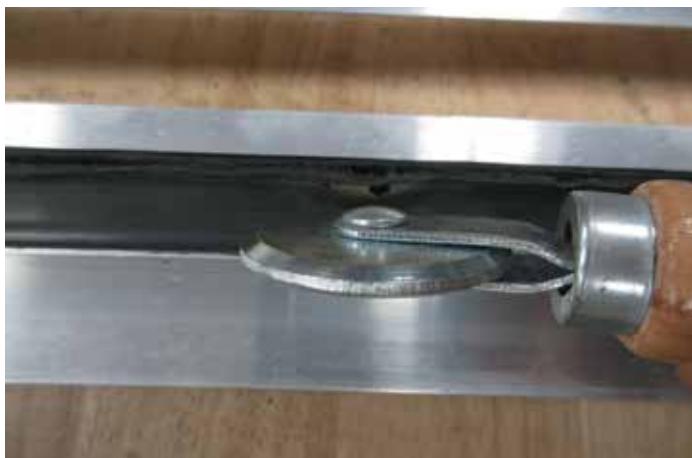
Figure 9. ASTM C1521 continuous nondestructive test at location of unadhered sealant.

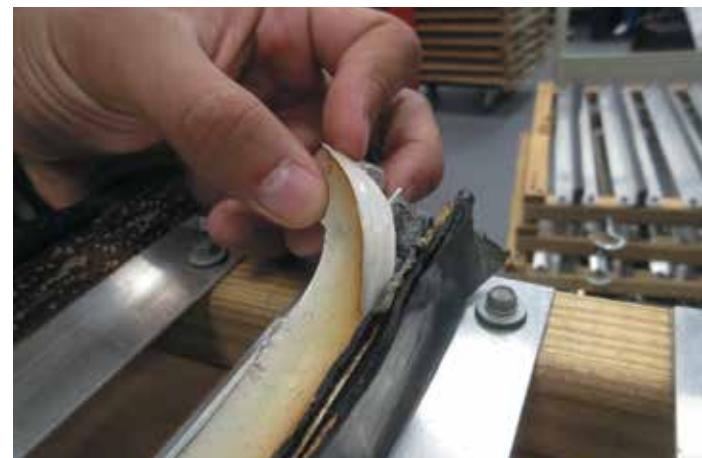
Figure 10. Top and side of sealant sample during extraction from the aluminum angles.

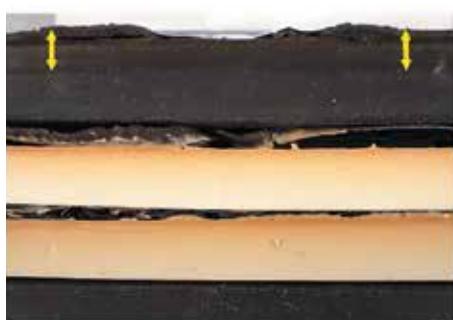
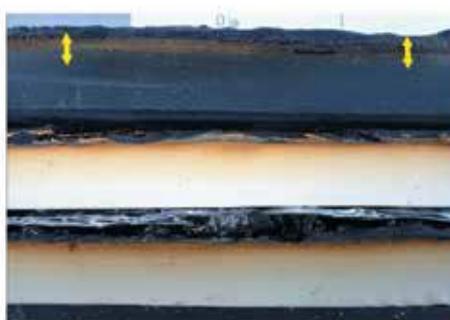
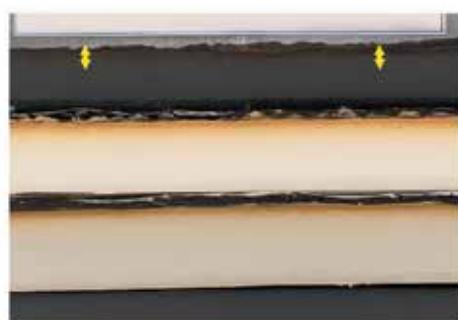
Figure 11. Comparison of sealant discoloration among color variants (black, white, and limestone, from top to bottom) for three products: (a) Type A2, (b) Type C2, and (c) Type A1. The area of most pronounced discoloration observed in the black sealants is marked by yellow arrows.

Sealant discoloration for each specimen was first compared across the three sealant colors (black versus limestone versus white). Although initial field observations indicated that discoloration varied by sealant color, laboratory analysis revealed that the overall extent of discoloration was consistent across all sealant colors, as shown in Fig. 11. Hues of orange were the predominant form of discoloration. While less apparent in black sealants, the orange hue was still present. Under controlled lighting conditions in the laboratory, discoloration in black sealants became more discernible and was comparable in extent to the discoloration noted in lighter colors.

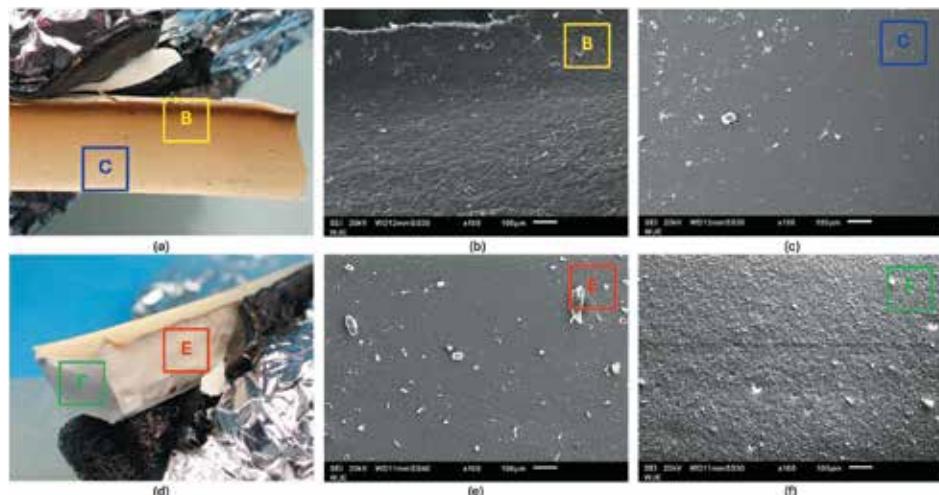
Figure 12. Close-up views of Sealant Type B1 showing (a) the surface and (d) the interior, with corresponding secondary electron images: (b) intense discoloration near the membrane edge (yellow), (c) light discoloration near the opposite edge (blue), (e) glossy interface with the membrane (red), and (f) intact sealant cross section (green).

Figure 12 illustrates differences in color noted at various surface regions of the sealant samples. The top surface showed a discoloration gradient, which was most pronounced near the edge previously adhered to the exposed bitumen (Condition W-F) and gradually fading across the width of the joint. In contrast, the bond surface (in contact with the exposed bitumen) displayed a glossy texture with no visible discoloration after extraction. A cross-sectional cut revealed a dull, intact interior surface. These distinct surface regions were further analyzed using scanning electron microscopy (SEM) and energy-dispersive X-ray spectroscopy (EDS), with corresponding secondary electron images included in Fig. 12.

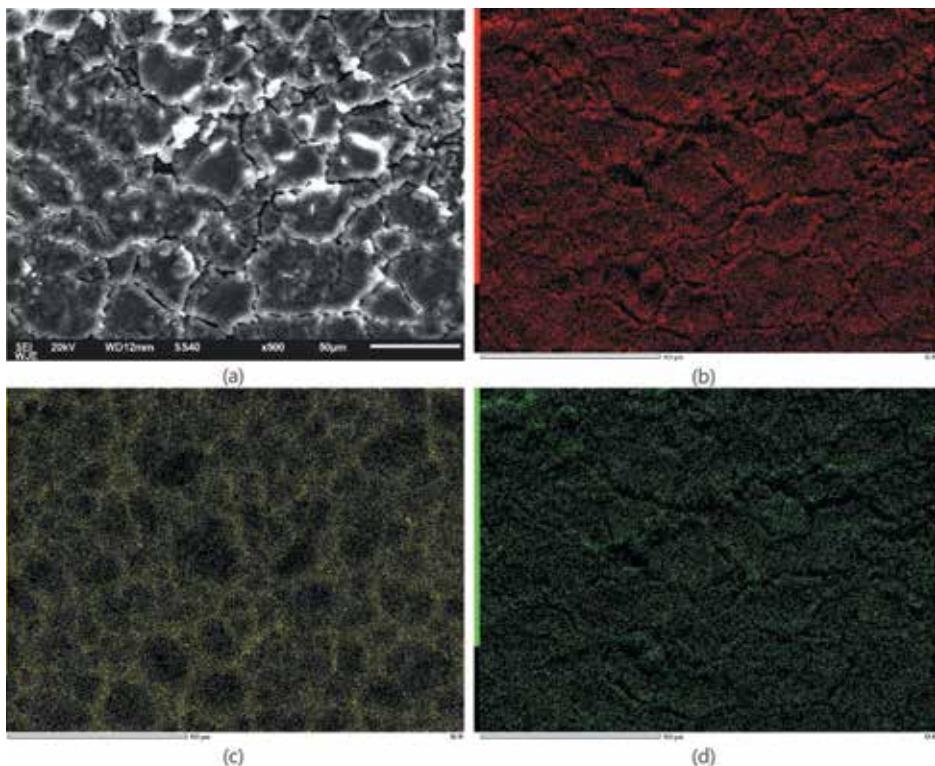
Figure 14. High-resolution of elemental mapping images of Type C2 showing trace element distribution: (a) secondary electron image, (b) carbon, (c) silicon, and (d) oxygen.

For better visualization, the top (discolored) surface of the sealant was further subjected to elemental mapping. The elemental mapping images shown in Fig. 14 displayed color-coded maps of carbon (Fig. 14[b]), silicon

(Fig. 14[c]), and oxygen (Fig. 14[d]), alongside a corresponding secondary electron image (Fig. 14[a]). The intensely discolored region revealed a "mud crack" pattern near the bond surface previously in contact with exposed bitumen that gradually transitioned into a smoother surface across the width of the joint. The surface of the sealant covered with a solid-like contaminant, referred to as "mud," which likely originated from oxidized membrane oils based on the high carbon and oxygen content. When this oxidized layer "cracked," the subsurface became visible in the crevices, where the sealant, having the high silicone content, is exposed.

This comparative image analysis indicates that both the top and side surfaces of the sealant were coated with varying amounts of carbon-rich materials, likely originating from the bitumen-based membrane. Compared to smoother surfaces, the mud crack pattern with elevated oxygen content reflects degradation

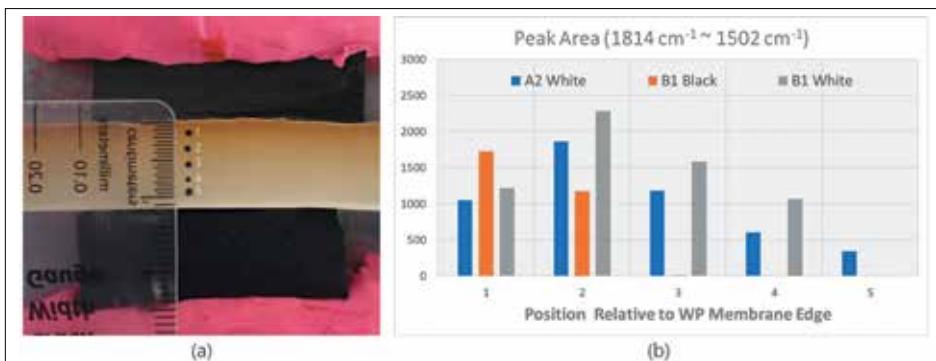
Figure 15. (a) Photograph showing the alignment of a sealant sample beneath the microscope, with black marks indicating designated chemical imaging positions. Five positions were selected uniformly along the flatter surface, from Position 1 (nearest the membrane edge) to Position 5 (farthest from the edge). (b) Fourier transform infrared spectroscopy peak area measurements between 1,814 cm^{-1} and 1,502 cm^{-1} plotted as a function of distance from the membrane edge: Sealant Type A2-white (blue), Sealant Type B1-black (orange), and Sealant Type B1-white (grey).

Using this membrane-specific spectral signature, chemical imaging was conducted to identify the spread of discoloration distribution across the sealant surface. As shown in **Fig. 15**, measurements were performed on predetermined positions under an optical microscope, with three to five measurements per position. The resulting peak intensities were quantified and averaged at each position. Although proper attenuated total reflectance crystal contact was limited near the edge

due to the concave surface profile and softness of the sealant, the integrated peak area between 1,810 cm^{-1} and 1,500 cm^{-1} generally showed a decreasing trend with distance from the membrane edge. Position 1 (nearest the edge) showed lower intensity despite severe discoloration, likely due to the curved surface profile causing poor contact upon crystal engagement.

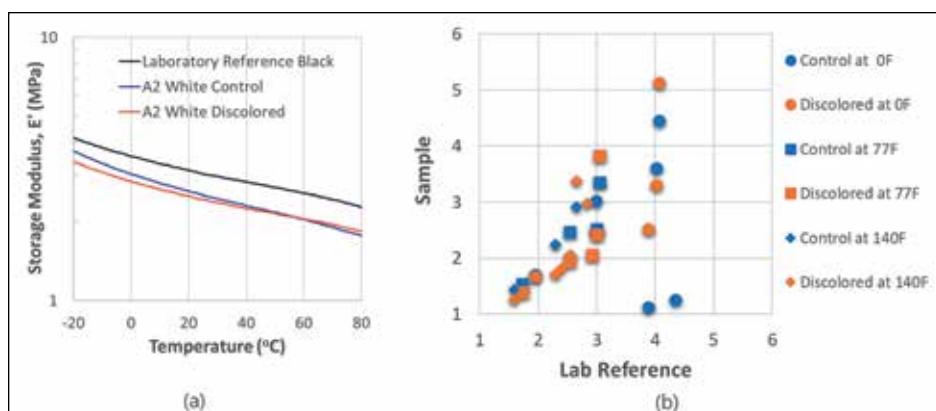
Figure 16. (a) Close-up view of storage modulus as a function of temperature from dynamic mechanical analysis for control (blue) and discolored (red) samples against corresponding lab reference samples (black). (b) Collective comparison of storage modulus (MPa) for control (blue) and discolored (orange) samples, relative to corresponding lab reference samples, across all sealant types at three temperatures: 0°F (-17.8°C) (circle), 77°F (25°C) (square), and 140°F (60°C) (diamond).

A sharp drop in storage modulus near -40°C (-40°F) marked the glass transition temperature (T_g), the point where the sealant transitions from a rigid, glassy state to a soft, rubbery state. Beyond this transition temperature, the storage modulus continued to decline with increasing temperature, reflecting typical softening behavior. In this context, storage modulus represents the energy stored and recovered per deformation cycle under oscillatory loading and is analogous to the material's stiffness or modulus of elasticity under dynamic conditions. In comparison to the lab reference sample (the black line in Fig. 16), both discolored and control samples (white colored) showed a lower storage modulus. Notably, the discolored sample exhibited a slightly lower storage modulus than the control sample, particularly within the service temperature range, as shown in Fig. 16(a). All other samples exhibited similar behavior.

In Fig. 16(b), a collective comparison of storage modulus values (MPa) across all tested sealant samples demonstrated this trend: discolored samples that had been in contact with bitumen-based waterproofing exhibited lower storage modulus (lower stiffness) than both control and lab reference samples.
