2026 IIBEC INTERNATIONAL CONVENTION & TRADE SHOW

PROCEEDINGS

MARCH 12-15, 2026
Sacramento, CA
iibeconvention.org

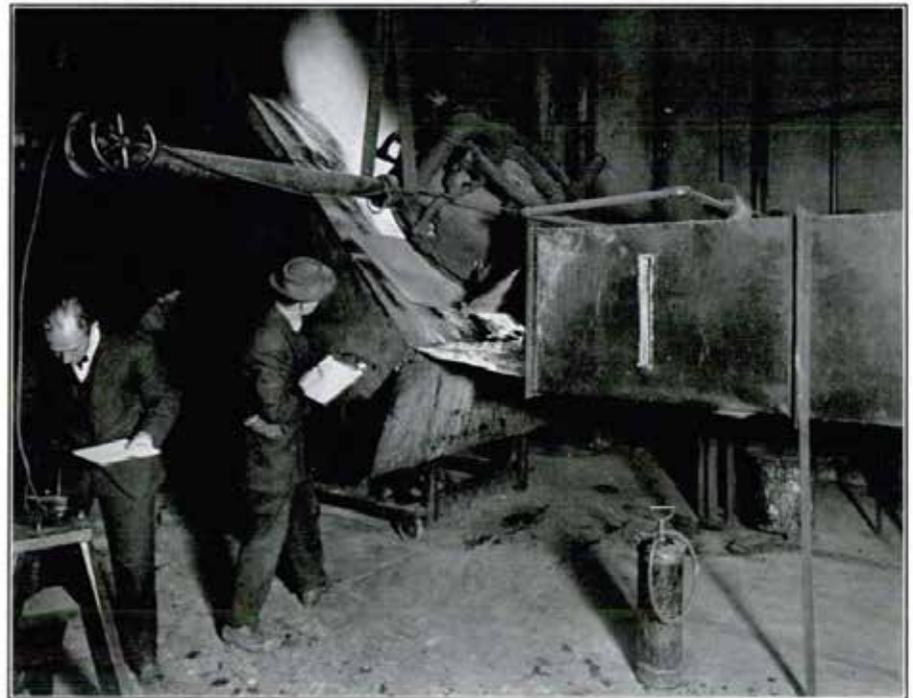
FIRE TEST OF ROOF COVERINGS
In this picture, flame propelled by an artificial gale of forty-five miles an hour is subjecting the roof covering to a real conflagration test. Inspectors note and record heat, air pressure, condition of roofing, etc. The drum-shaped device, suspended above the roofing, is used for making tests with radiated heat.

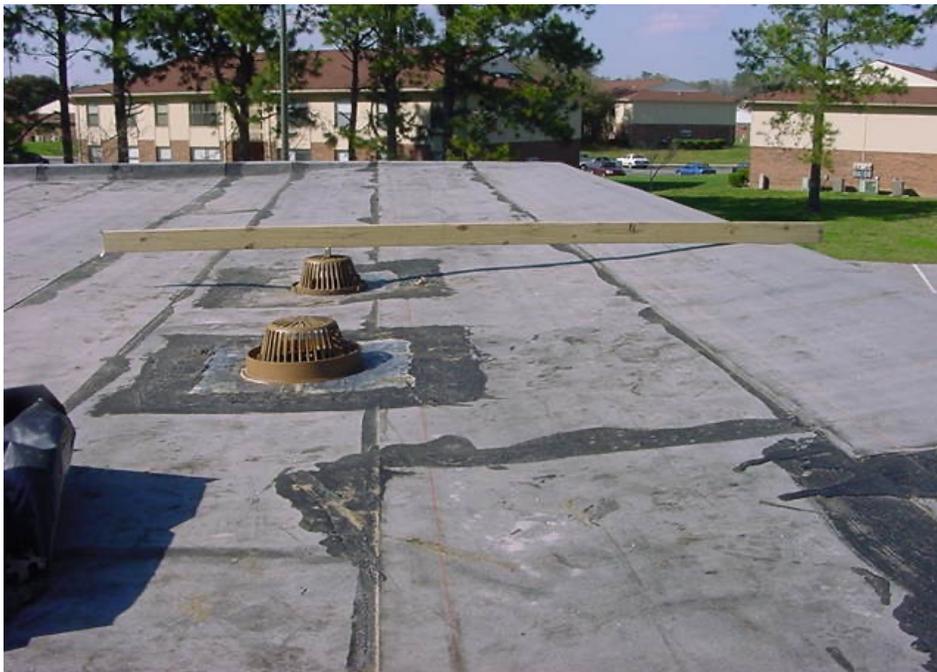
FIGURE 1. Roof slope and roof edge conditions may not meet the requirements for secondary roof drainage. In the photo above, a secondary emergency overflow roof drain was added (foreground) to address ponding instability.¹ Photo by Darren Perry, RRC, PE.

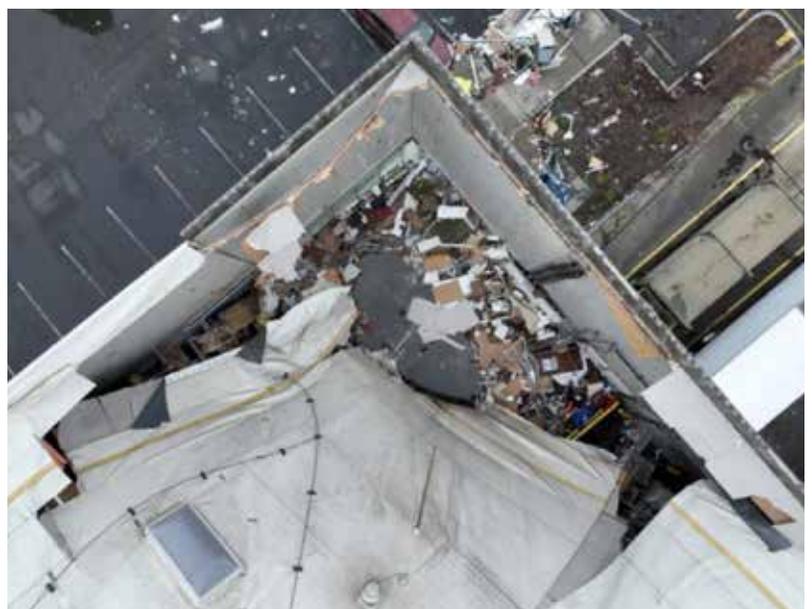
FIGURE 1. The March 2023 roof collapse in Oakland, California, owing to an intense rainfall event.

The previously mentioned March 2023 warehouse incident in Oakland, California, illustrates the hazard. On-site observations found the overflow drain located immediately beside the primary drain, rendering it ineffective as an early warning. While this proximity does not impair functionality when the overflow inlet is correctly elevated, typically 2 in. (≈50 mm) above the primary inlet,

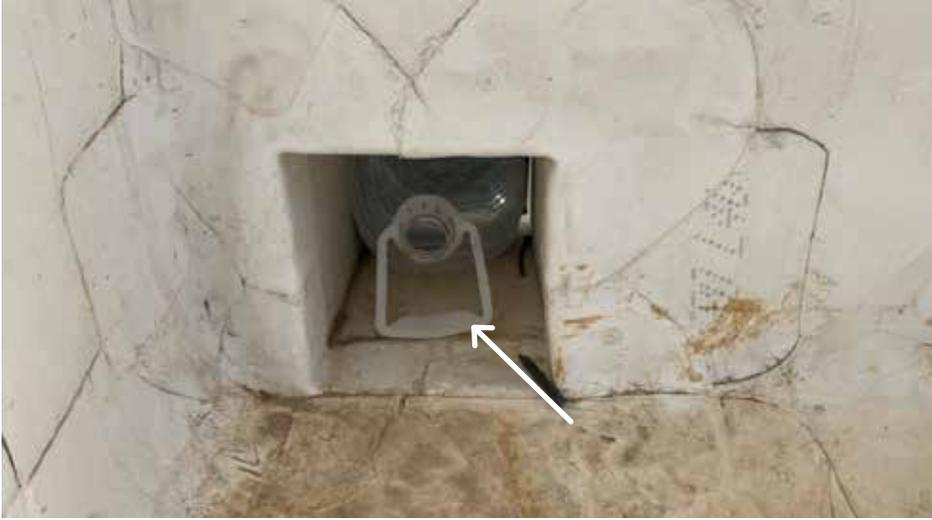
FIGURE 2. An example of an obstructed drain path. This shows how easily a scupper can clog, as roofs can quickly become blocked simply from objects being thrown onto them.”

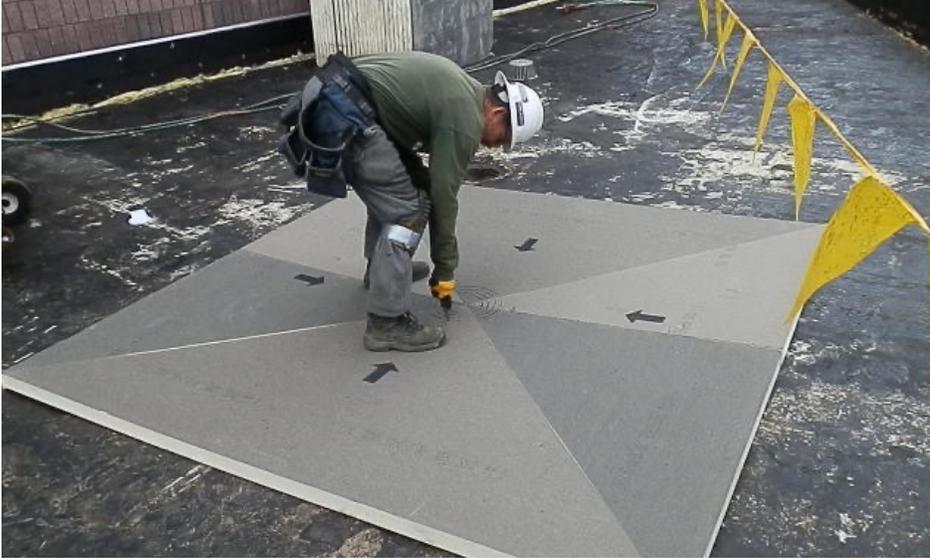
FIGURE 4. Tapered insulation to be installed to institute positive drainage, eliminating the need for sump pits.

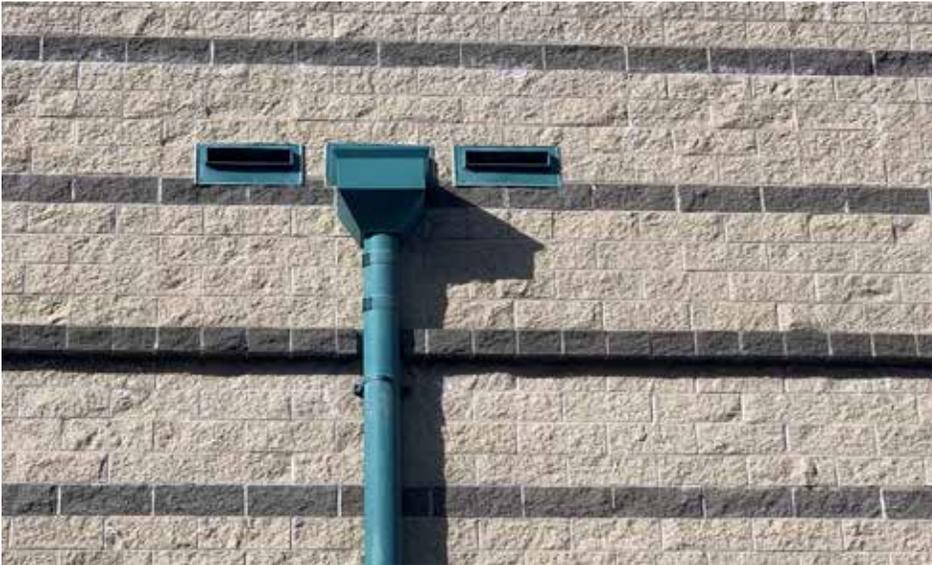
FIGURE 8. Best practice in the installation of overflow (secondary) scuppers, in that they double the size of the primary scupper.

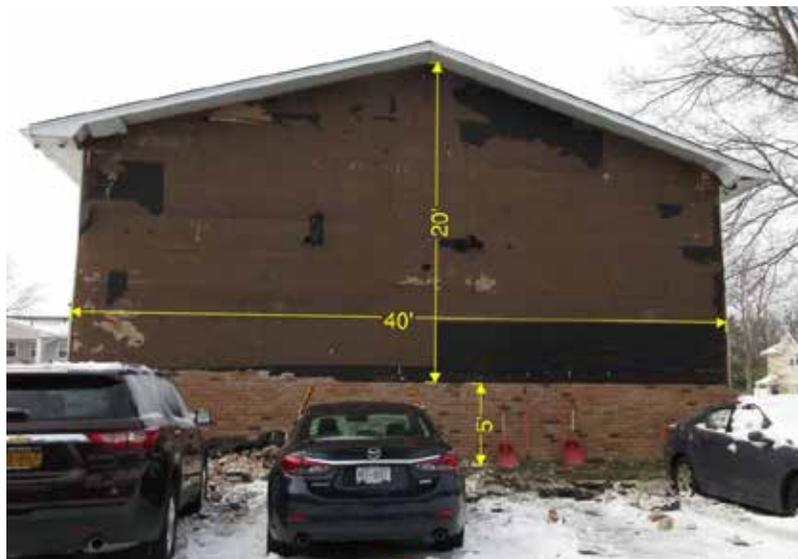
FIGURE 1. Subject building failure site.

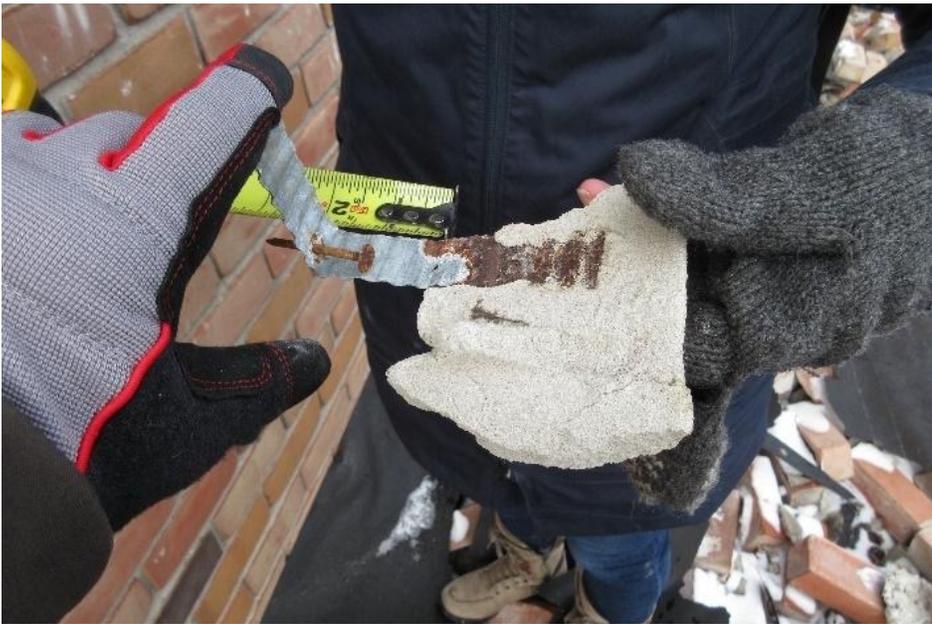
FIGURE 2. Corrugated sheet metal veneer tie pulled from collapse debris.

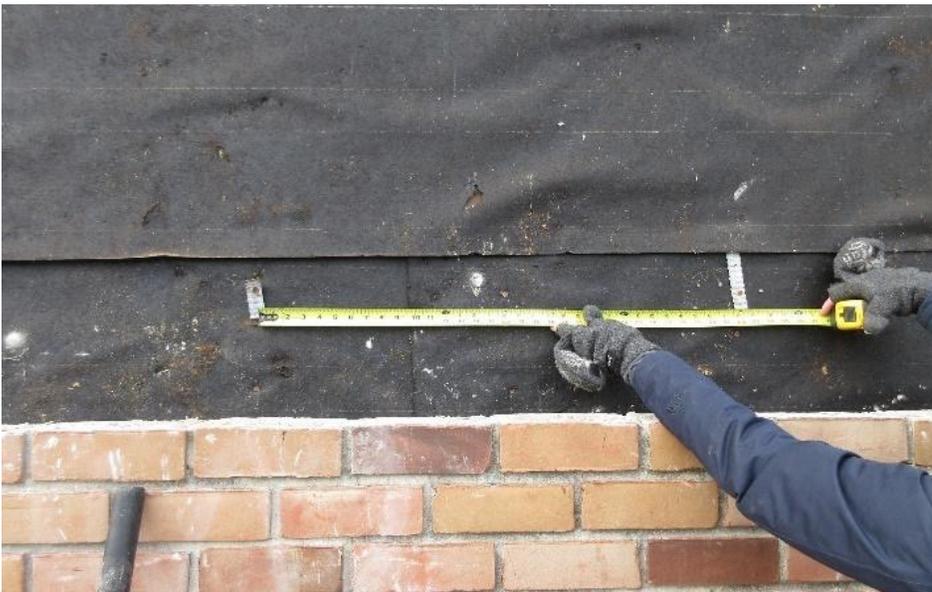
FIGURE 3. Existing tie spacing measurement (32 in. [813 mm])

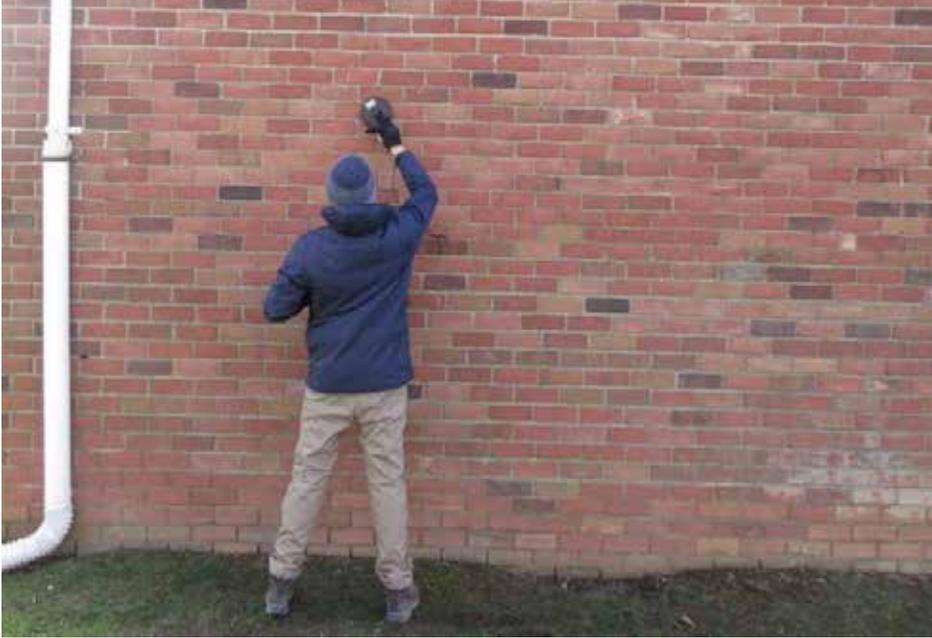
FIGURE 4. Protovale Imp Wall-Tie Locator scan in progress.

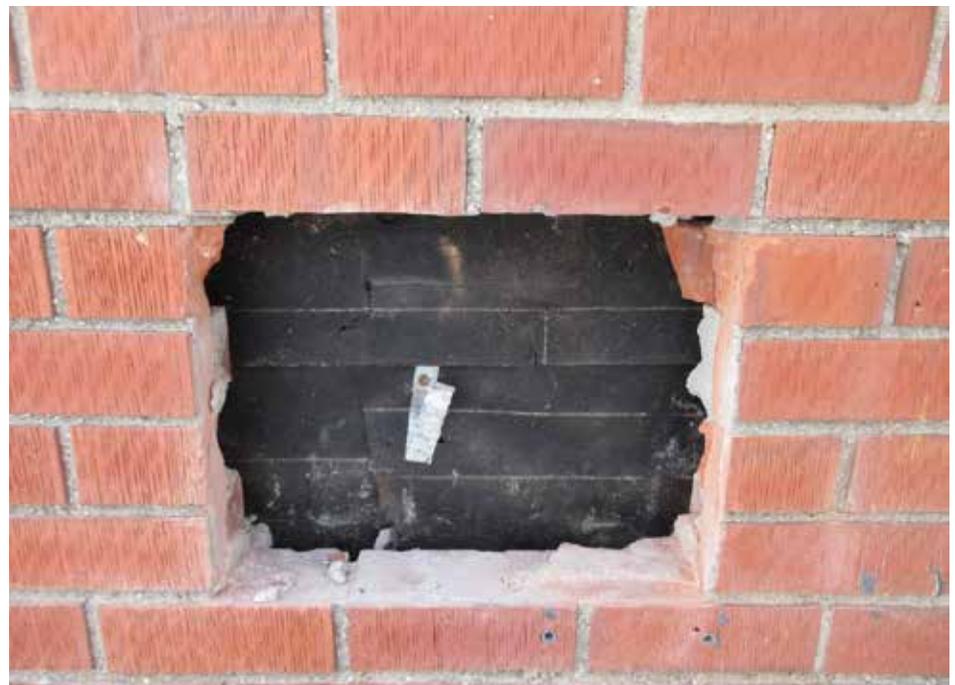
FIGURE 5. Exploratory probe confirmation of wall tie locator scan.

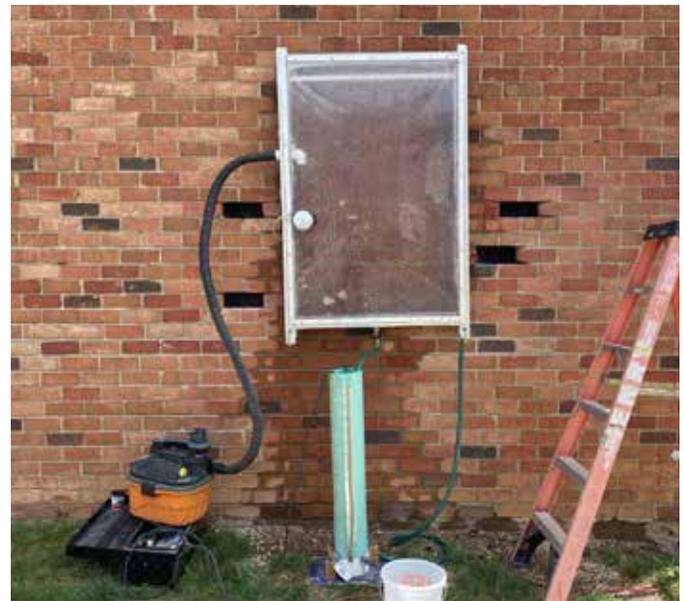
FIGURE 8. ASTM C1601, *Standard Test Method for Field Determination of Water Penetration of Masonry Wall Surfaces*, test setup.

To facilitate a decision, a mock-up of helical tie pinning of the brick veneer was tested per ASTM C1601, *Standard Test Method for Field Determination of Water Penetration of Masonry Wall Surfaces* (Fig. 8).¹¹ The standard provides specific water flow rate and air pressure conditions to develop and maintain a sheet of water on the wall during

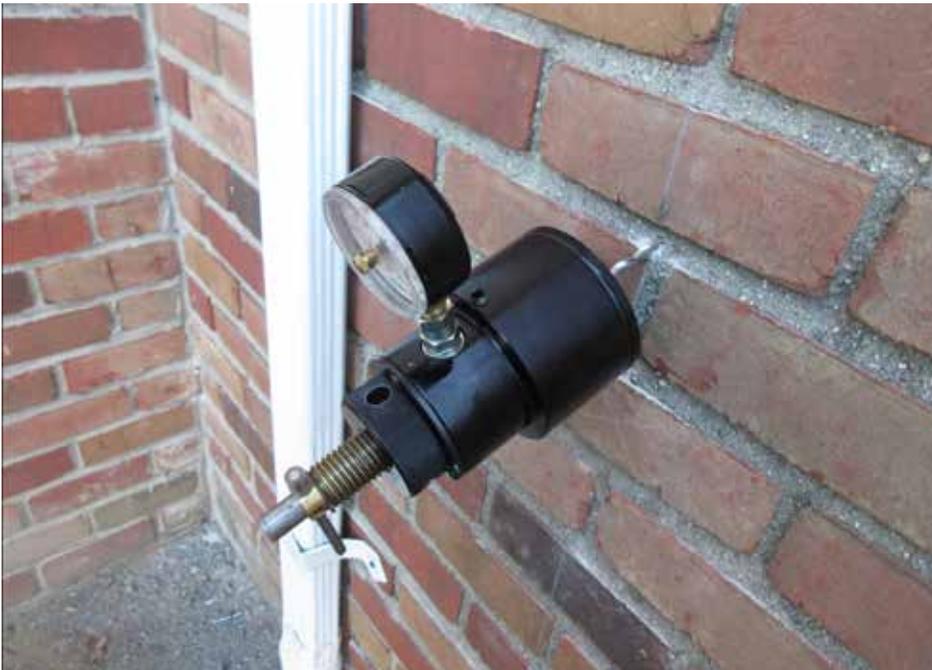
FIGURE 10. Helical tie pull test set-up.

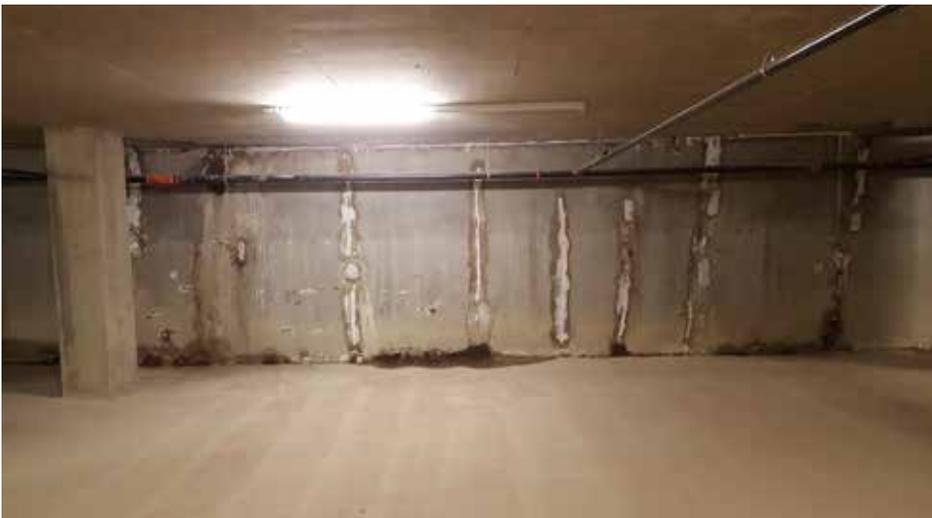
FIGURE 8. Crystal residue on a shotcrete wall (crystalline admixture).

cracks, thereby closing off the water intrusion path (Fig 8).

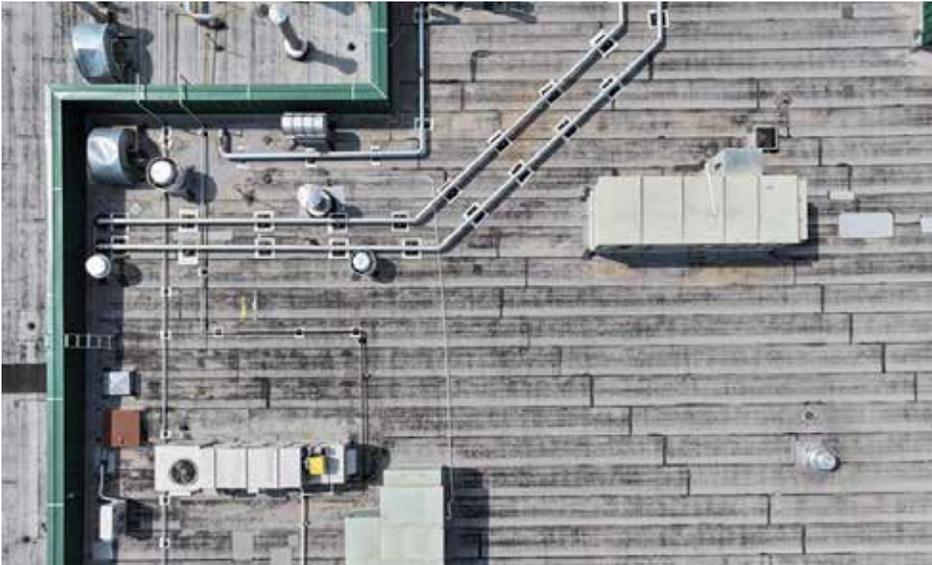
FIGURE 2. Image of roof prior to restoration.

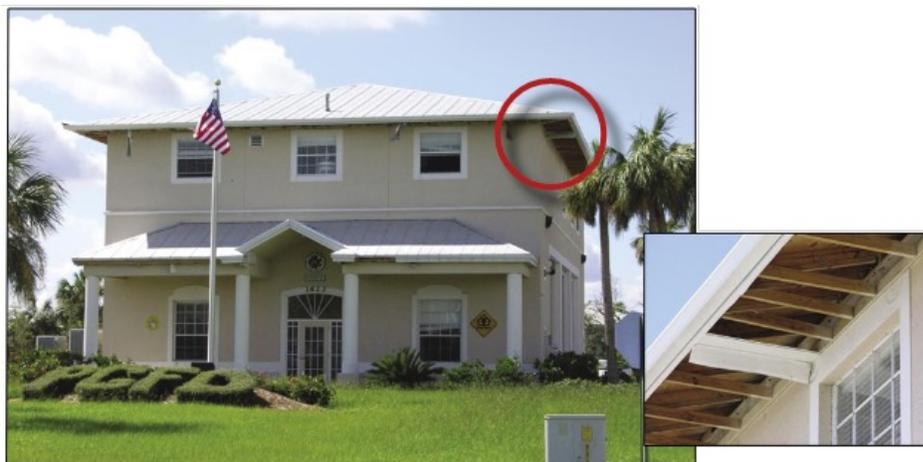
FIGURE 2. Hurricane Charley blew away the aluminum soffit on a fire station in Aquia Esta, east of Punta Gorda Isles.¹

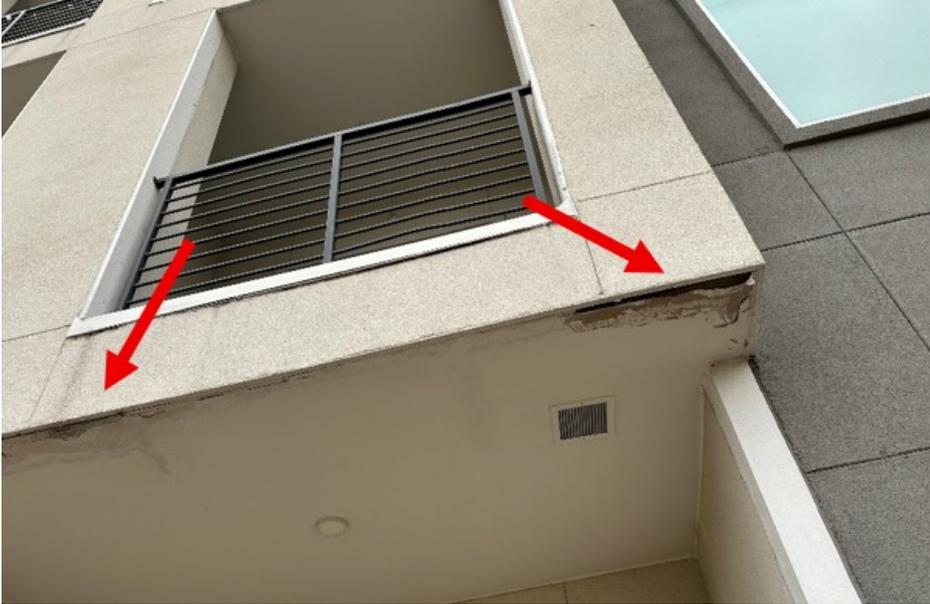
FIGURE 3. Staining and gypsum board deterioration at the soffit.

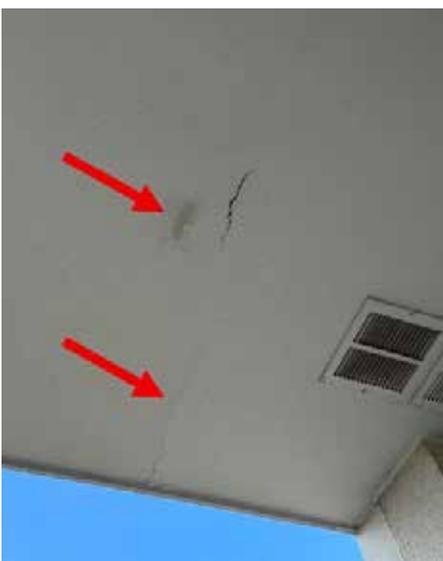
FIGURE 4. Staining and paint deterioration at the soffit.

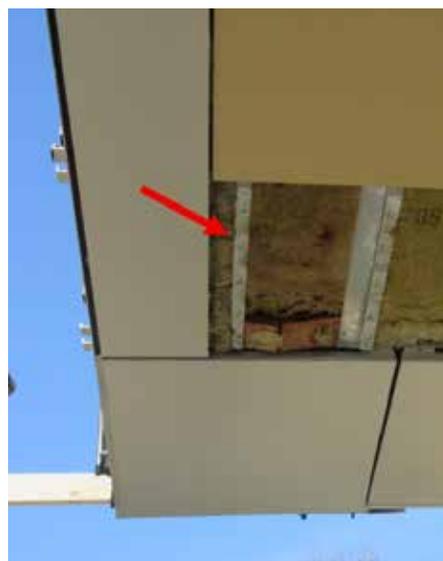
FIGURE 5. Metal framing corrosion in soffit cavities.

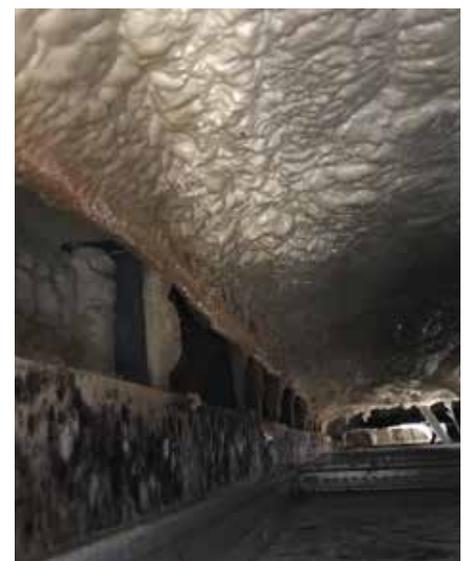
FIGURE 6. Microbial growth within soffit spaces.

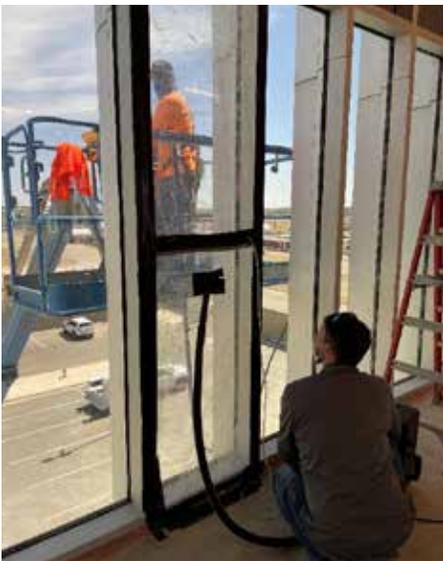
FIGURE 5. ASTM E1105/AAMA 501.2 field verification testing of the curtainwall system.

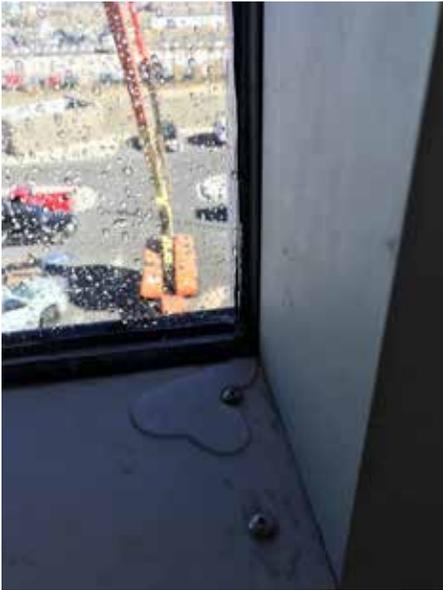
FIGURE 7. Building enclosure commissioning tests revealed a small amount of water was able to bypass the assembly similar to factory lab testing. Although water leaked past the glass units, this condition was determined by the manufacturer, architect, and owner to be acceptable.

intersecting vertical-to-horizontal frame interface with the IGU. The BECx agent concluded that the curtainwall frame internal water dams were likely leaking as found in the factory tests, and the removal of the exterior mullion cap with repair to the field-formed sealant dam was necessary. The installer performed the repairs on a subsequent day, and the assembly was retested; however, the same water bypass occurred. The installer presented to the owner that the test protocol did allow for some water to bypass the IGU and still be considered a satisfactory pass condition. The BECx agent did not agree, but the owner accepted the testing as satisfactory and took occupancy of the building (Fig. 6 and 7).

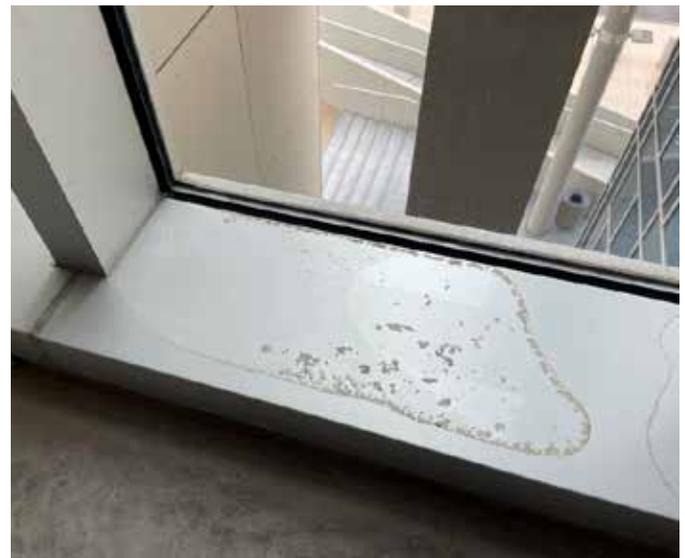
FIGURE 8. Water infiltration following a normal rainstorm event.

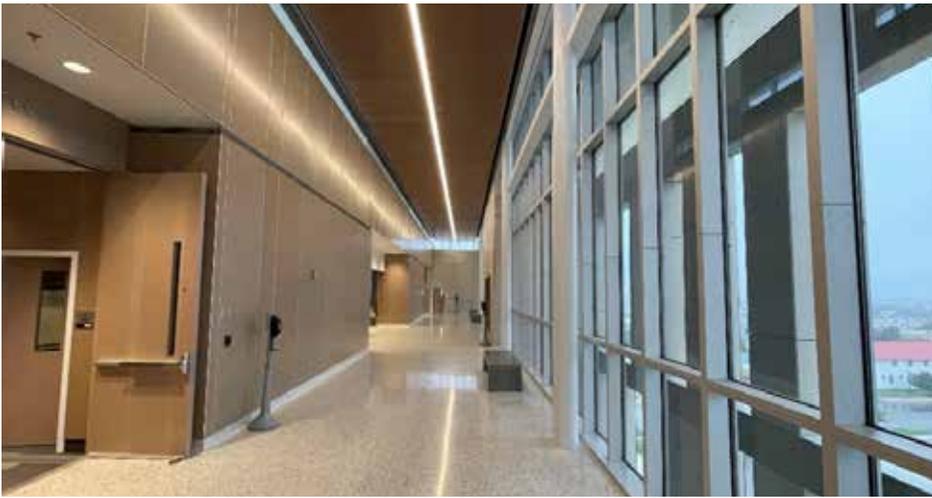
FIGURE 9. Second-floor west-facing lobby with curtainwall glazing system that leaked rainwater through the lobby into the central judge's chambers and courtrooms visible in this photograph at the far left of the hallway.

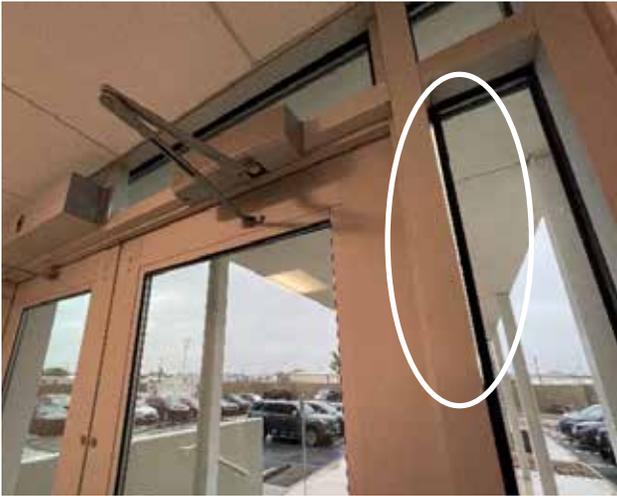
FIGURE 11. East staff entrance lobby with storefront insulated glass unit displaced allowing uncontrolled outside air infiltration.

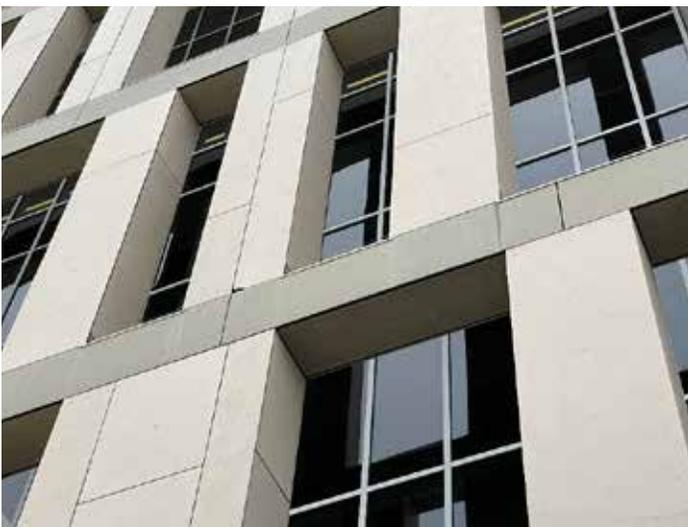
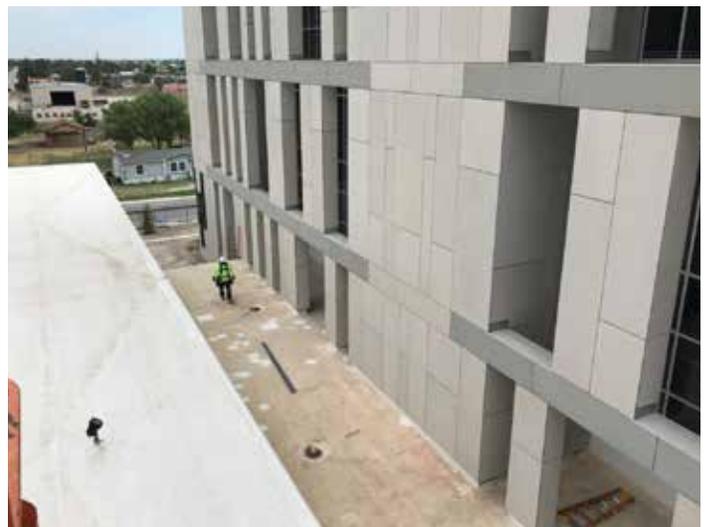
FIGURE 12. The building's west-facing elevation with a brise soleil shade structure standing off the glazed curtainwall to provide relief from direct west sunlight.

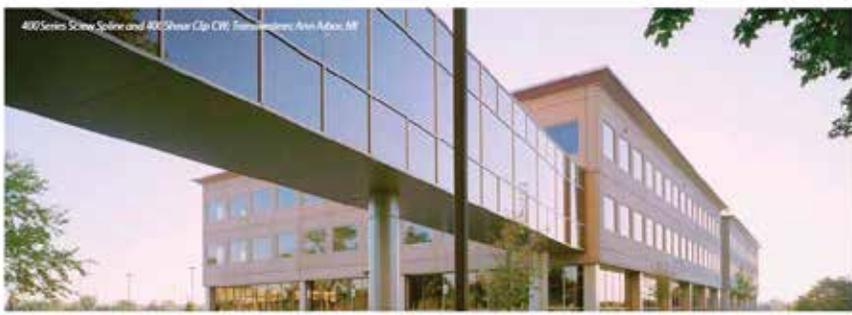
400 Series Screw Splice and 400 Shear Clip CW Framing from Ann Arbor, MI

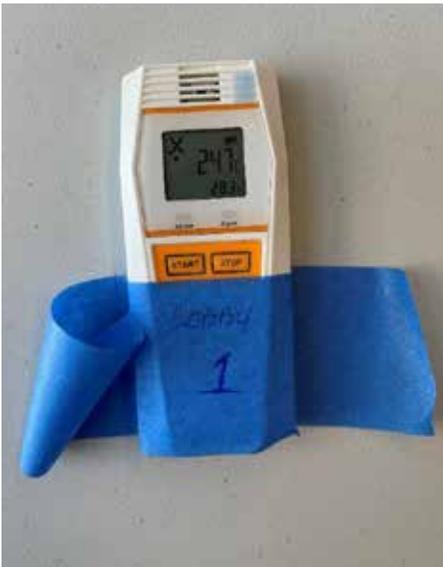
FIGURE 14. One of several portable data loggers used to track interior environmental conditions over a period of time during the diagnostic test phase of 3 months.

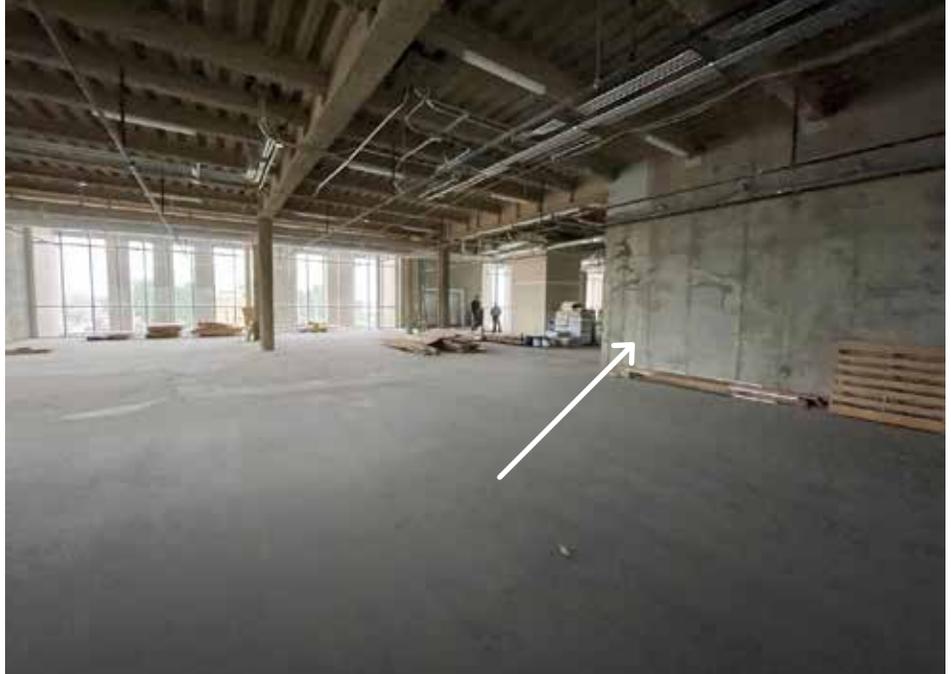
FIGURE 17. Depicts the third-floor shell space for future expansion. The enclosure at right of this photograph is a return-air vertical shaft that allows all floors and all air handlers to share a common return-air path.

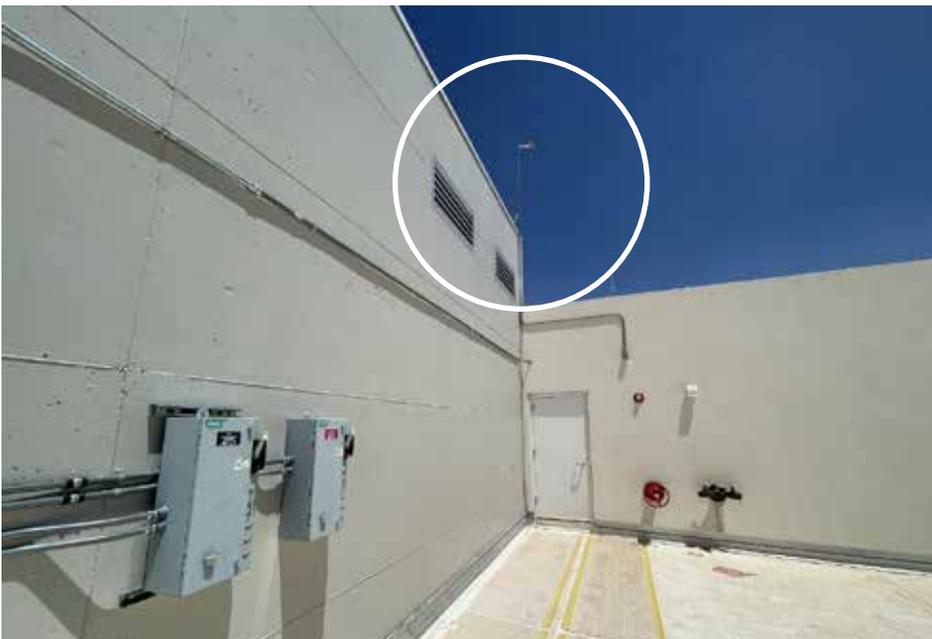
FIGURE 18. Heating, ventilating, and air-conditioning weather mast with barometric sensors and wind meters that are required to feed the interior air handlers information about the exterior atmospheric conditions was found to have been damaged by high winds. The location of the mast is vulnerable to weather when located at the sixth-floor penthouse roof.

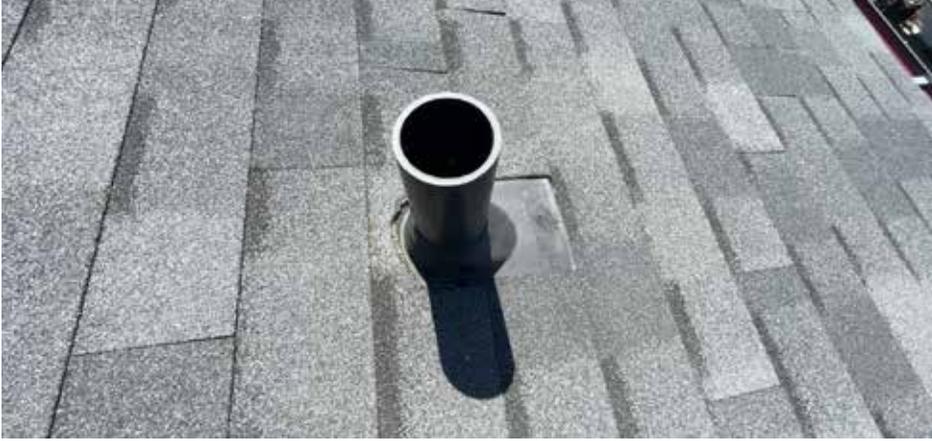
FIGURE 1. Typical flashed pipe vent penetration—reported leaking.
