# Glass Breakage Analysis: The Impact of Nickel Sulfide Inclusions in Building Glazing

## Part Two: Manufacturing, Prevention, and Case Studies

By Misael Rojas, RRO, AIA, NCARB

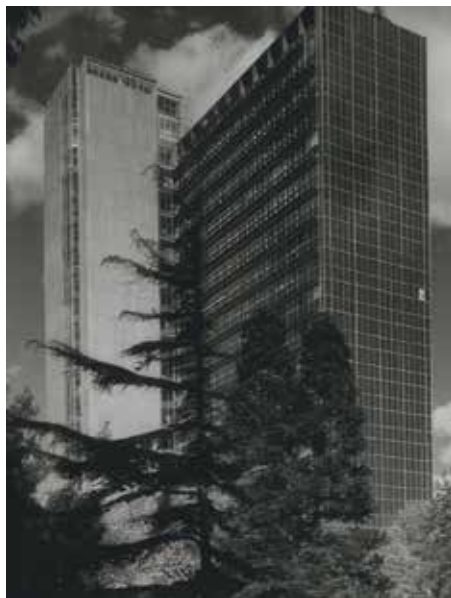
**Figure 1.** View of ICI House when constructed in 1958. Photo courtesy of [pursuit.unimelb.edu](http://pursuit.unimelb.edu).

The issue of spontaneous glass breakage attributable to NiS inclusions possesses a substantial historical trajectory, with incidents documented globally. One of the earliest and most prominent cases transpired in the 1960s at ICI House (presently Orica House—see **Fig. 1**) in Melbourne, Australia,<sup>2</sup> which was the nation's inaugural skyscraper, where 71 glass panels spontaneously shattered. This event catalyzed pioneering research by Ron Ballantyne in 1961, which was one of the first research projects of its type to formally describe the NiS breakage mechanism. This discovery led to the development of HST, thereby bringing the NiS phenomenon to international prominence. Decades later, similar dramatic failures have persisted, as evidenced by incidents at Waterloo Station in London, with its iconic glass-and-steel roof, completed in 1994. In 1999, it became apparent that numerous glass panels in the roof were spontaneously shattering and, in some cases, falling onto the platforms below.<sup>3</sup> The investigations into the failures found that the breakage was indeed caused by NiS inclusions.

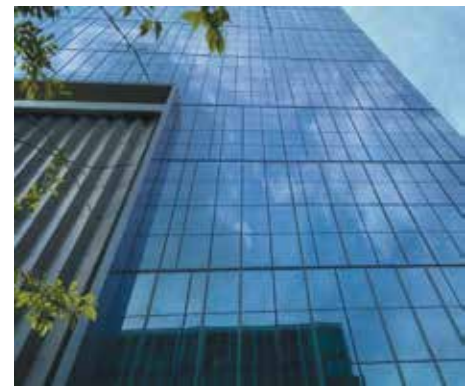
An analysis of spontaneous glass breakage within a Nashville, Tennessee, mixed-use property was executed through a comprehensive, multi-stage process (**Fig. 2**). This investigation was commissioned by the client to scrutinize a series of glass breakage incidents that transpired over a 15-month period in an office building component. By reviewing project documentation, conducting on-site examinations, and correlating data with independent laboratory analyses, the investigation sought to ascertain the root cause of these failures.

**Figure 2.** Curtainwall on eastern exposure.

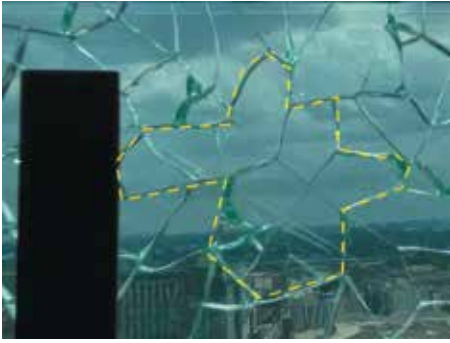
- Crack patterns indicative of internal stress: The crack patterns observed consistently displayed “butterfly” or web-like features, conspicuously lacking any signs of physical impact or handling damage (**Fig. 3**). In several instances, minute particles were identified at the origin of the fracture pattern, strongly suggesting a defect-triggered mechanism rather than external trauma.

**Figure 3.** Close-up view of butterfly pattern of origin point within cracked glass.

The collective evidence for the Nashville project indicated that NiS inclusions constituted the primary cause of the observed spontaneous glass breakage. NiS particles, typically ranging from 0.002 in. to 0.004 in. (0.05 mm to 0.10 mm) in size, are inadvertently incorporated during glass manufacture. Under conditions of thermal fluctuation, these inclusions undergo expansion when the glass experiences significant temperature changes. Due to the constrained flexibility of the glass core, the expanding NiS inclusion generates sufficient internal stress to initiate cracking from within, thereby producing the distinctive “butterfly” fracture pattern.

The report provided by the glass testing laboratory confirmed NiS inclusion as the cause of the breakage. It was pertinent to point out to the client that NiS inclusion-based breakage occurring in HS glass is exceedingly rare, if indeed possible. This observation supports the inference that the installed glass was not HS but rather tempered glass, which was subjected to higher thermal stress than HS glass and facilitates the NiS phase transformation, leading to particle size increase and subsequent cracking of the glass from within.

- Glass replacement strategy: (1) Promptly remove and replace affected units. (2) Preserve broken samples for ongoing technical analysis to further validate the root cause.
- Manufacturer engagement: (1) Notify the glass manufacturer regarding the confirmed defect and discuss potential revisions in their production process to reduce the risk of NiS inclusions. (2) Where possible, consider additional HST or enhanced screening methods before installation.
- Long-term monitoring and maintenance: (1) Implement a regular inspection regime that includes detailed documentation of environmental conditions to track any subsequent occurrences. (2) Adopt updated industry best practices to minimize the likelihood of future incidents.
