# The D-I-P-F Curve: A Framework for Predicting and Preventing Roof Failures

By Frank Louis-Jeune, RRO

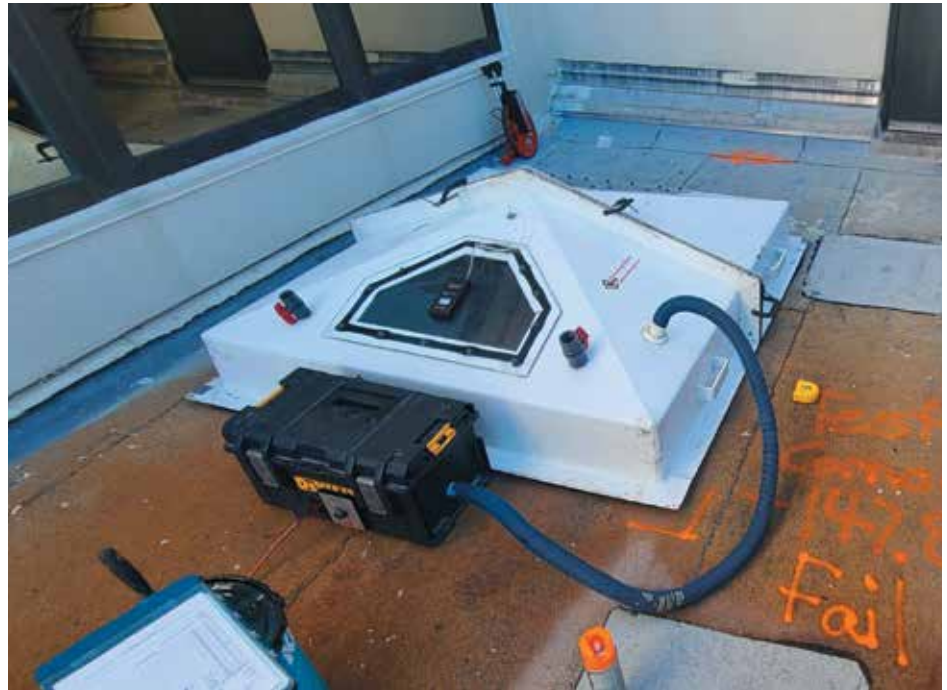
**Figure 4.** Negative-pressure wind-uplift testing performed over the installed roof system. Several test locations recorded insufficient attachment strength, consistent with membrane plies installed over a damp substrate and asphalt applied at marginal temperatures. This testing confirmed installation-phase deficiencies as the primary failure mode.

After installation, negative-pressure wind-uplift testing was conducted using a calibrated chamber as depicted in **Fig. 4**. Results showed inconsistent attachment across test locations, with some areas achieving less than half the expected bond strength. The deficient adhesion was consistent with asphalt applied below the manufacturer's recommended temperature and onto a damp substrate. During the first warm season, localized blistering developed as trapped moisture expanded beneath the membrane—confirming improper installation conditions as the primary failure mode.

The I phase introduced risk when work continued despite moisture on the substrate. Lack of field-adhesion testing and weather monitoring allowed incomplete bonding. Within 3 years, wind uplift caused seam separation and interior leakage. Preventive QA/QC procedures—pull tests and moisture-meter verification—could have identified the defect before occupancy.
