# Glass Breakage in Insulating Glazing Units in Spandrel Assemblies

**George Torok, CET, BSS**

*Morrison Hershfield Corporation*

**IIBEC 2020 Virtual International  
Convention and Trade Show  
June 12-14, 2020**

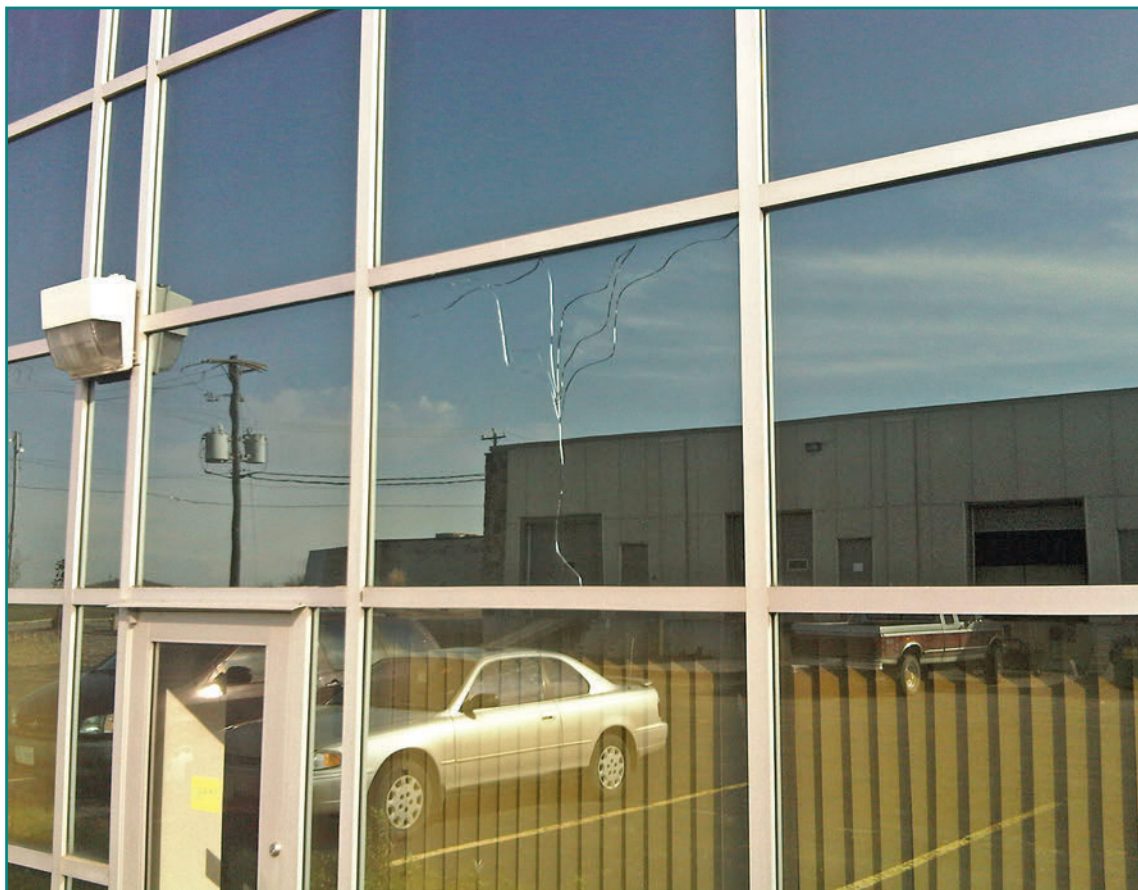
the glass substrate (HS, FT). Studies of ceramic enamel-coated glass that cracked in service indicate that thermal stress is usually the cause, although mechanical stress may be a contributing factor. Thermal stress cracks usually begin at the perimeter and progress inward toward the center-of-glass region. With repeated application of stress, cracks may branch, continue to another edge, and/or return to the same edge. HS glass breaks into pieces of various sizes—often quite large—characterized by flowing/curving cracks. The irregular shapes of broken HS glass shards tend to lock together, so for the most part, the broken glass stays in place (*Figures 1 and 2*). FT glass shatters into small pieces and usually falls out of the IGU or fenestration product frame.

**Figure 1 – Fractured heat-strengthened glass in a single-glazed curtainwall spandrel panel. The crack likely started at the bottom, extending into the center-of-glass region, before branching and continuing across the unit to the top.**

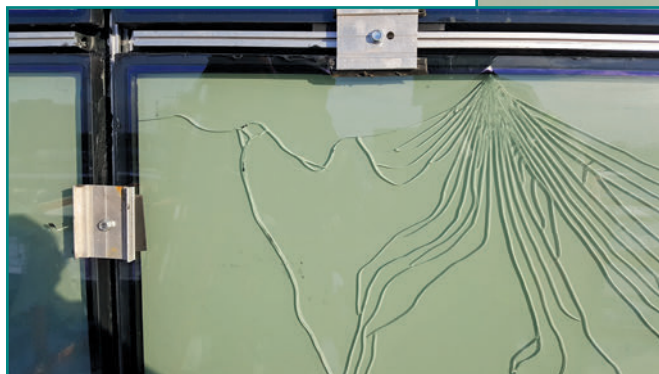
*Figure 2 – Fractured heat-strengthened glass in an inboard pane of glass in an IGU of a curtainwall spandrel panel. The crack started at the upper left corner, to the right of the temporary restraint (dutchie) to the curtainwall frame behind, indicating a combination of thermal stress and mechanical stress contributed to breakage.*

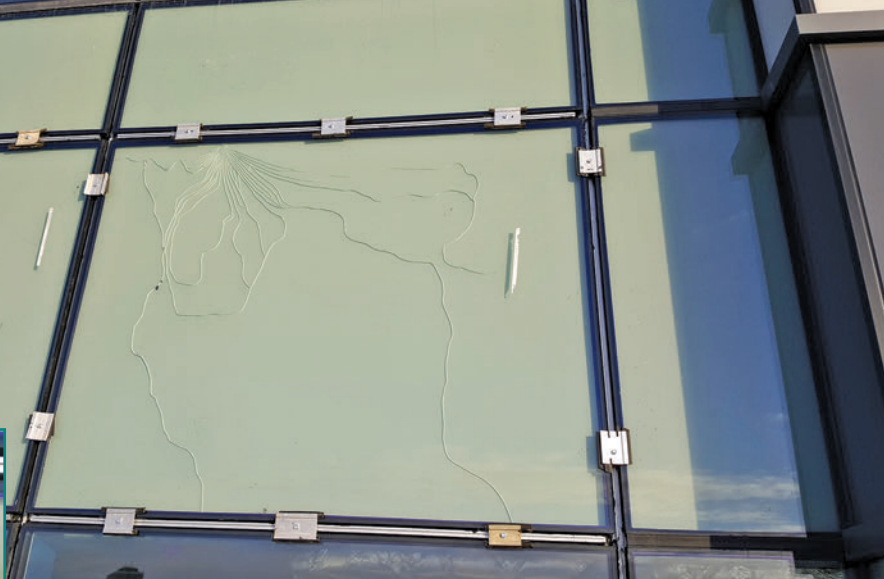
Close-up examination typically shows the crack origin is inward of the glass edge, at the enamel-coated face of the glass (*Figures 3 and 4*). The origin of the crack at the ceramic enameled surface indicates a damaging effect of the enamel to the glass surface. The specific nature of the damage is uncertain, but it may be related to intrusion of particles of frit into the glass surface, acting as stress concentrators. Research is ongoing.

*Figure 3 – View of the back side of the spandrel IGU in Figure 2, after it was removed from the curtainwall. The crack split toward the center-of-glass area, as seen in Figure 2 and also to the edge of the inboard pane, indicating the origin of the crack was inward from the edge.*

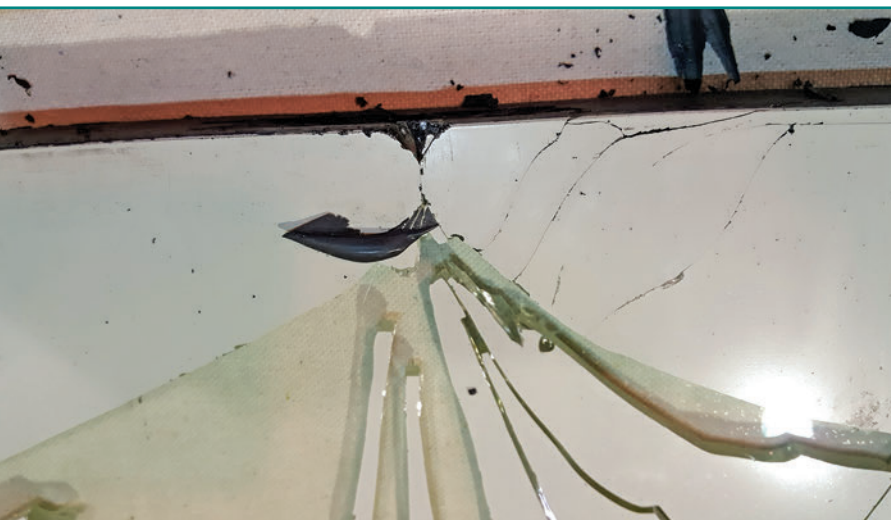
*Figure 4 – View of the crack face, exposed after glass on one side of the crack was removed. Visible are features typical of a crack origin (mirror, mist, and hackle),<sup>1</sup> which indicate the crack origin is at the top, at the flat face of the glass with the ceramic enamel coating, and with the fracture radiating away into the thickness of the glass, most clearly indicated by the ridges in the hackle. The origin is located within the depth of the perimeter spacer and sealants.*

1. The mirror, mist, and hackle derive their names from their appearance, when a crack is separated and

the edges examined. The mirror is smooth and reflective to the naked eye, the mist appears similar to condensation on a mirror, and the hackle is roughly textured like broken shards of glass oriented in the direction of crack movement. Each feature represents stages in the progression of the crack from explosive release of pent-up stress (the mirror) and increasing turbulence as the advancing energy dissipates and spreads through the glass (mist and hackle). These three features identify the origin of a crack and can be analyzed to reveal the type and amount of stress present at the moment of fracture, from which the cause of fracture can be determined.
