# Glass Breakage Analysis: The Impact of Nickel Sulfide Inclusions in Building Glazing

## Part One: Understanding and Identifying NiS Inclusions

By Misael Rojas, RRO, AIA, NCARB

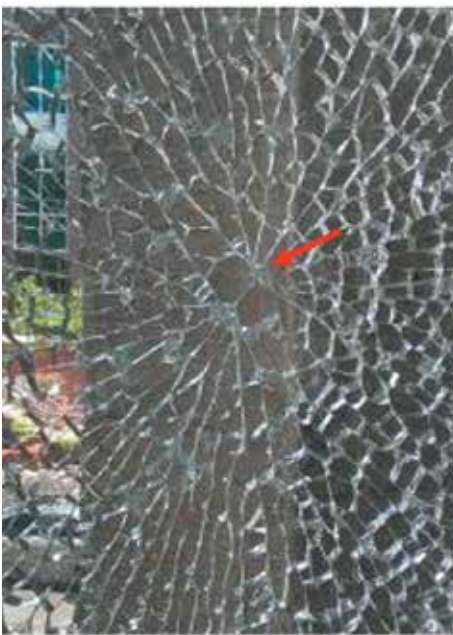
**Figure 1.** View of shattered glass indicating butterfly pattern.

Spontaneous breakage attributed to NiS inclusions exhibits a highly distinctive and recognizable fracture pattern, which is crucial for forensic analysis. This pattern typically originates from a singular point within the glass and radiates outward in a symmetrical formation, frequently described as a butterfly, figure eight, or cat's eye. At the precise focus of the break, observers will likely discern a pair of polygons bordering one another. If these polygons are nearly identical in size, it strongly suggests an NiS inclusion as the causative factor.

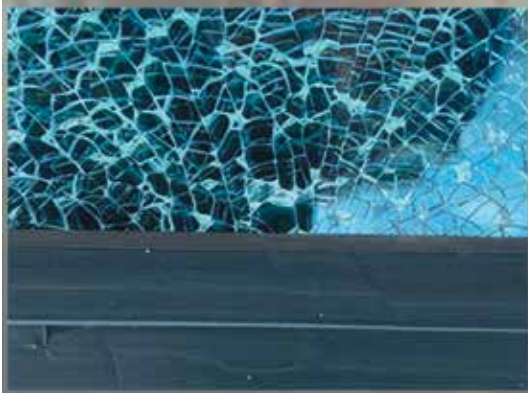
**Figure 7.** Close-up view of edge glass failure.

- Damage originating at the edge or corners.
- Visible chips or cracks along the perimeter.
- Breakage pattern might show larger fragments and radiating fractures.

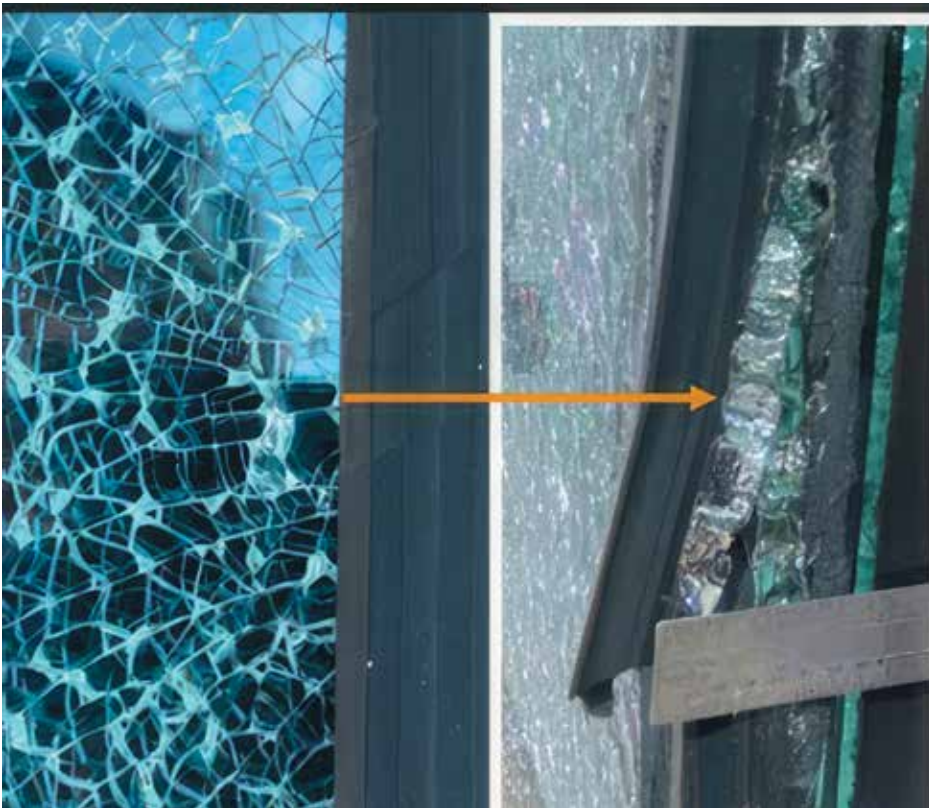
**Figure 8.** Close-up view of edge glass failure.

Setting blocks, typically made of neoprene, ethylene propylene diene terpolymer, or other elastomeric materials, provide cushioning and load distribution for glass units. When overly rigid or improperly placed, they create localized stress points at the glass edge, creating what is known as glass edge damage. This leads to microfractures that propagate over time, edge chips due to concentrated pressure, and increased vulnerability to thermal and mechanical loads, accelerating failure (Fig. 7). This is one of the main defects often confused with NiS breakage. Unlike NiS inclusions, edge damage is typically introduced during handling, transportation, or improper installation. Hard setting blocks and incorrect glass placement can exert excessive localized pressure, causing small fractures that propagate under environmental and mechanical stress. These edge defects become stress concentrators, weakening the glass and increasing the risk of spontaneous failure under relatively normal conditions (Fig. 8).
