Effects of Hail-Caused Dents on the Thermal Performance of Insulation under Single-Ply Roofing

By Steven R. Smith, PE; Robert Danielson, PE; and Cory Hurtubise, EIT

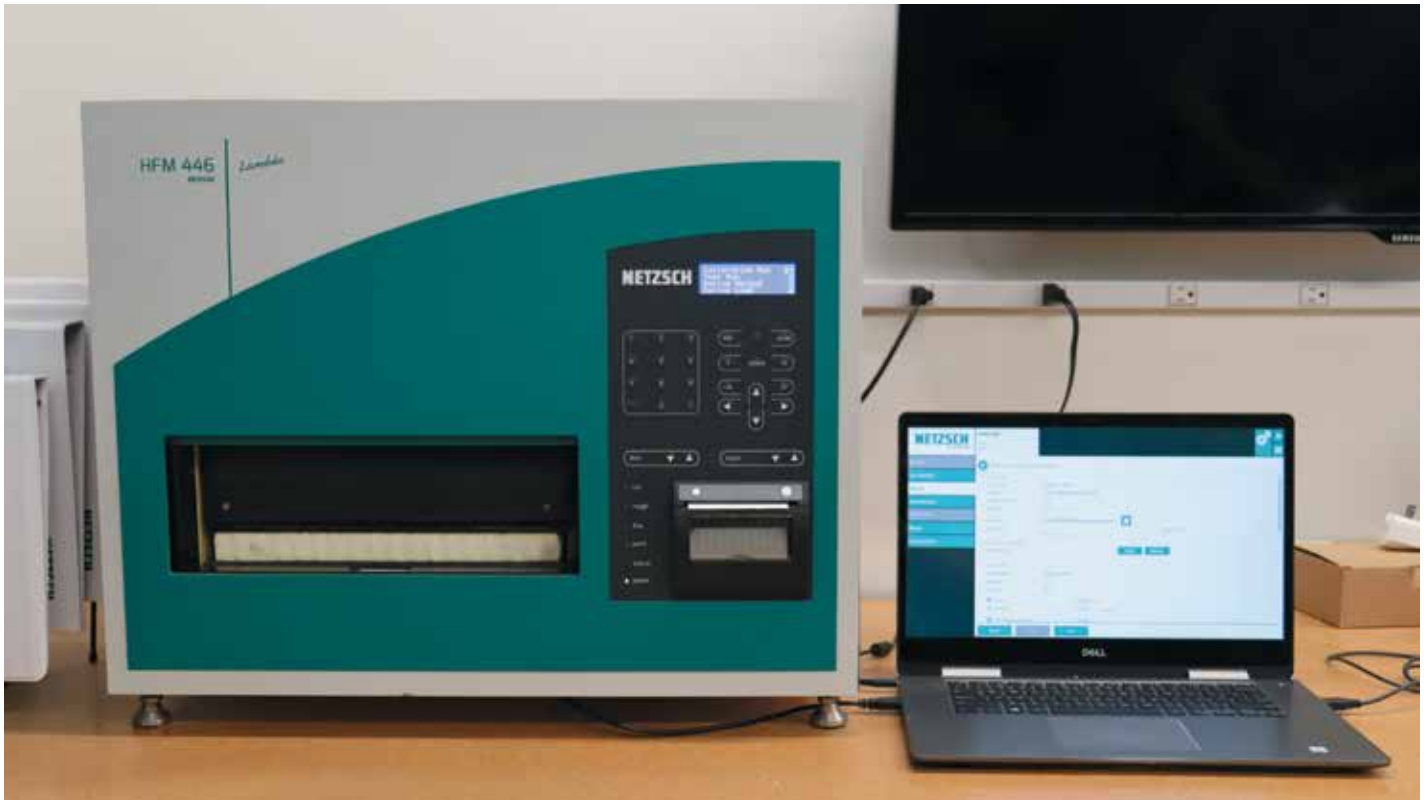
Figure 1. Heat flow meter test setup.

Haag uses a heat flow meter (HFM) to evaluate the thermal performance of roof insulation and measures the thermal resistance to conductive heat flow (*R*-value). The HFM test chamber is thermally insulated and contains two temperature-controlled plates. Both plates are fitted with heat flow sensors and thermocouples. The upper plate is maintained at a constant higher temperature, and the lower plate is maintained at a constant lower temperature. The insulation sample is placed onto the lower plate within the chamber, and the upper plate is lowered onto the insulation sample. The thickness of the insulation (distance between the two plates) is measured by the HFM. During a test, a thermal equilibrium condition is achieved, and steady-state heat flow through the insulation is measured. **Figure 1** shows the HFM test setup.

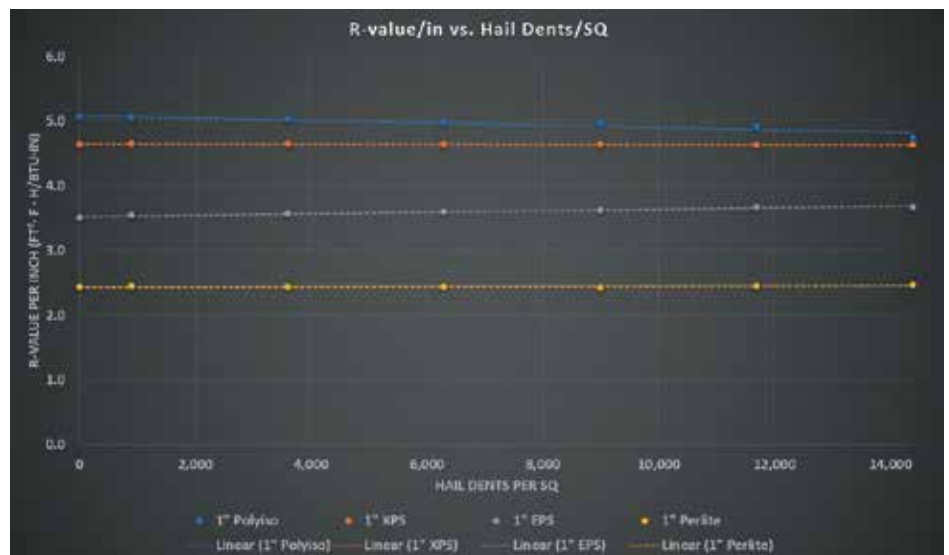
Figure 4. Plot of insulation R-values versus hail-caused dents per roofing square (SQ = 100 ft² [9.3 m²]). Note: 1 in. = 25.4 mm.

Similar analysis was conducted for each configuration of denting for each insulation type and thickness tested. **Figure 4** is a graph of the results for all four types of 1-in.-thick (25-mm) insulation tested. Measurements were deemed to be statistically significant when measured R-values deviated from

the nondented specimens (test run 1) by more than 1%. Note that the plots of R -value for XPS and perlite are essentially flat and the changes in R -value for these insulations were insignificant. The plot for polyiso insulation has a slight downward slope (as previously shown in Fig. 3), and the plot for EPS has a slight upward slope. Analysis of data for polyiso and EPS insulations showed insignificant changes in R -value with four or fewer dents added (3600 dents per roofing square), and small but significant results with more than four dents in the metered region of the HFM. R -value measurements of XPS and perlite insulation remained within 1% of the test run 1 values even after test run 7, which represented 14,400 hail-caused dents per roofing square.

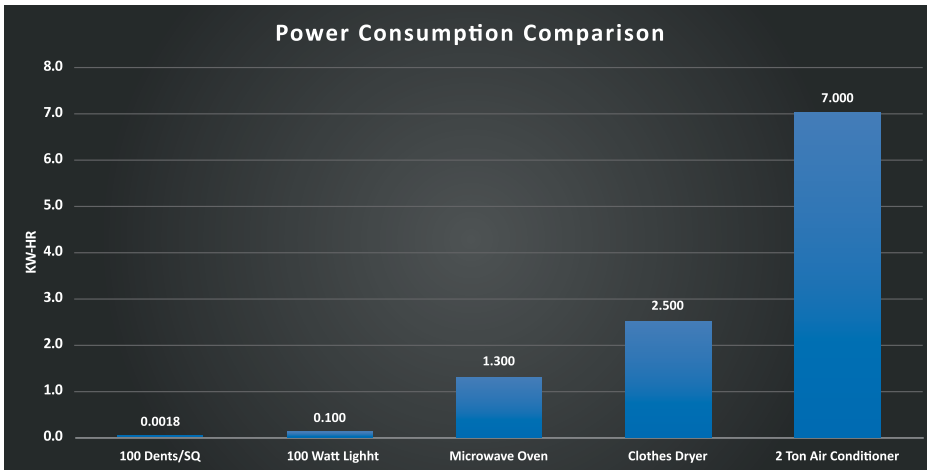
Figure 6. Power consumption comparison: hail-dented roofing square (SQ = 100 ft² [9.3 m²]) versus selected appliances.

To put the magnitude of this estimate into perspective, **Fig. 6** compares the 100 hail-caused dents per roofing square example to the power consumption of several common appliances.¹⁴ Interestingly, operating a single 100-W light bulb for one day would consume about 55 times the energy associated with the increase in thermal energy through the roof due to the hail-caused dents. The hail-related thermal energy increase would be roughly equivalent to having the light bulb on for about 26 minutes a day or running a 2-ton (7-kW) air conditioner for about 22 seconds per day, although these comparisons overestimate the effects of the dents because the roofing square example assumes the roof remains at peak temperature for 24 continuous hours each day.
