# 2021 IIBEC International Convention and Trade Show

# Proceedings of the IIBEC International Convention and Trade Show

# It's Not Raining—Where is the Water Coming From? Moisture Movement in Building Enclosures

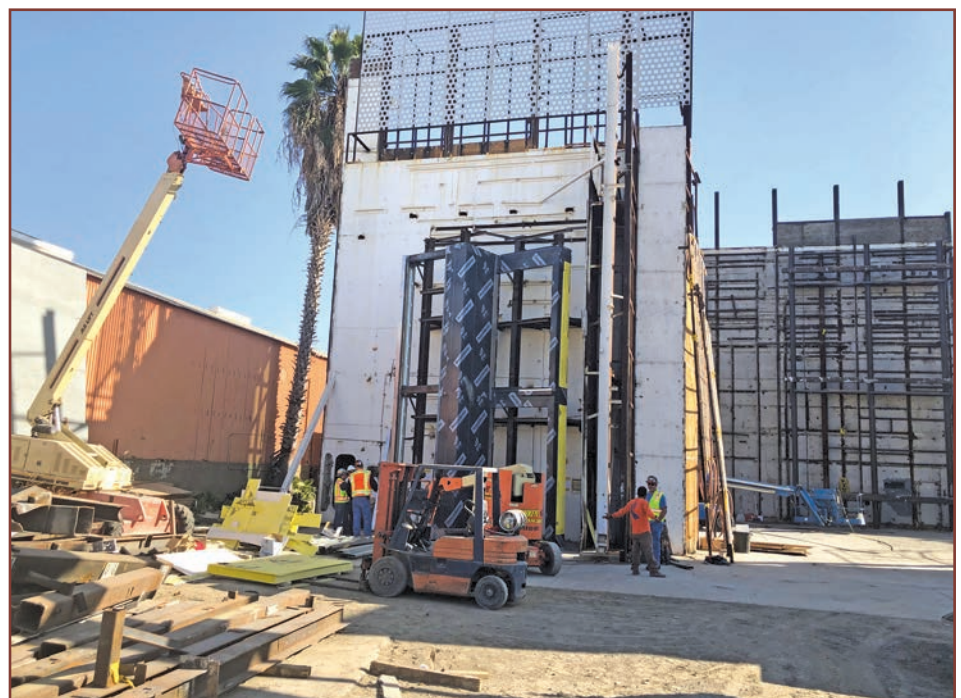
*Figure 9. Performance mock-up in construction.*

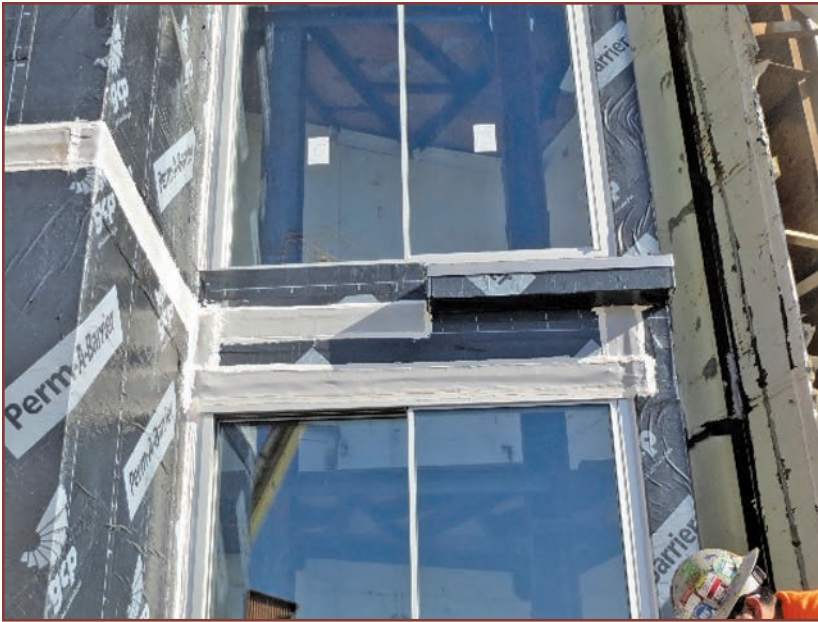
Figure 12. Failed original joint installation.

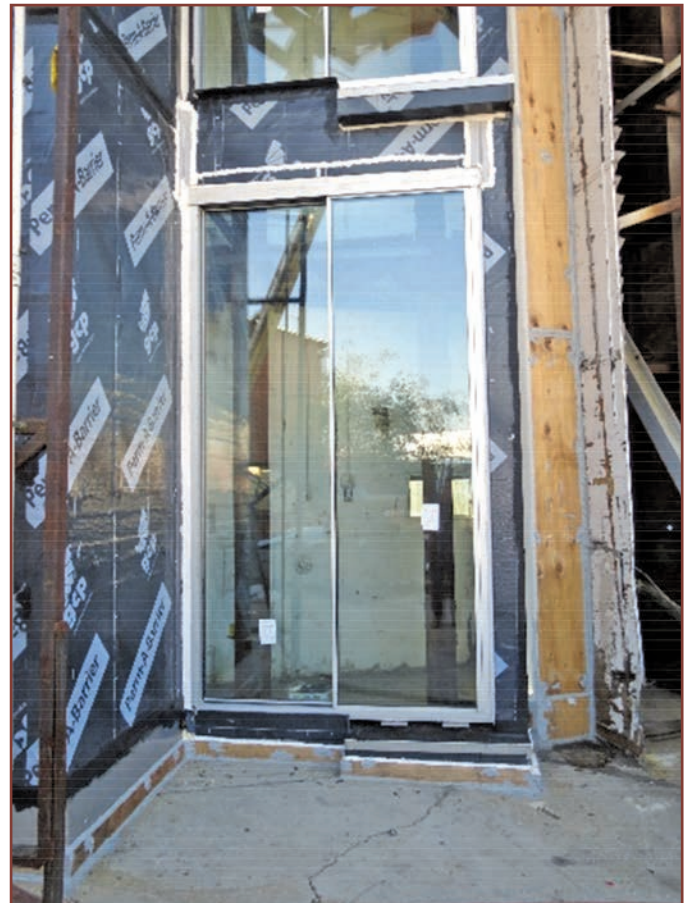
Figure 14. Successfully reinstalled joint installation.

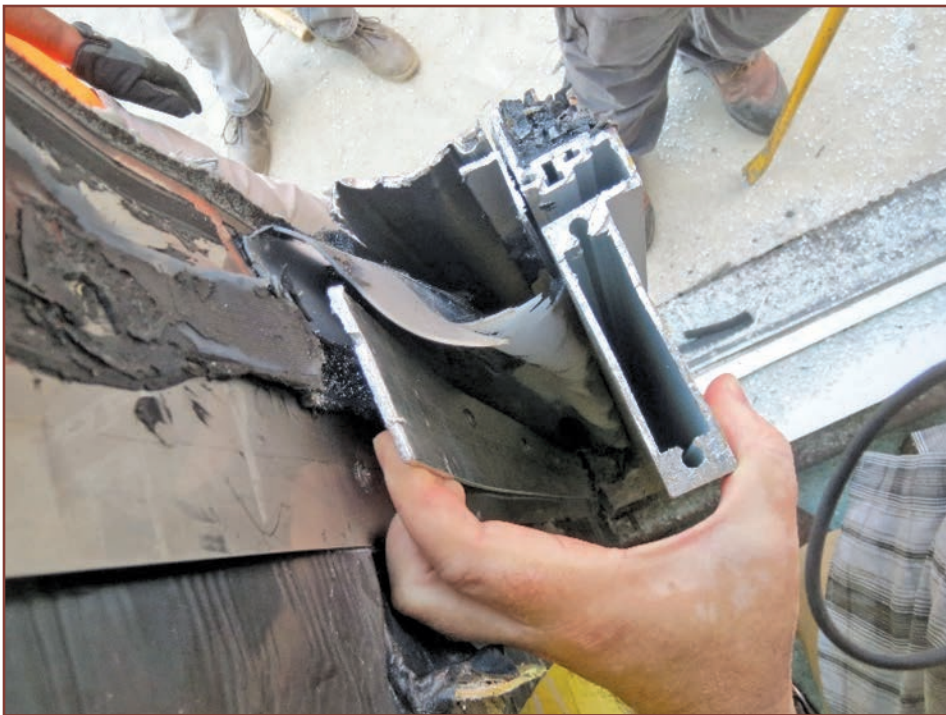
*Figure 15. Deconstruction of performance mock-up components.*

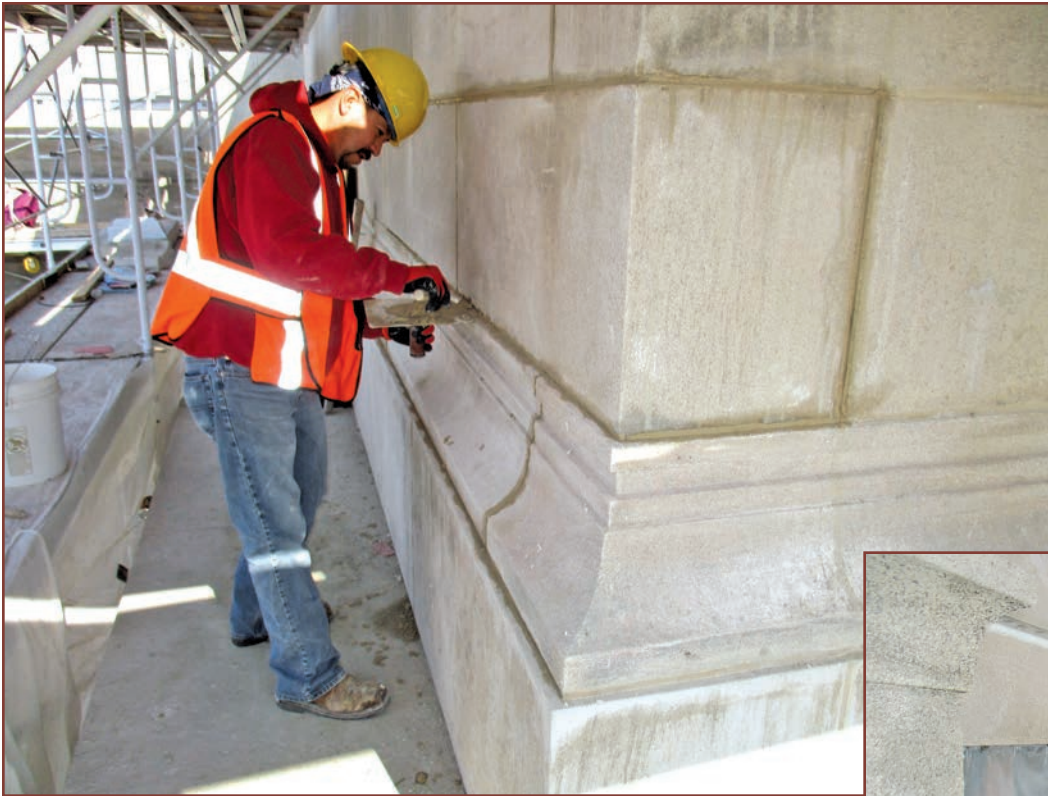
*Figure 12. Repointing effort at the limestone at the 30th Street Station.*

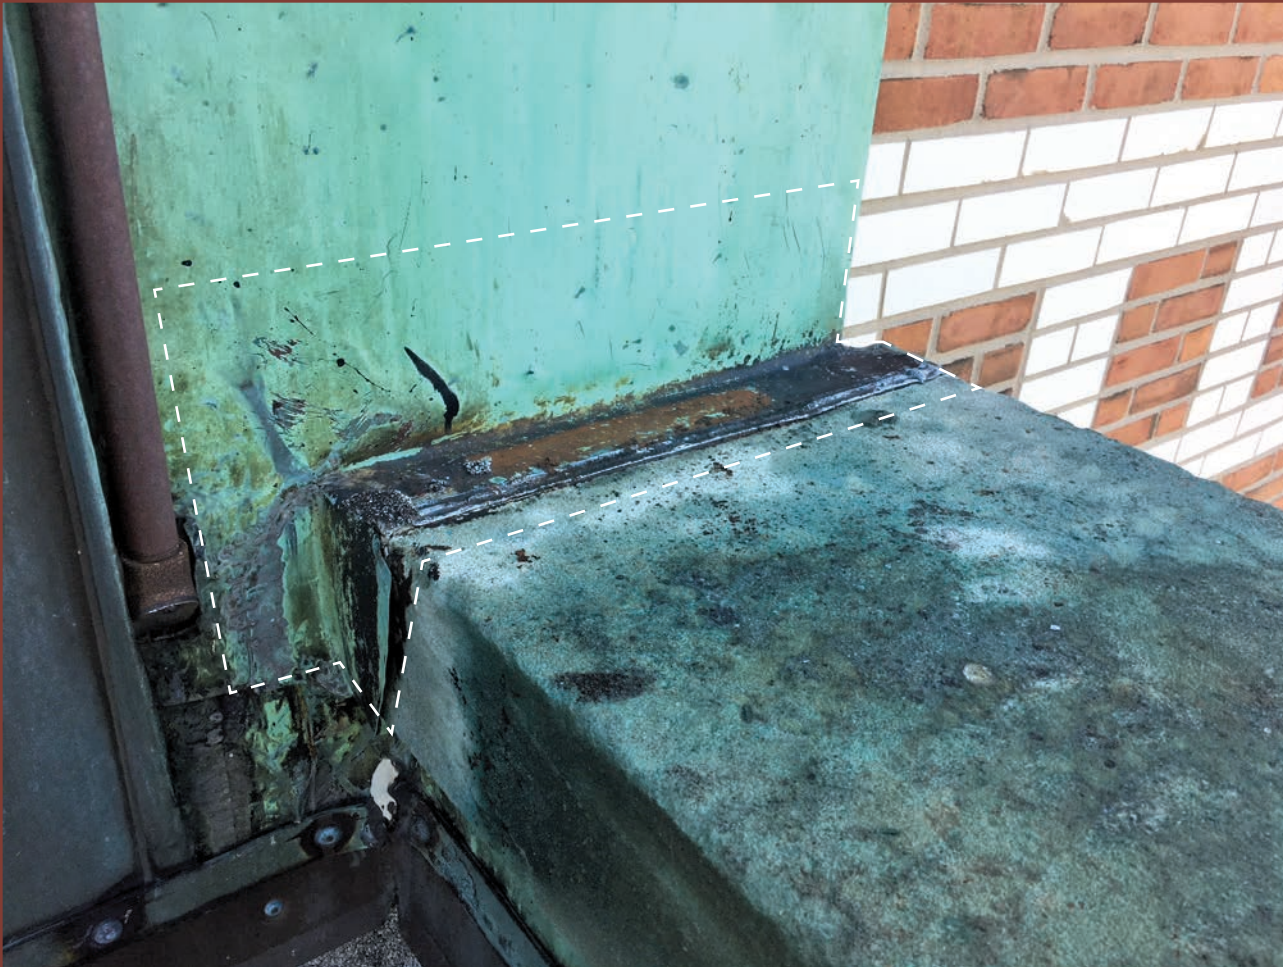
*Figure 1. Example of copper saddle flashing (dashed outline) installed on a building constructed in 1913.*

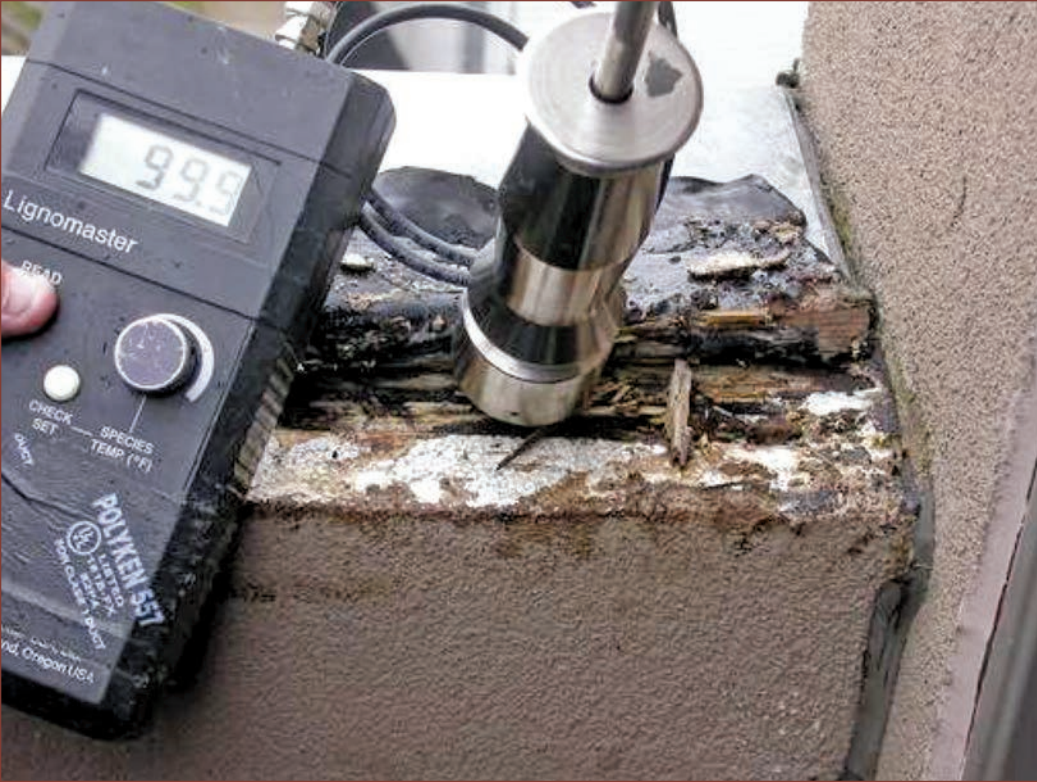
**Figure 3. Deteriorated and wet wood blocking at a parapet-to-wall condition.**

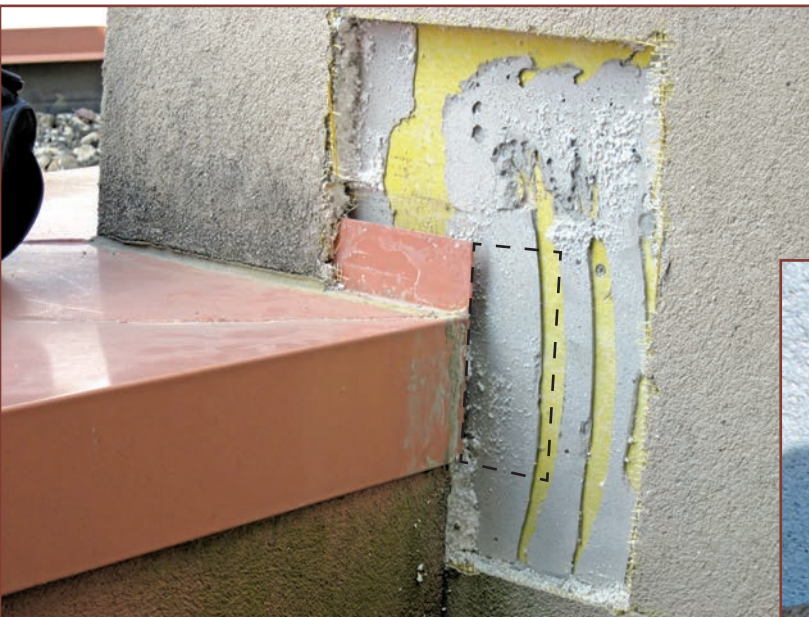
**Figure 4. Coping with the exterior insulation and finish systems lapped over the upturned leg of the coping. Side flanges (dashed outline) were omitted.**

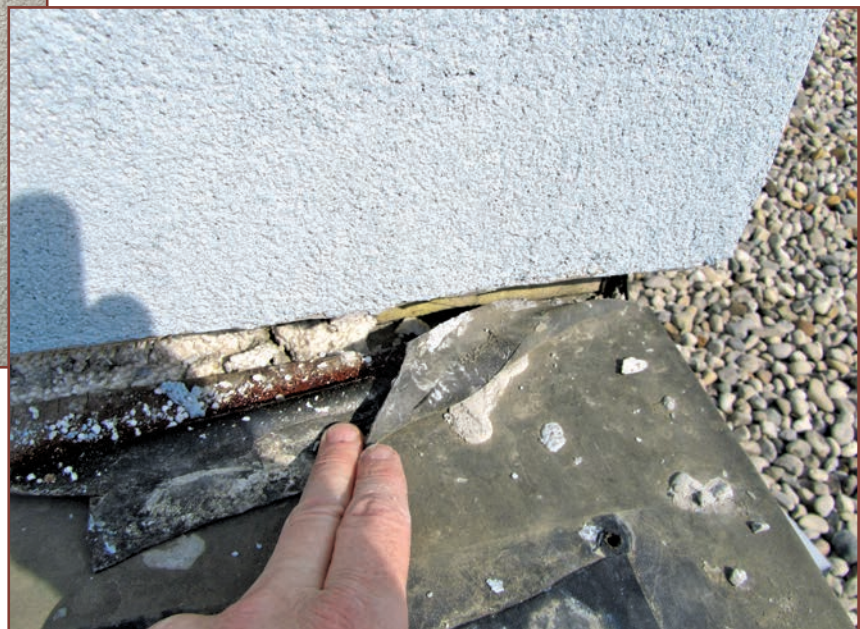
**Figure 5. Parapet-to-wall condition with no integration of the single-ply roofing membrane with the exterior insulation and finish systems.**

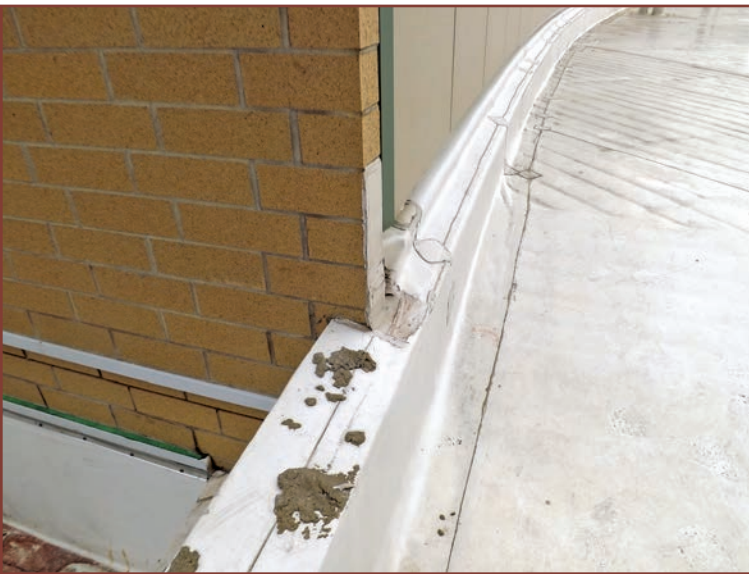
*Figure 7. End of parapet-to-wall at a building corner with brick masonry, metal wall panels, roofing, and a roof-to-wall expansion joint.*

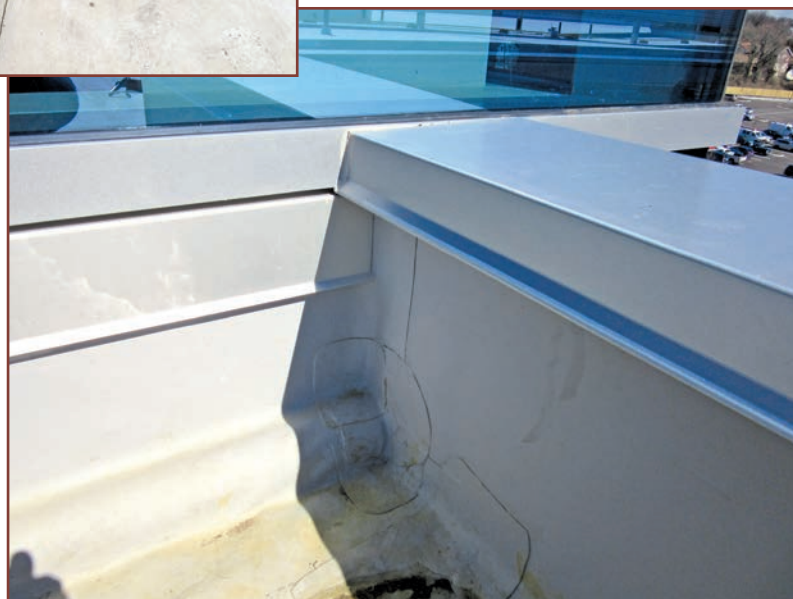
*Figure 8. End of parapet-to-wall interface condition with curtainwall, counterflashing, roofing, and building expansion joint.*

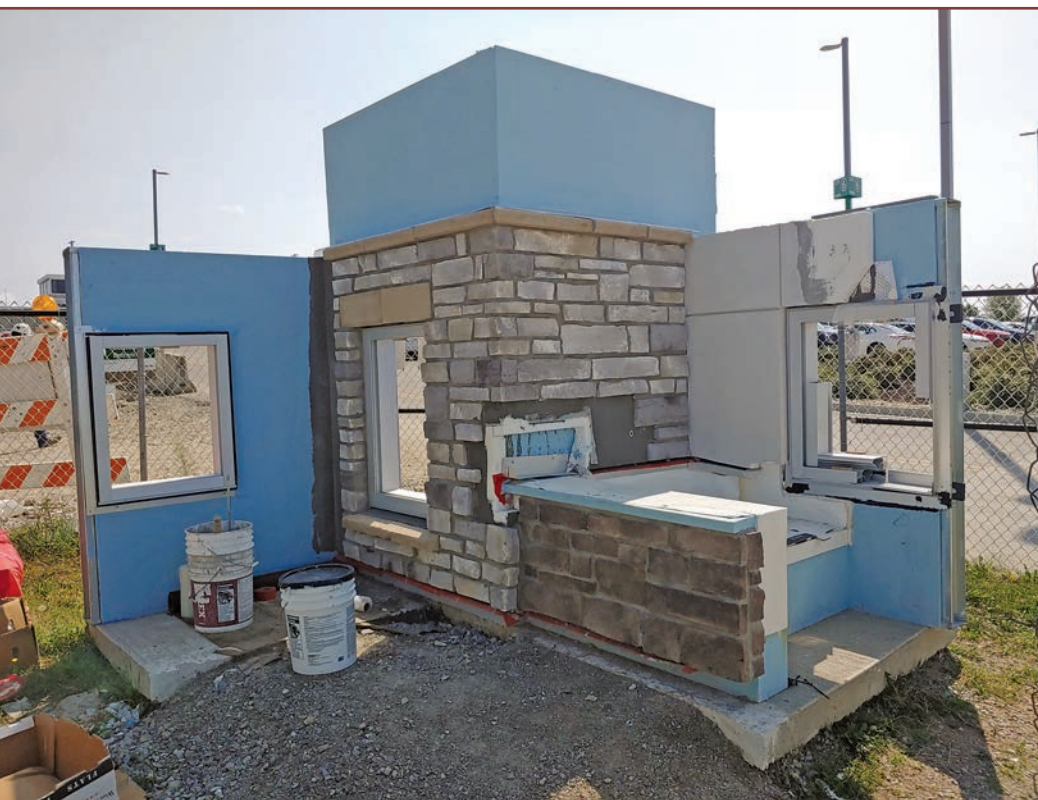
*Figure 9. Example of construction mock-up incorporating a saddle flashing condition at the parapet-to-high-rising wall condition. Photograph provided courtesy of M+A Architects of Columbus, Ohio.*

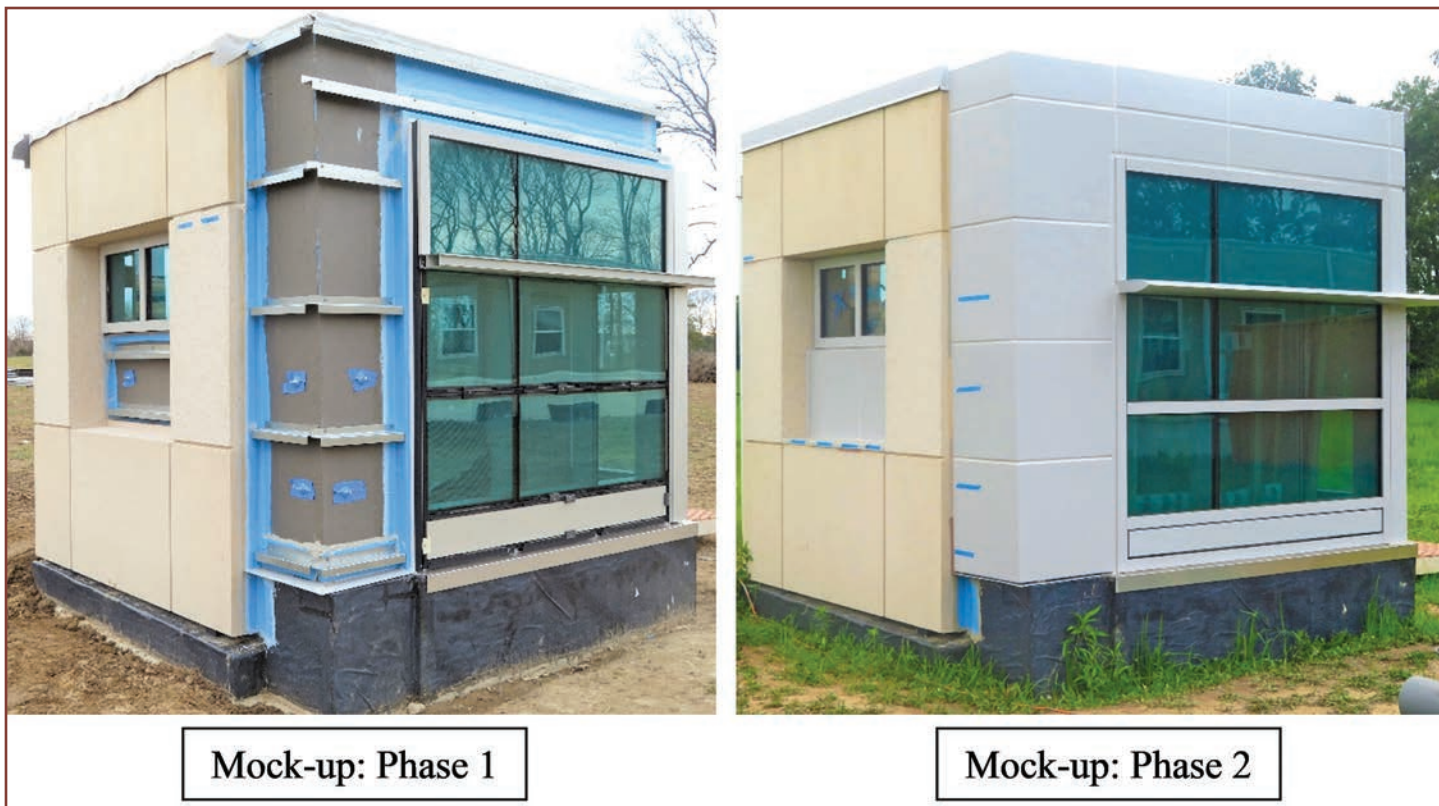
*Figure 4. Preconstruction mock-up constructed in two phases.*

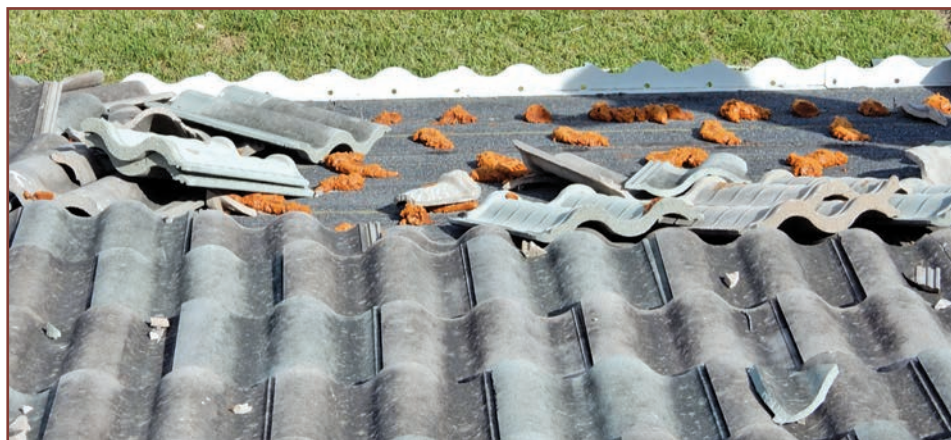
**Figure 7. Hurricane Irma: Winds 100 to 110 mph. Inadequate adhesion.**

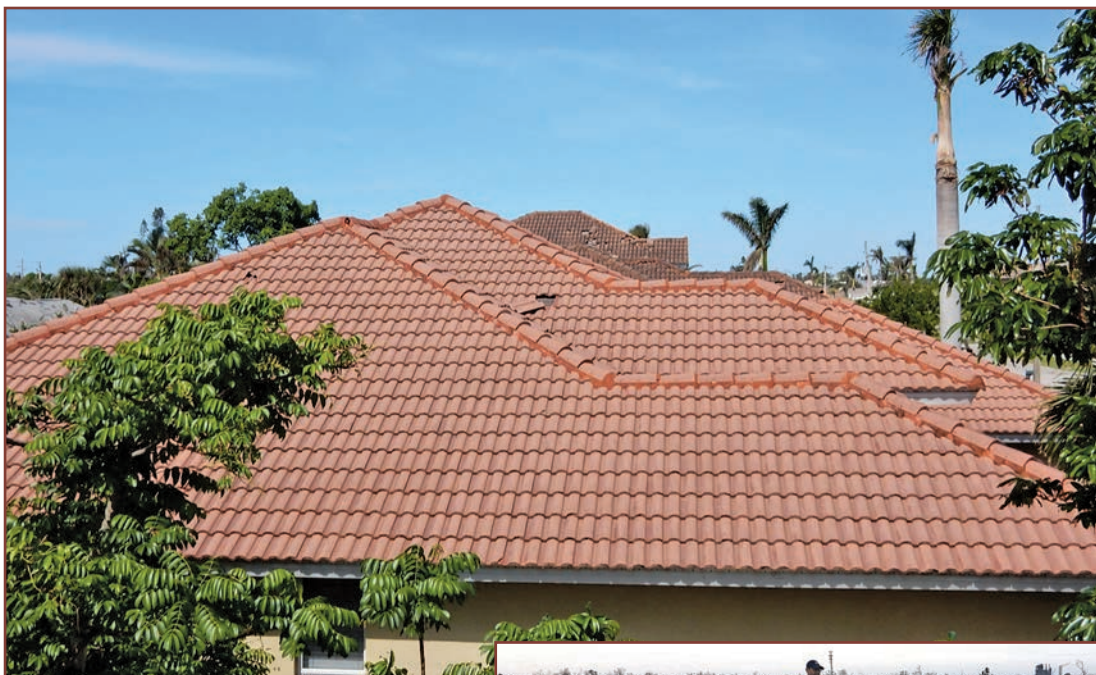
*Figure 8. Hurricane Irma: 100 to 100 mph winds. Missile impact damage.*

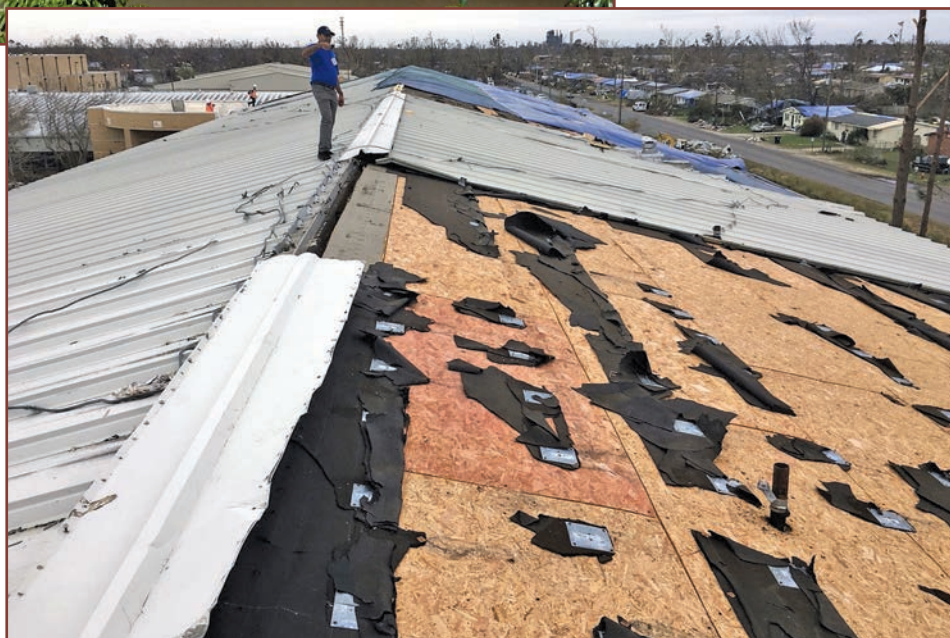
*Figure 9. Hurricane Michael: 140 mph winds. This metal-panel roof was blown off. One of the weak links was the edge fasteners totally missing the edge nailer. This roof also had significant internal pressurization from failed soffits.*

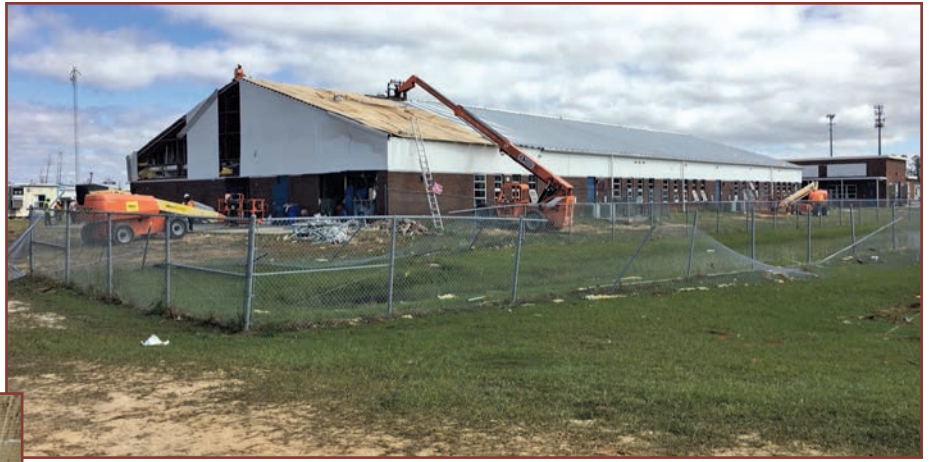
*Figure 10. Metal panels where the perimeter was not fastened to the edge nailer.*

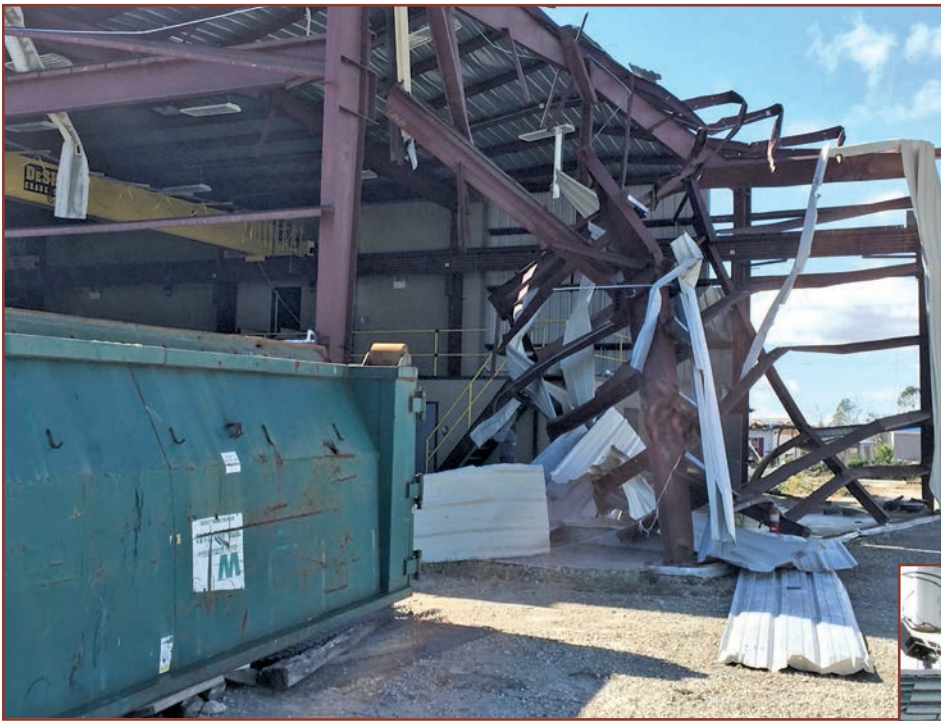
*Figure 13. Hurricane Michael: 140 mph winds. This open metal building had cladding and roof loss. Many of the connections were corroded.*

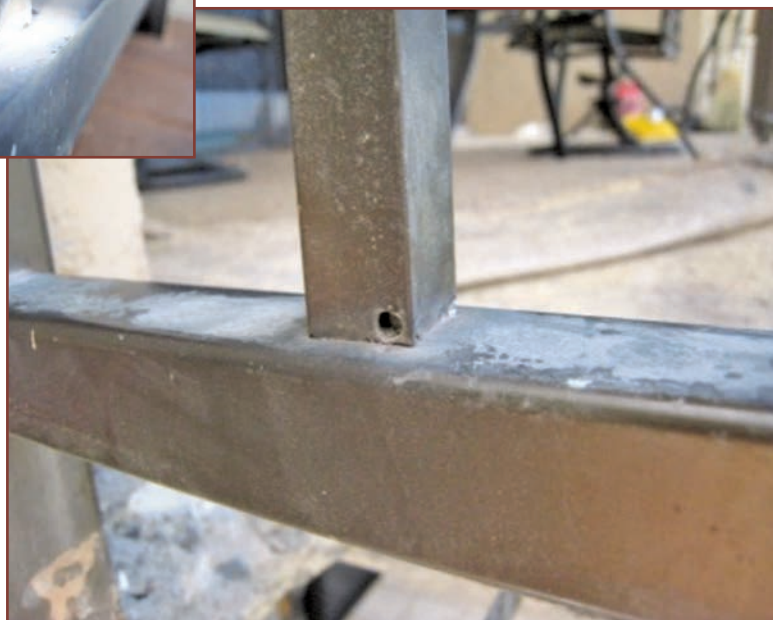
*Figure 2. Galvanic corrosion on anodized aluminum guardrail.*

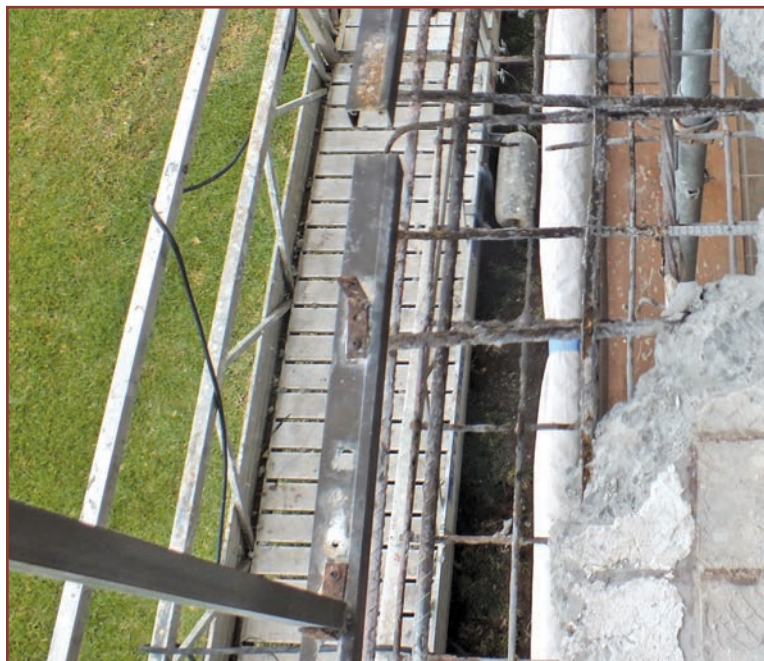
*Figure 3. Steel angles used to repair aluminum pickets.*

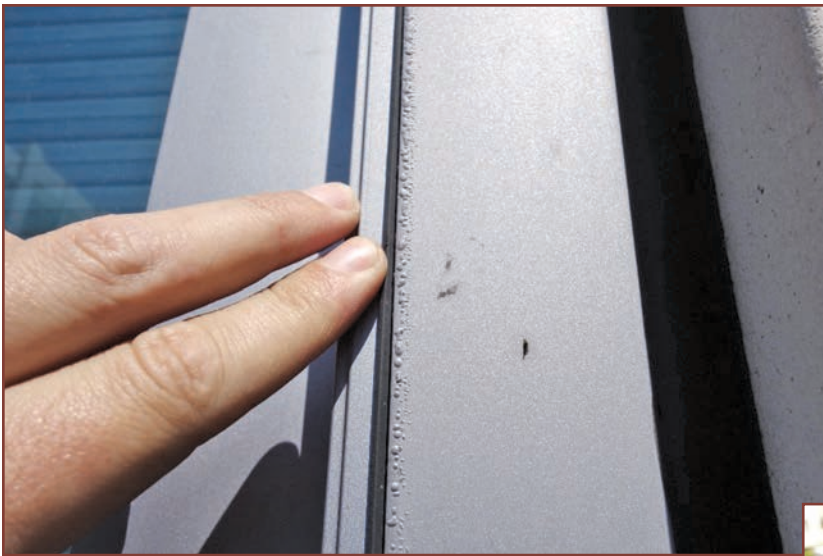
*Figure 7. Polyvinylidene fluoride coating failure: Corrosion at aluminum window wall frame.*

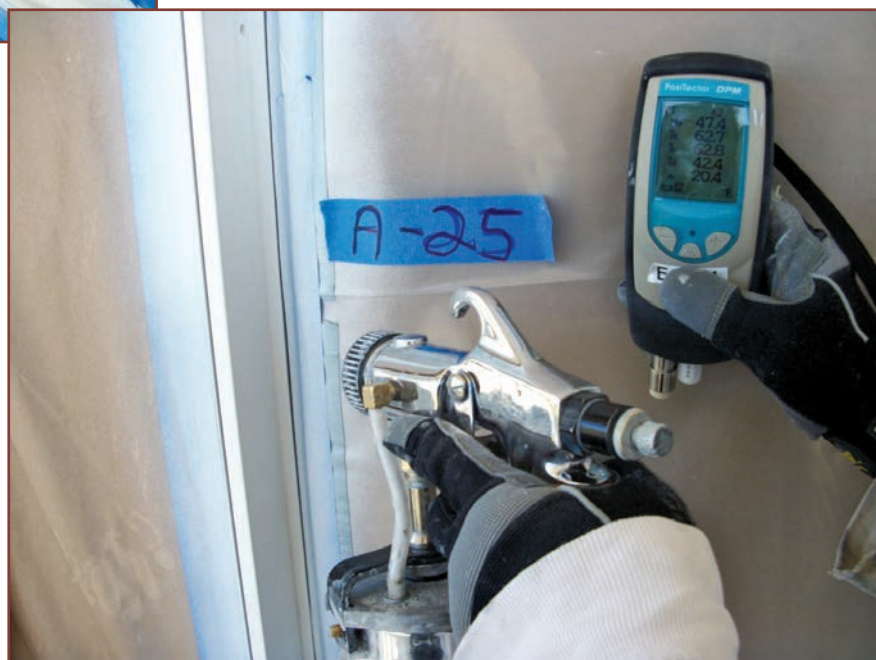
*Figure 14. The coating repair process: Top coat application. Courtesy of Stuart Dean.*

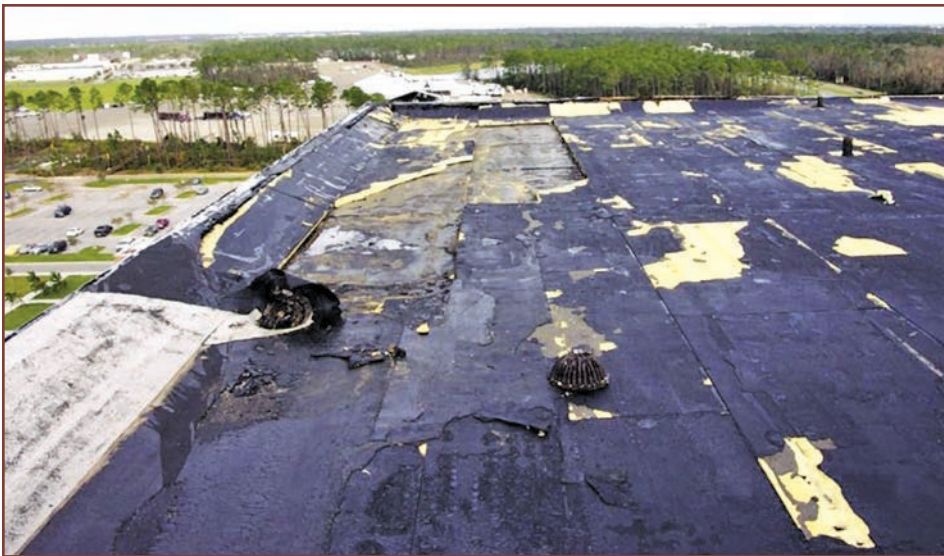
**Figure 2. Damage to the Pensacola Naval Hospital in Florida from Hurricane Ivan.**

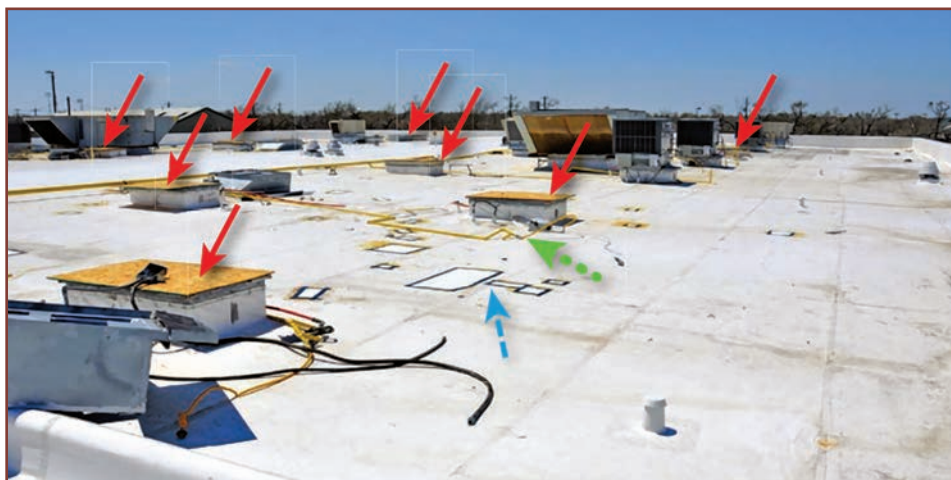
The red arrows indicate where HVAC units were blown off their curbs (the curb openings were temporarily covered with plywood). Emergency patches had been installed at membrane punctures (blue dashed arrow). The gas lines (green dotted arrow) had ruptured.

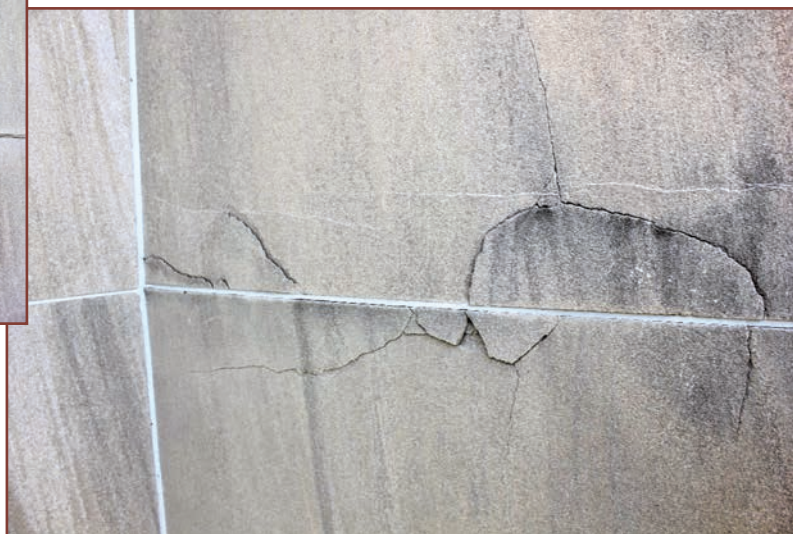
**Figure 7. Incipient spalls located along a stone joint.**

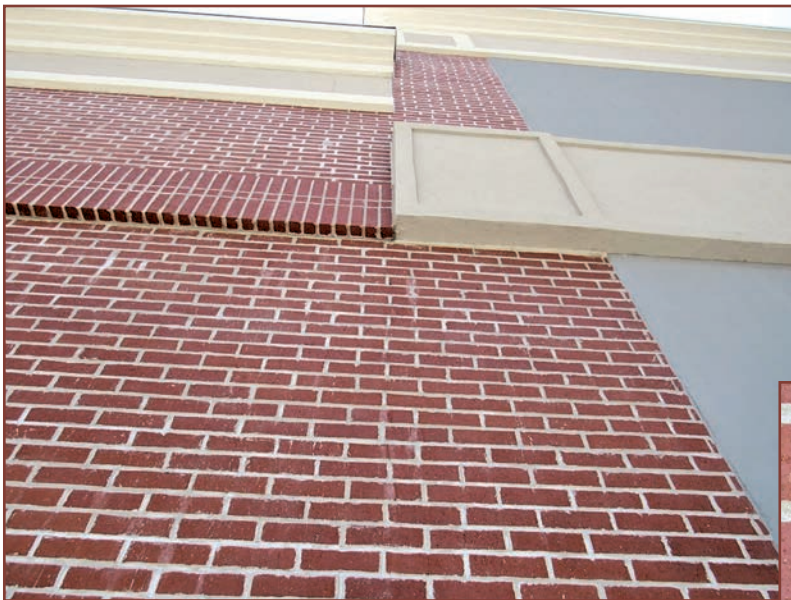
*Figure 8. Large area of manufactured stone veneer without any control joints.*

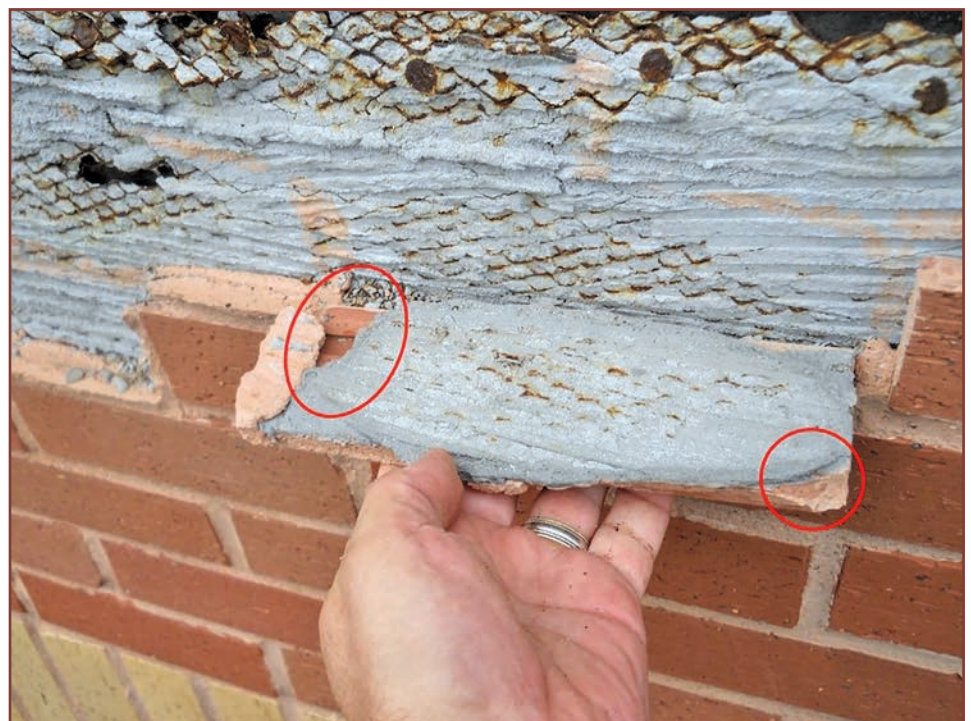
*Figure 10. Incomplete setting bed resulted in voids/pockets behind the adhered brick veneer.*
