PROCEEDINGS

IIBEC

**INTERNATIONAL
CONVENTION
& TRADE SHOW**

PROCEEDINGS TABLE OF CONTENTS

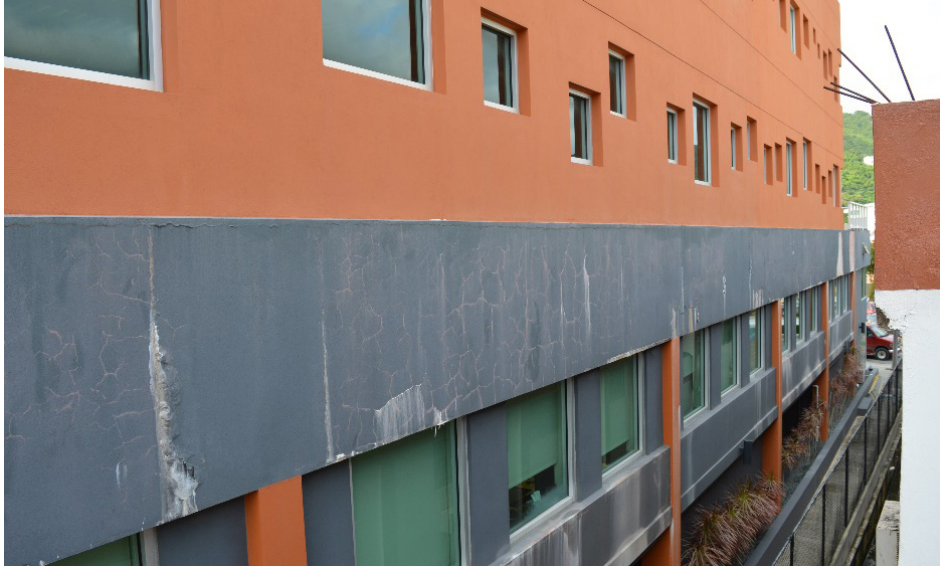
FIGURE 2. Concrete beam between the first and second floor where metal lath was used with stucco.

of thumb is to install control joints in the stucco directly in line with control joints on the building. In addition, stucco directly applied to a consistent masonry base usually performs well and minimizes the potential for cracks to develop unless there are bonding issues. In the original design drawings for the Tortola International Pancake House, control joints were shown on the elevation plans for the stucco cladding, primarily at the substrate transition where concrete masonry units were used as infill between the structural concrete floor slabs. The installed stucco system included horizontal reveal joints placed along those areas where materials varied. The building design did not have expansion joints in the structure, and vertical joints shown in the drawings for the stucco cladding were not installed. ASTM C1063⁷ states that stucco systems should have joints placed for dimensions exceeding 18 ft (5.5 meters), no panel size should be more than 144 ft² (1.4 m²), and the ratio of length to width should not exceed 2.5 to 1. At some of the locations on the Tortola Office Building, we observed metal lath behind the stucco and found that it was not continuous. Where the lath was discontinuous, the stucco cladding was continuous but transition details such as reveal joints or accessories for movement were not provided. Application of the stucco over metal lath did not seem to comply with the ASTM C1063⁷ requirements, particularly where the concrete beam exists between the first- and second-floor levels (see **Fig. 2**).

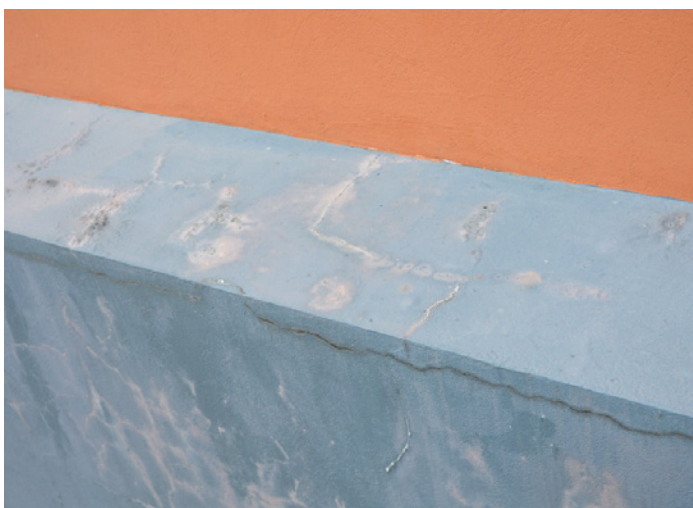
FIGURE 9. Stucco on water table is cracked.

application in the water table area was thicker than that at the vertical face. One of the worse areas of observed cracks was located where varying thicknesses of stucco combined with a change in plane at a building corner. Thicker areas of stucco tend to move differently from thinner areas, and the same applies to different planes (**Fig. 9**).

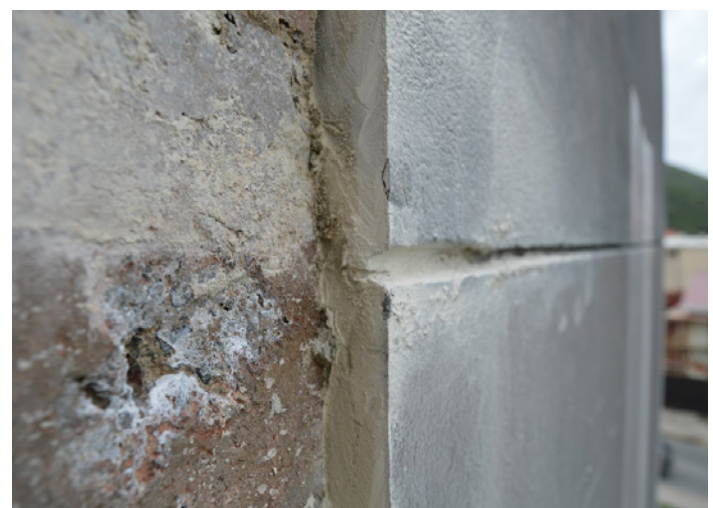
FIGURE 10. Destructive opening at a reveal of the stucco. No joint accessories were observed.

pieces with relative ease, indicating that failure was occurring at the bond line. No joint accessory was observed at the reveals. Joint accessories can be used to divide wall areas and control cracking as well as to control the stucco thickness (**Fig. 10**). ASTM C926⁶ provides a list of waterproofing materials behind control joints for consideration, as this is where cracking is likely to occur.

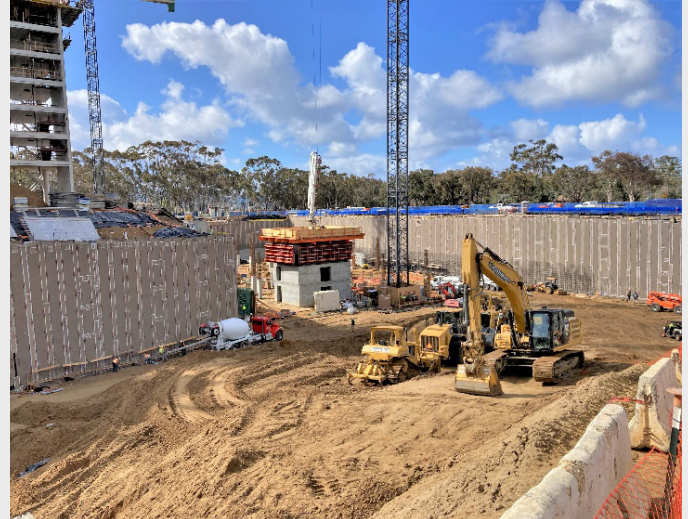
FIGURE 1. Waterproofing at a deep foundations site.

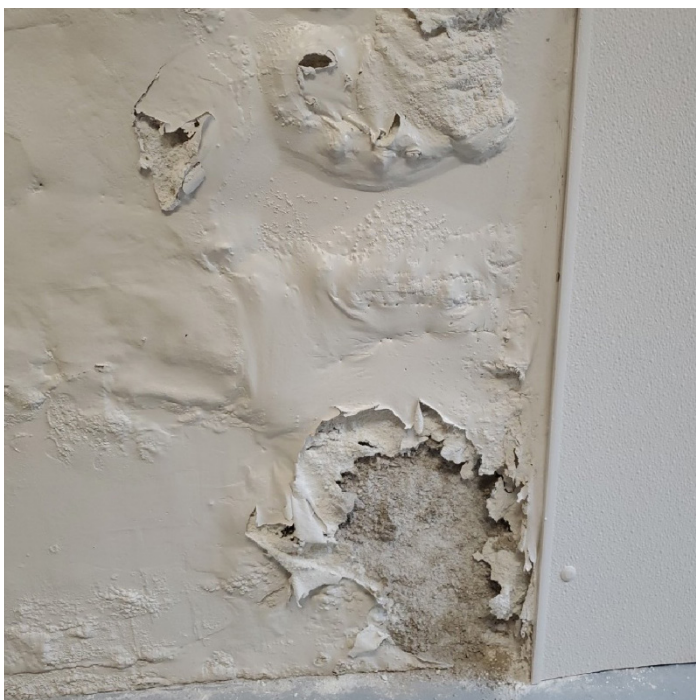
FIGURE 2. View of moisture-related damage to interior finishes.

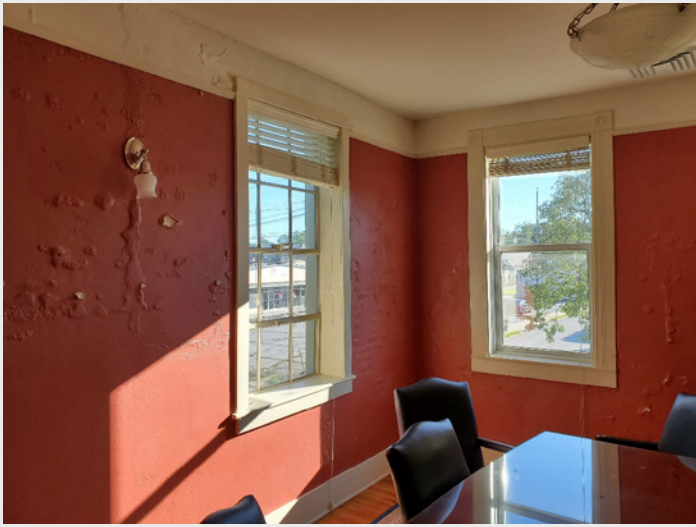
FIGURE 6. Representative view of unadhered pockets of interior coating with efflorescence behind unadhered coating.

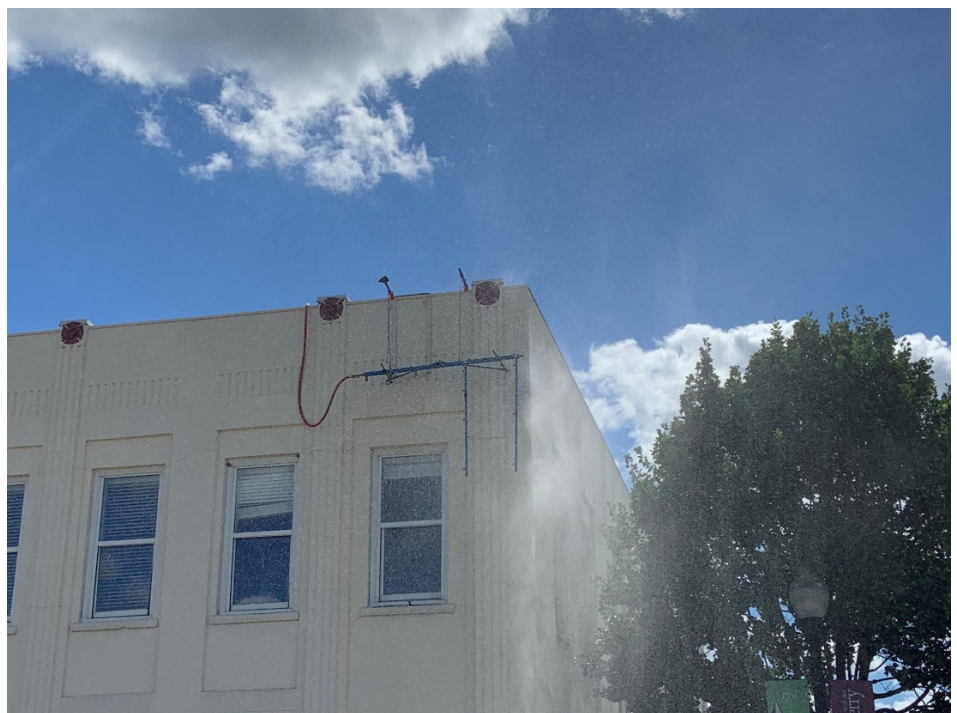
FIGURE 8. Representative view of Modified ASTM E1105 testing of mass masonry.

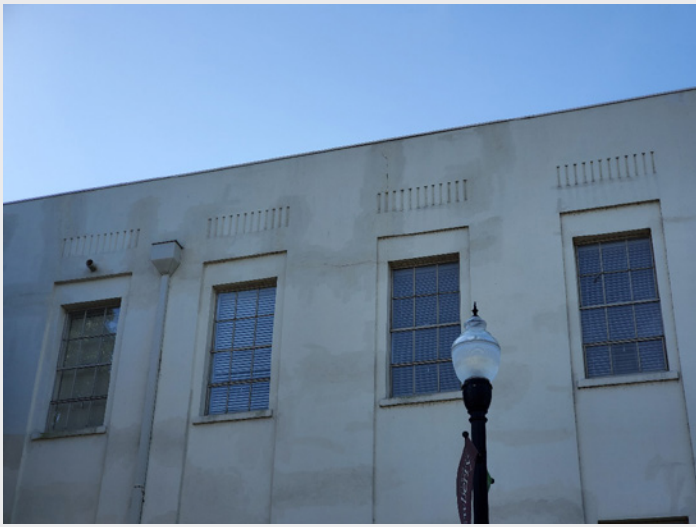
FIGURE 11. Representative view of cracking in stucco.

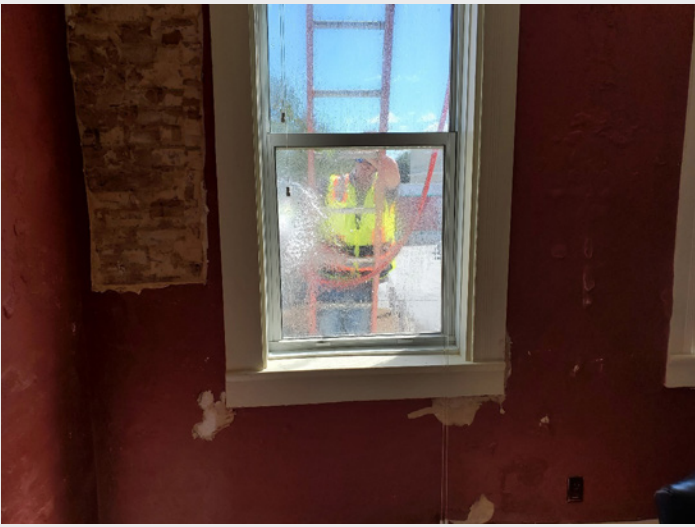
FIGURE 12. Representative view of forensic water testing.

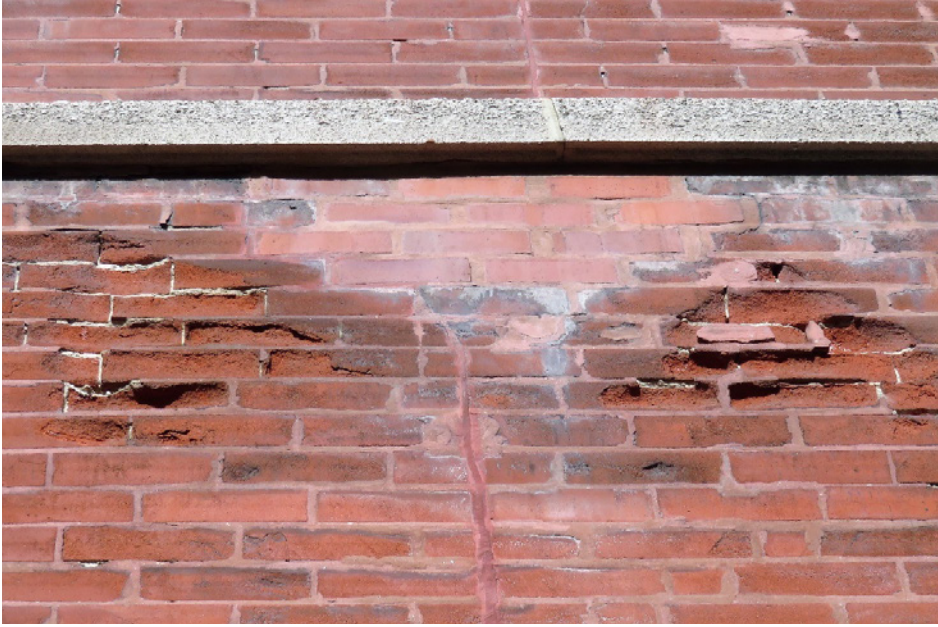
FIGURE 2. Various forms of exterior masonry wall deterioration.

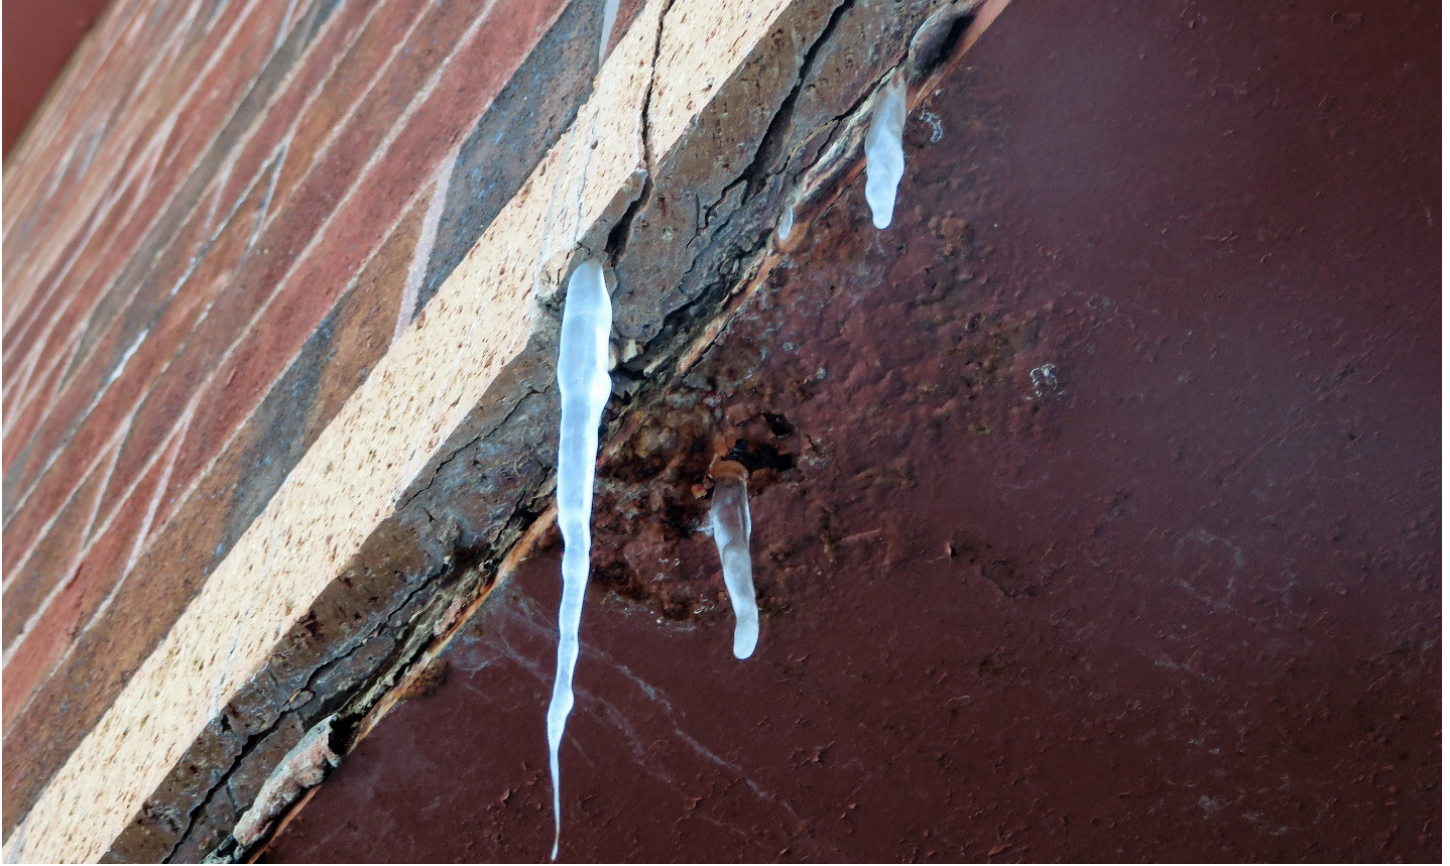
FIGURE 3. Deterioration of brick veneer from freezing and thawing cycles.

- » **Deterioration from freezing and thawing cycles:** When water freezes and expands within the pores of a masonry unit, internal tensile stresses within the material can lead to cracking, delamination, and possibly spalled units (**Fig. 3**).
- » **Efflorescence:** Efflorescence is generally a benign form of distress in which light-colored minerals are deposited on the surface of masonry units after water evaporates from within the walls. Efflorescence can occur on both the interior and exterior sides of the walls.

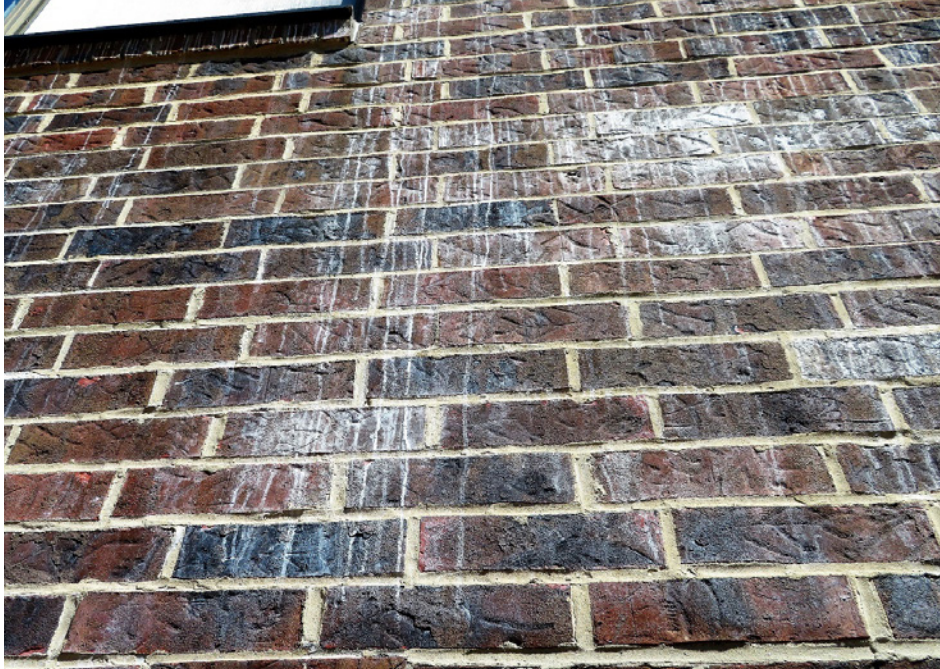
FIGURE 8. Water-repellent staining on an exterior masonry wall surface.

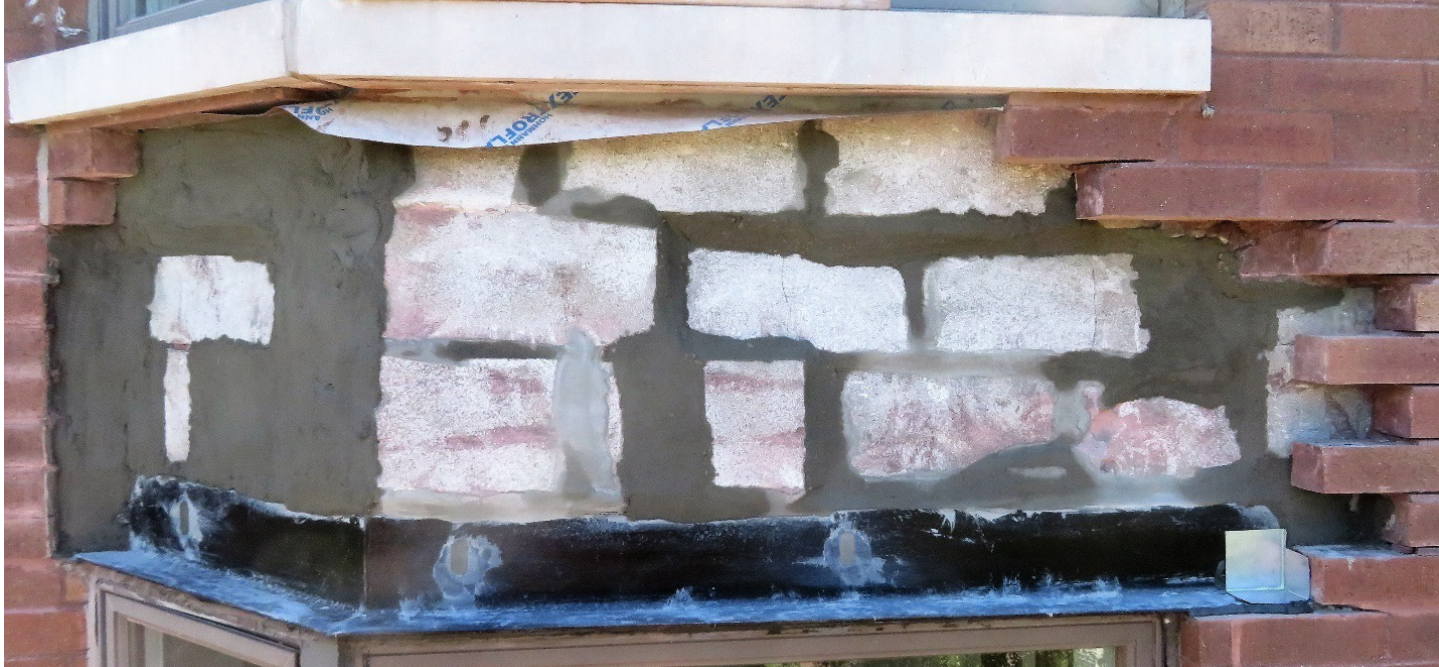
FIGURE 9. Preparation of a backup wall prior to installation of the AWB and through-wall flashing.

The condition of the backup masonry varied throughout the building and included areas of out-of-plumb masonry, loose masonry units, and significant voids in the backup CMUs. Project specifications required repairs to the backup wall in the form of repointing, parging, and unit replacement to ensure a suitable substrate for the AWB and through-wall flashing (**Fig. 9**). Although

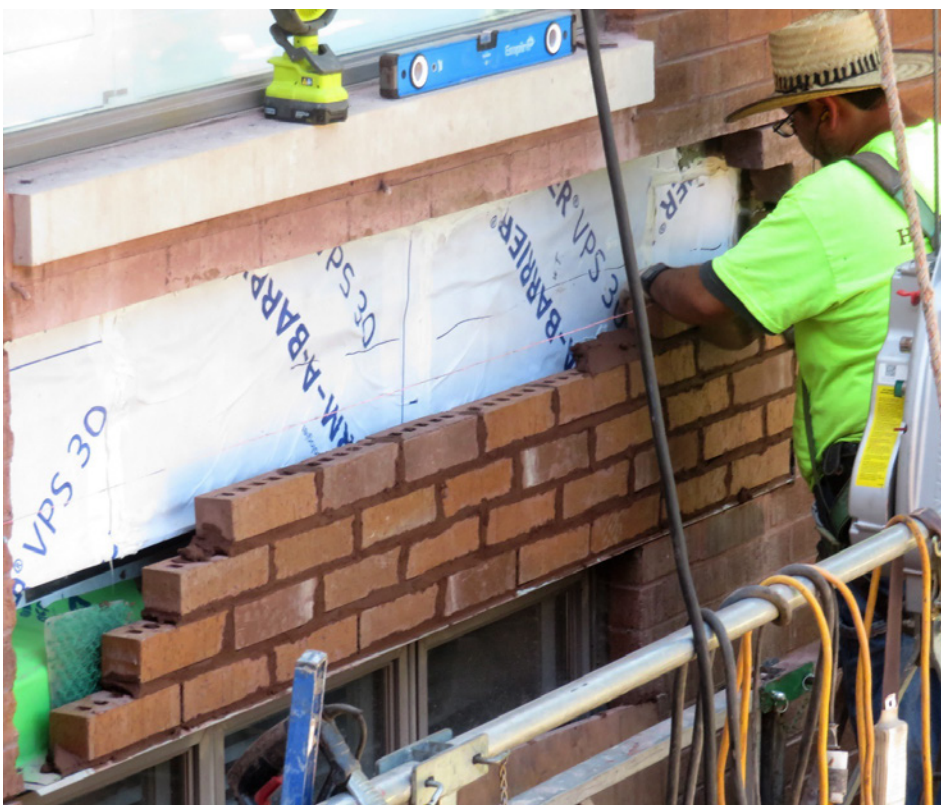
FIGURE 10. Installation of brick veneer following installation of the AWB and through-wall flashing.

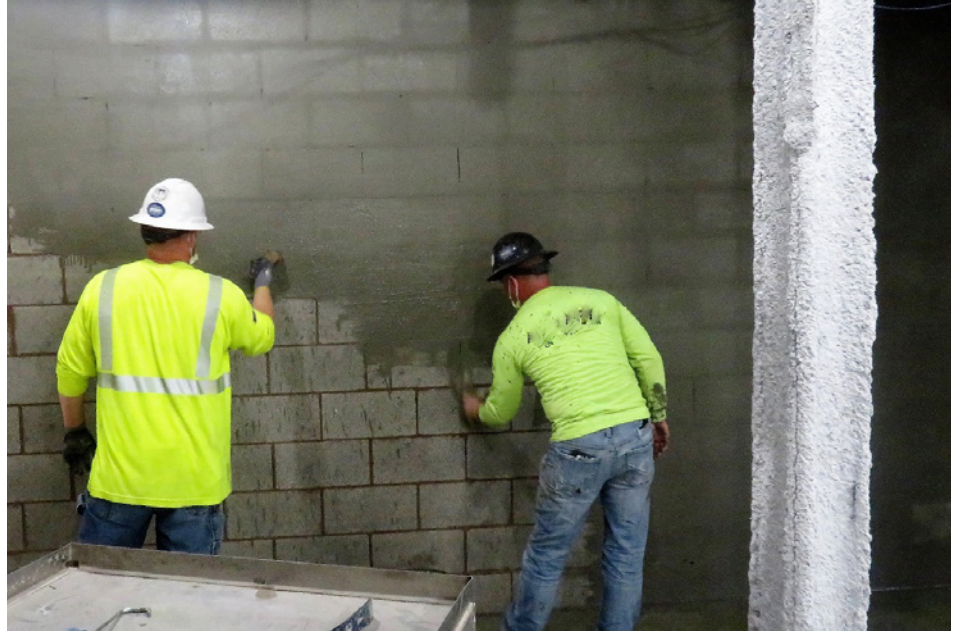
FIGURE 14. Crystalline waterproofing application on the interior side of a CMU wall.

Following demolition of interior finishes, water leakage through the field of the walls and at through-wall flashing locations was documented on several occasions during precipitation events. Therefore, the authors recommended a hybrid repair strategy that would incorporate traditional masonry repairs and window replacement in conjunction with application of a crystalline waterproofing system on the interior face of the CMU walls (**Fig. 14**). In

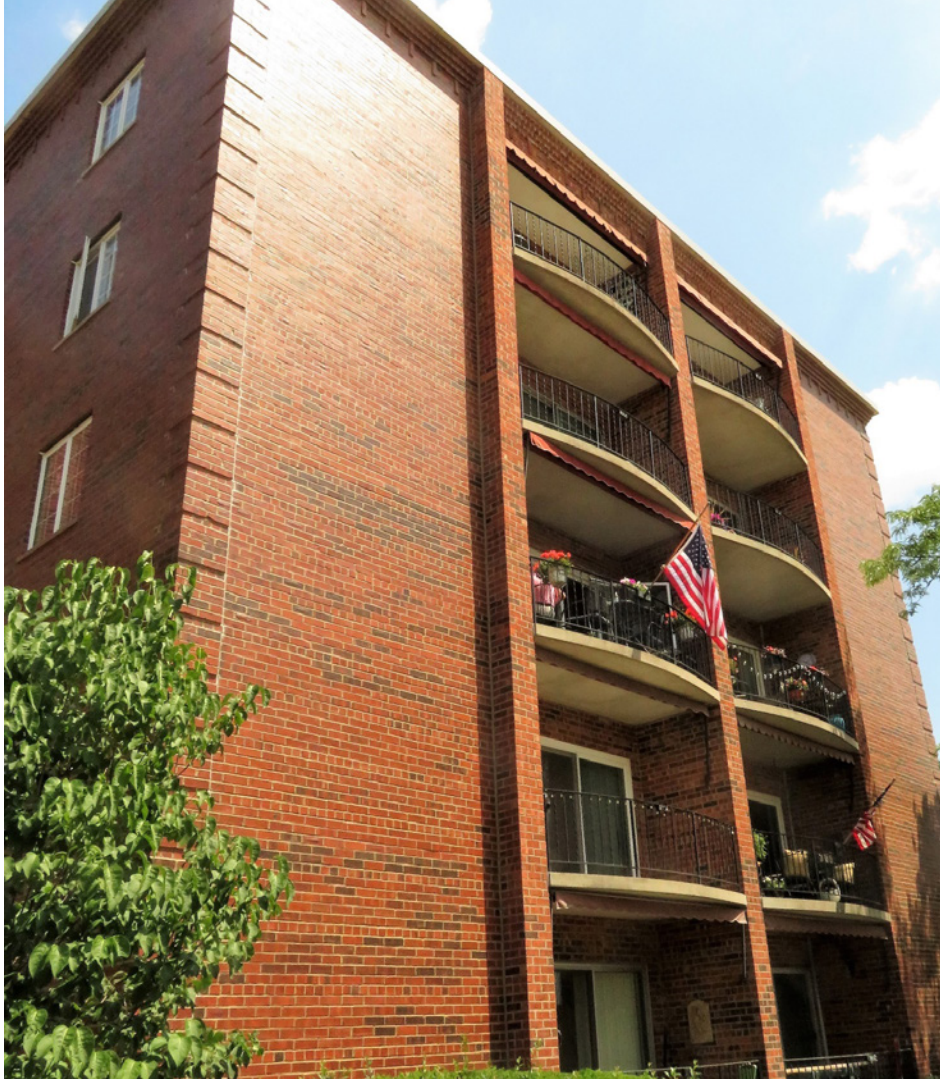
FIGURE 15. Translucent silicone coating applied to the exterior face of a two-wythe mass masonry wall.

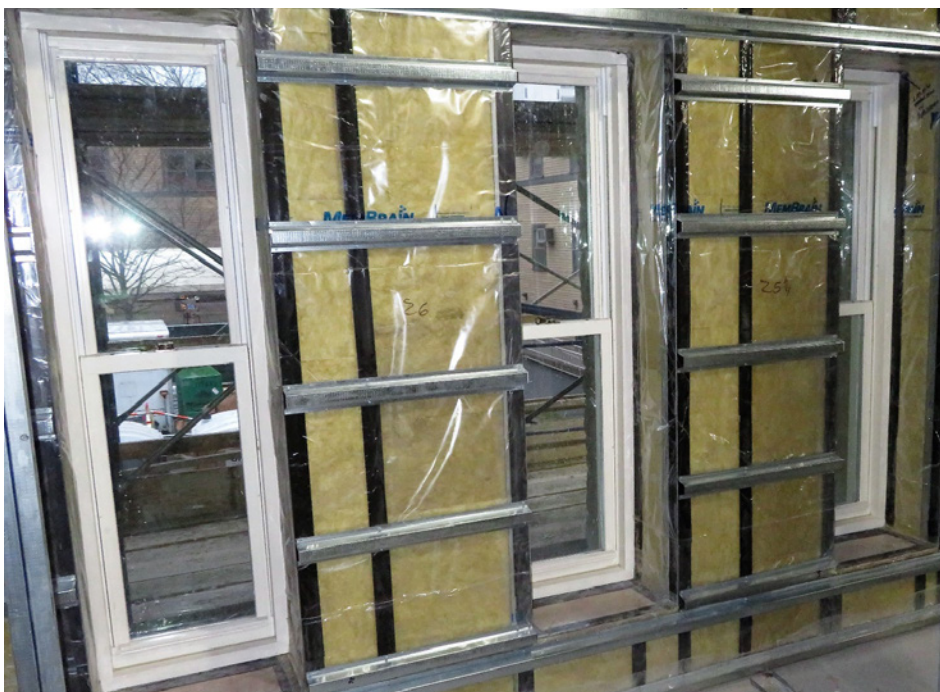
FIGURE 16. Interior insulation and a variable vapor retarder installed on the interior side of a mass masonry wall.

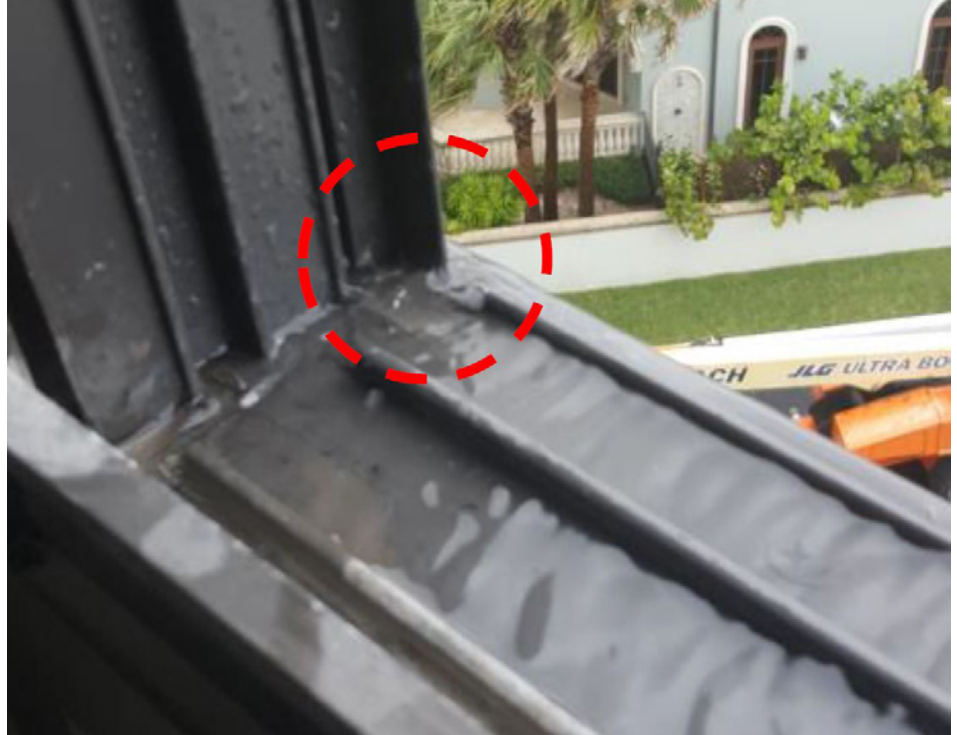
FIGURE 1. Base of Sliding Window was previously blocked and allowed water accumulation.

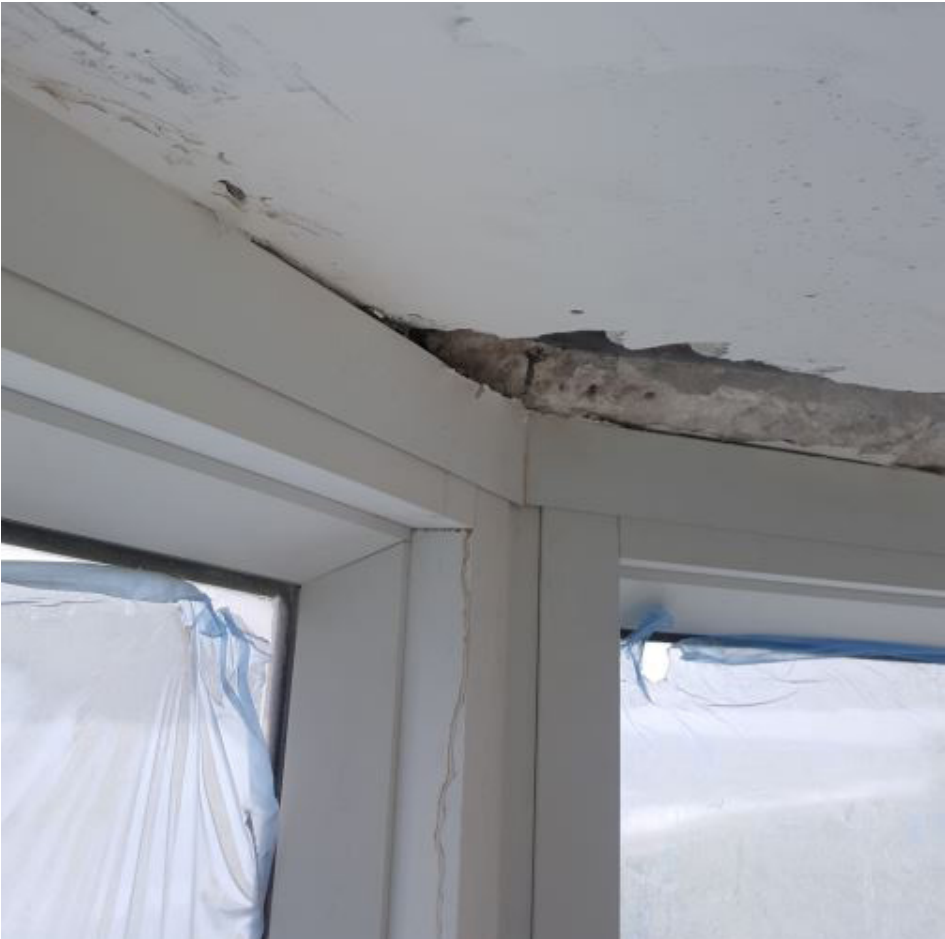
FIGURE 4. Red stains reveal compromised conduit not window assembly.

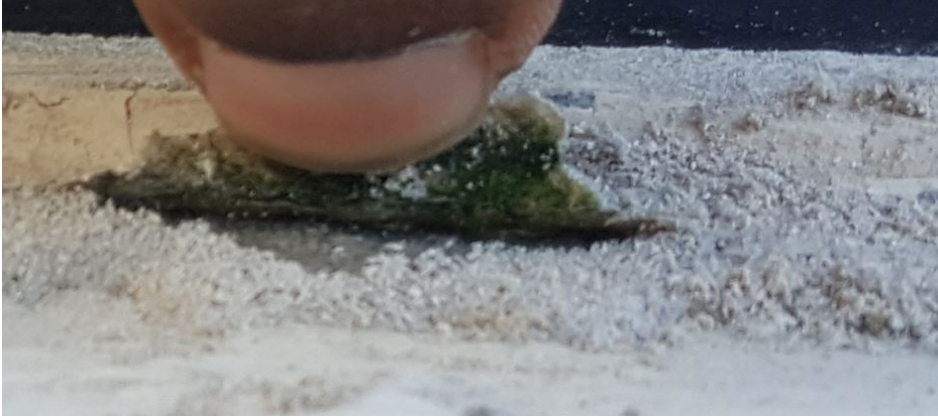
FIGURE 5. Example of Bio growth.

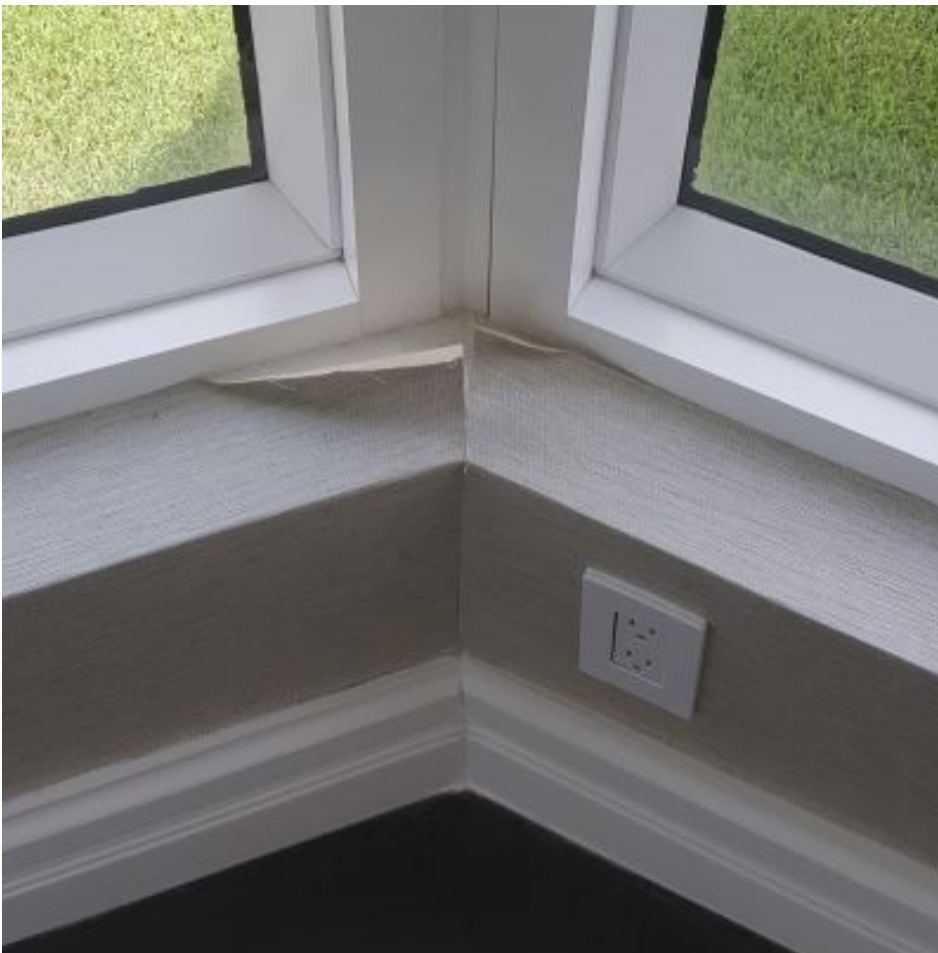
FIGURE 6. Distortion at window.

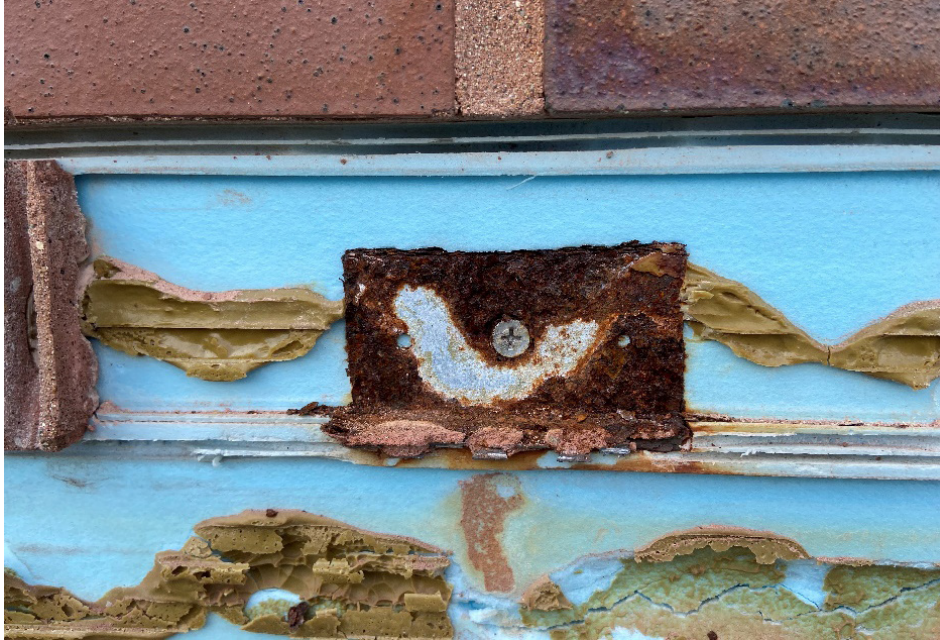
FIGURE 2. Insulation clip in the wet zone of the wall, which has begun to corrode.

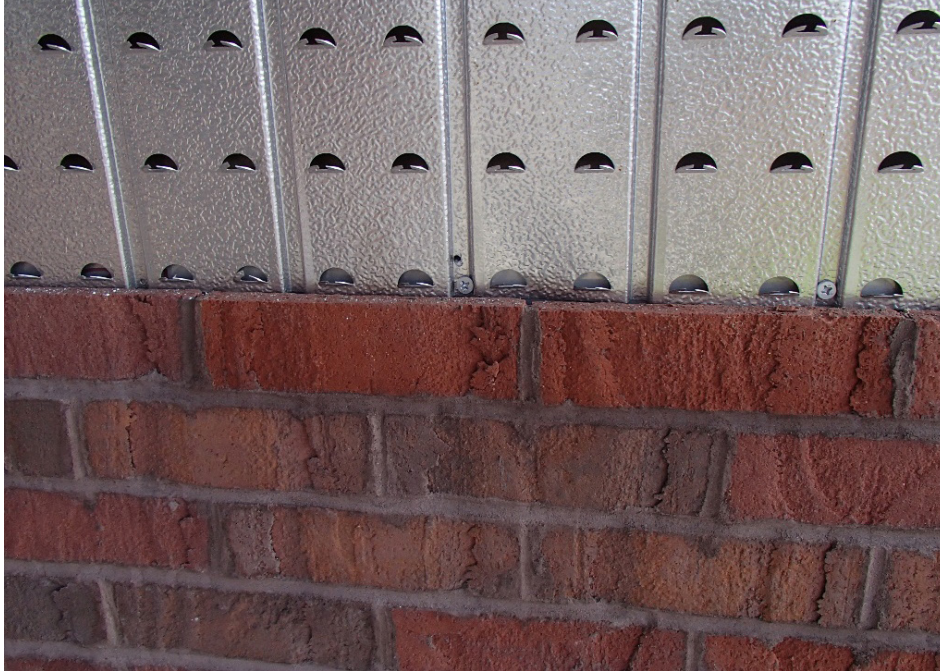
FIGURE 3. Panel-backed TBV system.

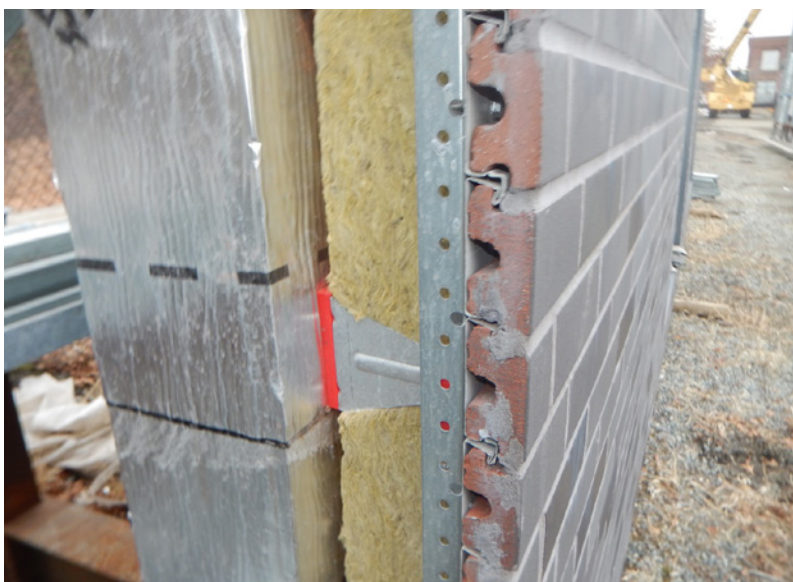
FIGURE 4. Thin brick rail system on a rainscreen support system.

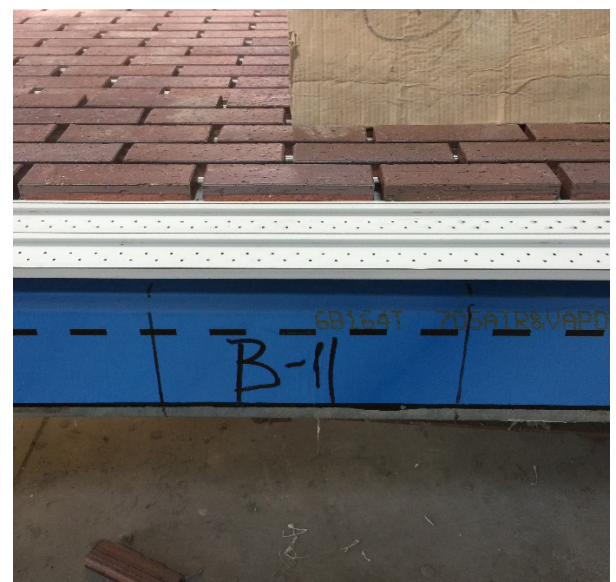
FIGURE 5. Panelized thin brick rail system project during construction, rails installed, bricks set in place, mortar work not yet complete.

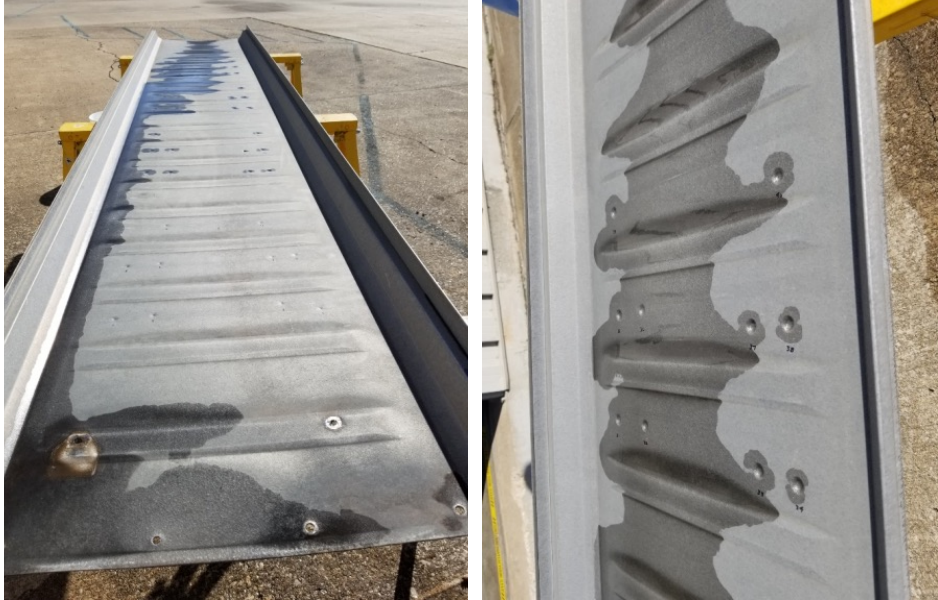
FIGURE 16. Non-uniform water distribution on panel as it dries (L) and subsequent effect on volume of water flowing into divots on the opposing sides of the panel (R).

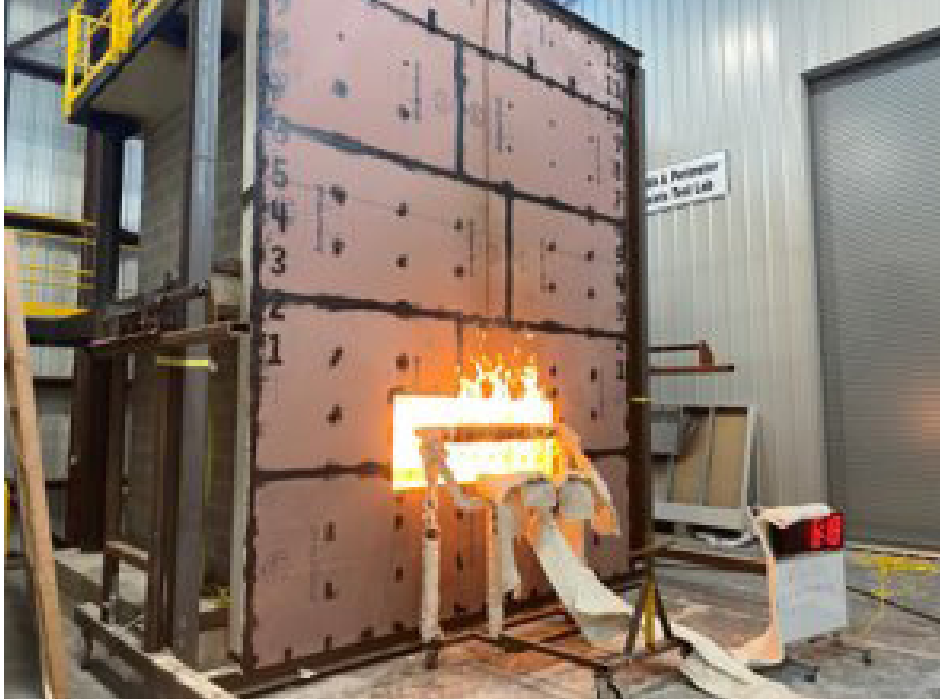
FIGURE 8. NFPA 285 wall assembly while burning from both the exterior and interior.

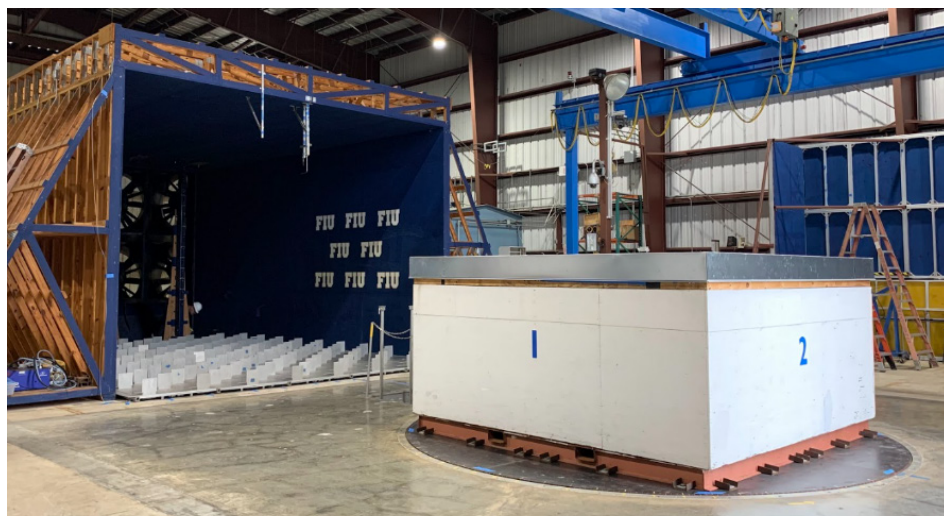
FIGURE 5: Photo of a test deck in the wind tunnel (inactive).

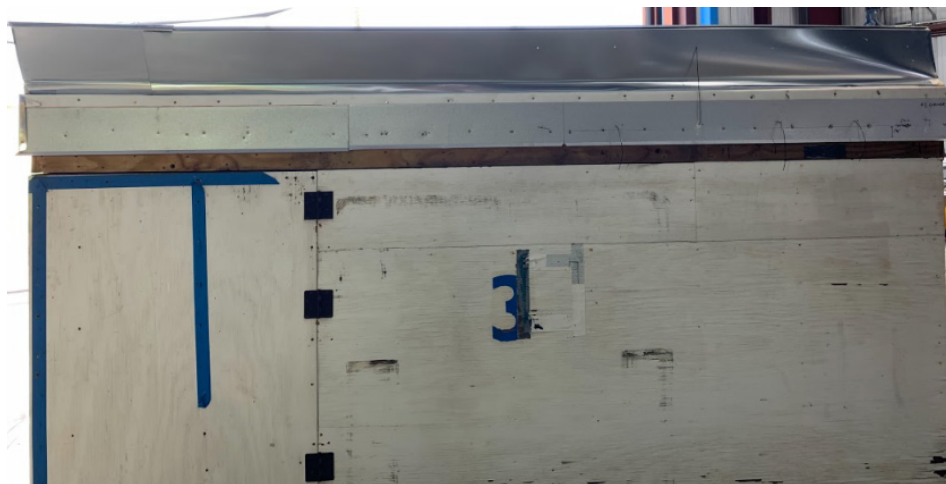
FIGURE 10: Photo of failure mode of Configuration #1.

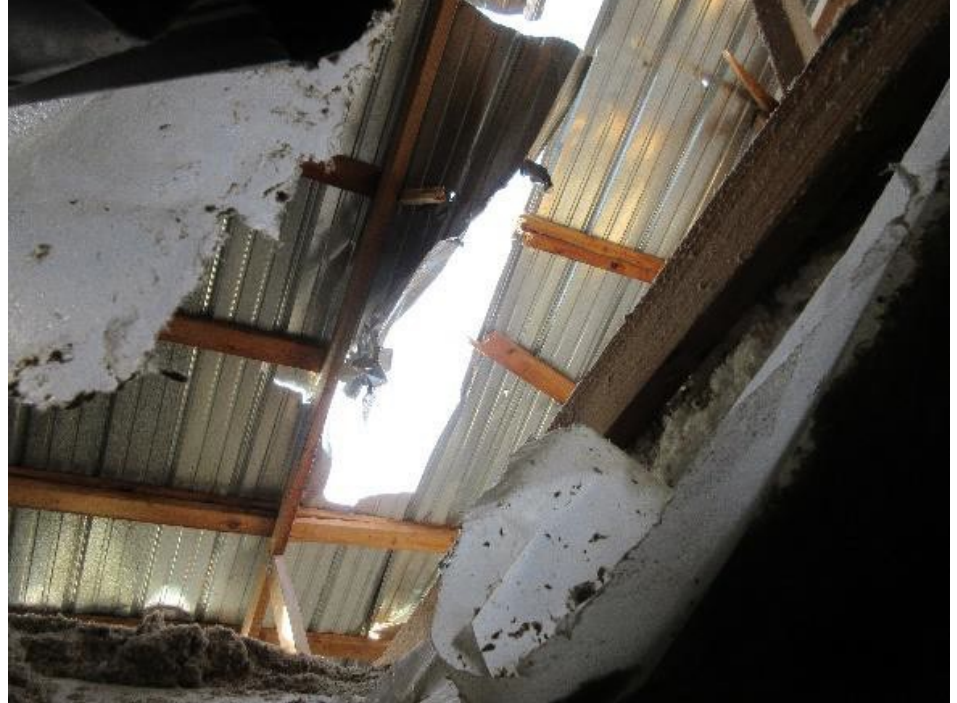
FIGURE 2. Dangerous roof condition with broken and dangling roof members and cladding.

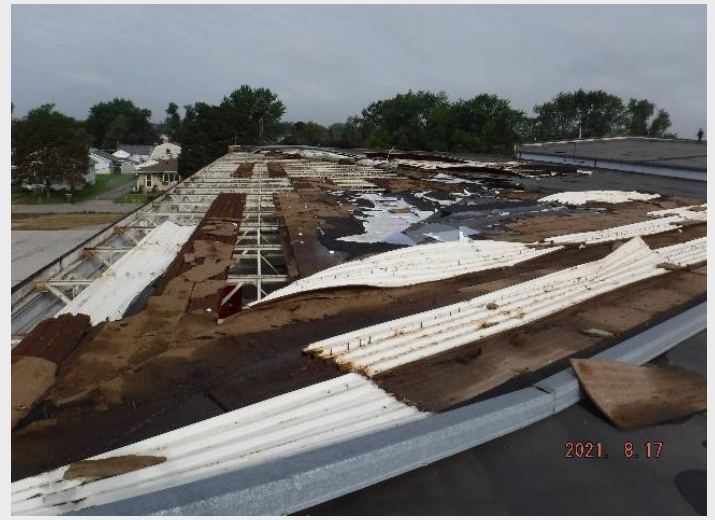
FIGURE 4. Wind damage in the southwest corner of the roof.

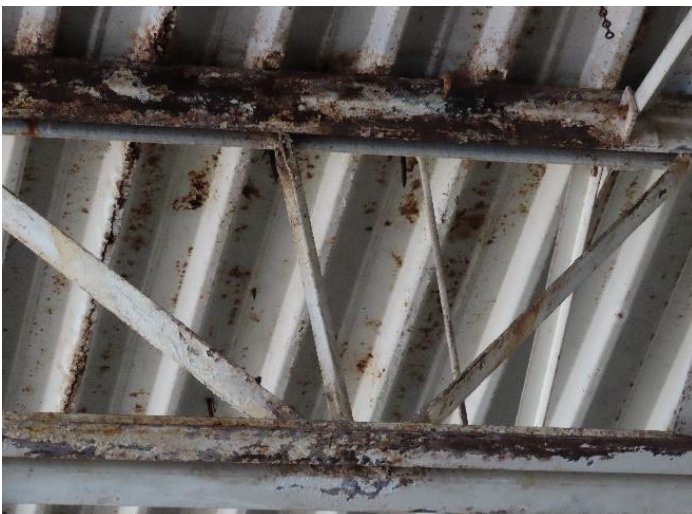
FIGURE 5. Typical metal deck corrosion.

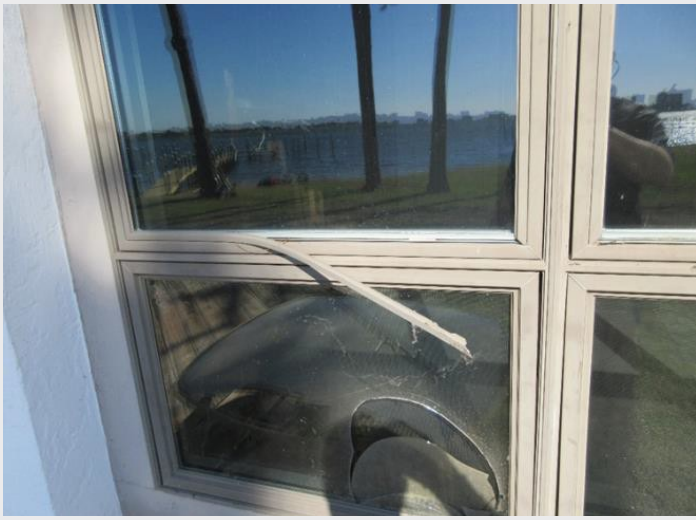
FIGURE 9. Typical window damage (broken lite and displaced glazing bead).

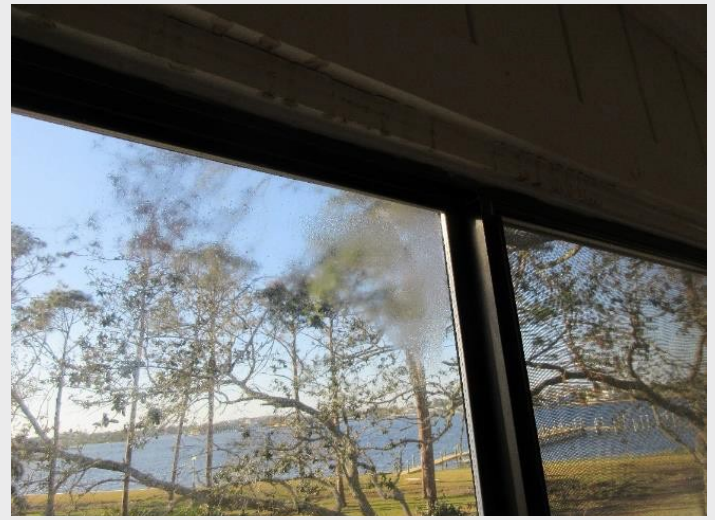
FIGURE 10. Typical window damage (fogged lite).

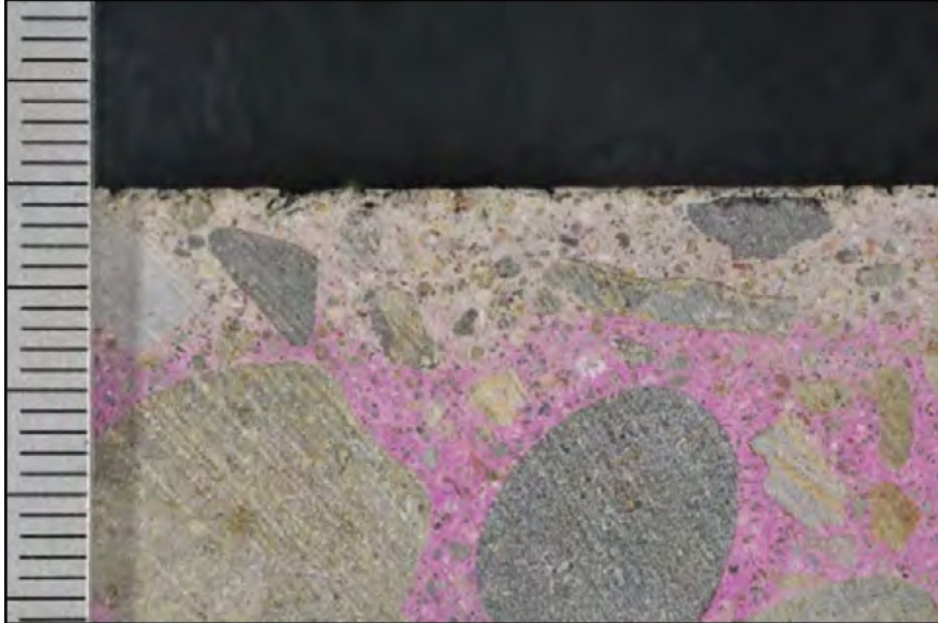
FIGURE 9. Typical view of carbonation results.

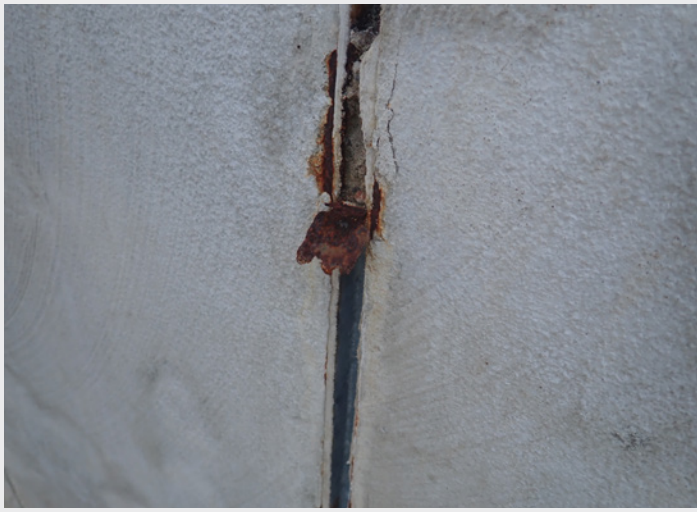
FIGURE 9. Corroded galvanized brick tie.

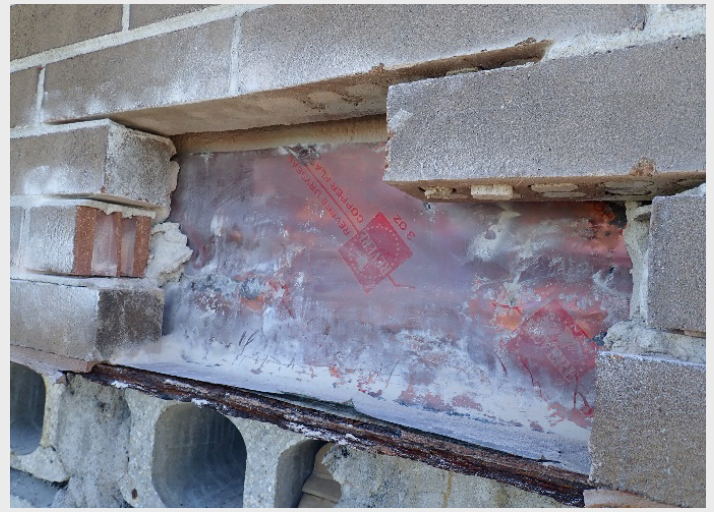
FIGURE 10. View of shelf angle detailing.

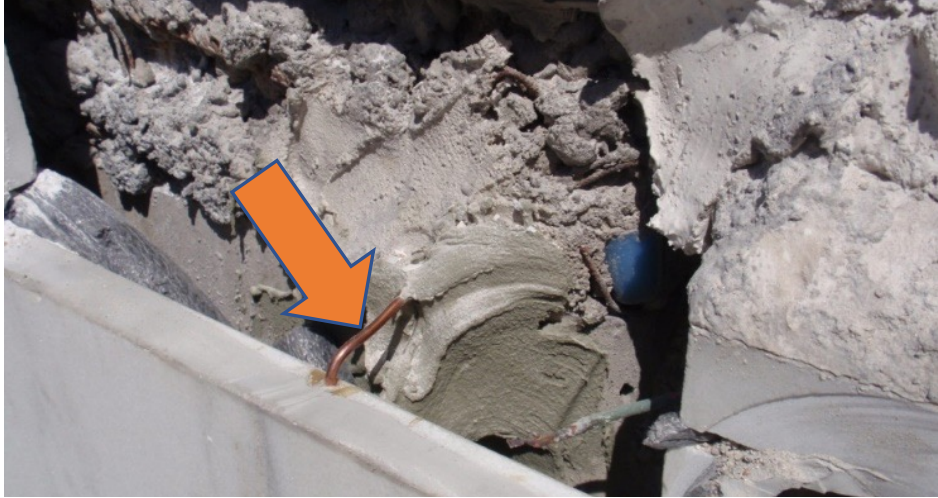
FIGURE 12. View of copper wire ties originally installed as lateral anchors in combination with mortar spots. Note that the wire tie is installed very close to the inside edge of the panel rather than centered.
