PROCEEDINGS

IIBEC

**INTERNATIONAL
CONVENTION
& TRADE SHOW**

PROCEEDINGS TABLE OF CONTENTS

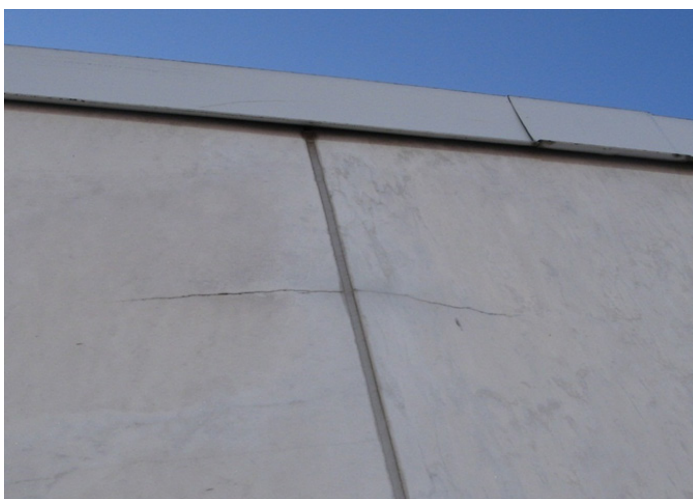
FIGURE 13. View of typical cracking of panels.

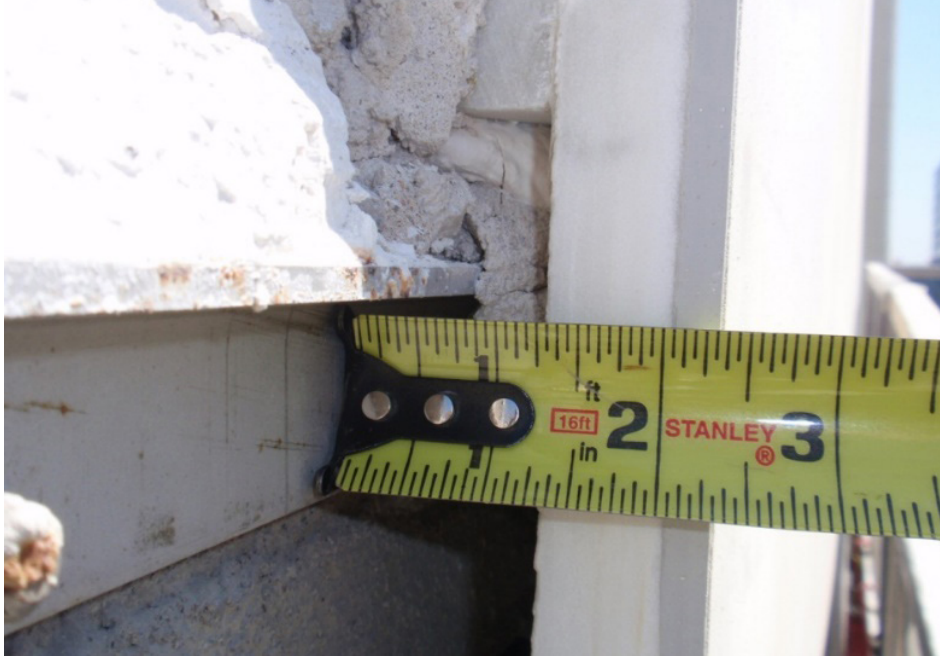
FIGURE 15. Gravity support of panels consisting of a liner block adhered to the back of the panels and bearing on a shelf angle.

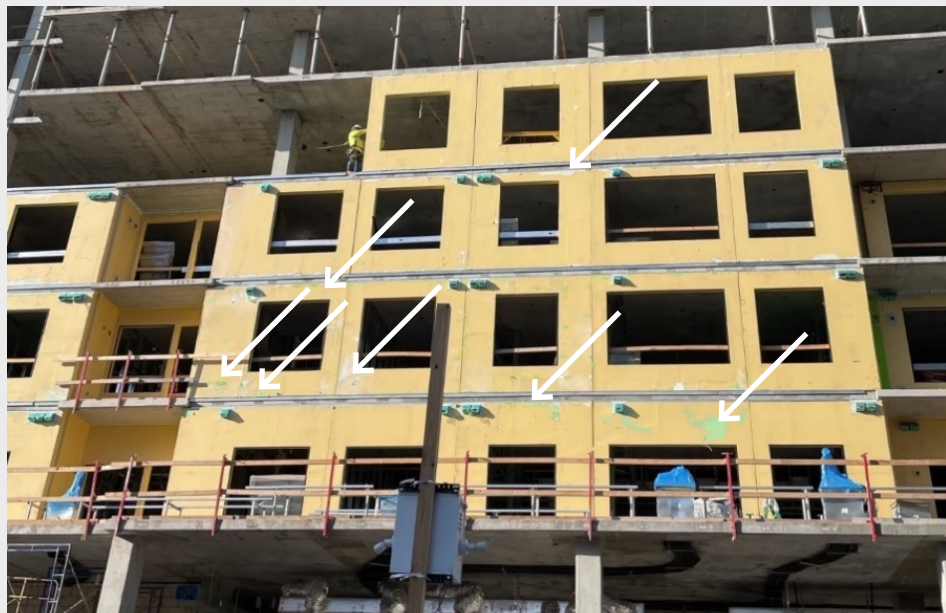
FIGURE 6. Panels with damaged AWB membrane from stacking during transport.
