# Small Unmanned Aerial System Applications in the Building Enclosure Industry: Using Thermal Imaging to Assess Building Performance

By Christopher N. Grey, PE; Kelsey A. Dunn, PE; and Sean D. Gordon

*This paper was originally presented at the 2021 IIBEC International Convention and Trade Show.*

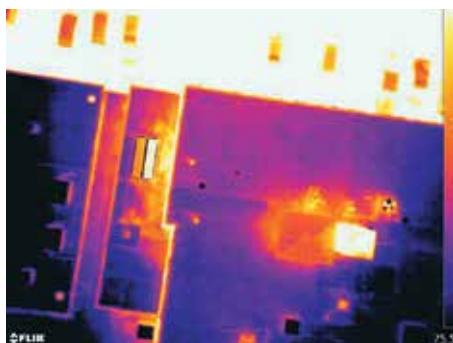
Figure 2. Infrared images from a handheld camera (left) and an sUAS-mounted camera (right).

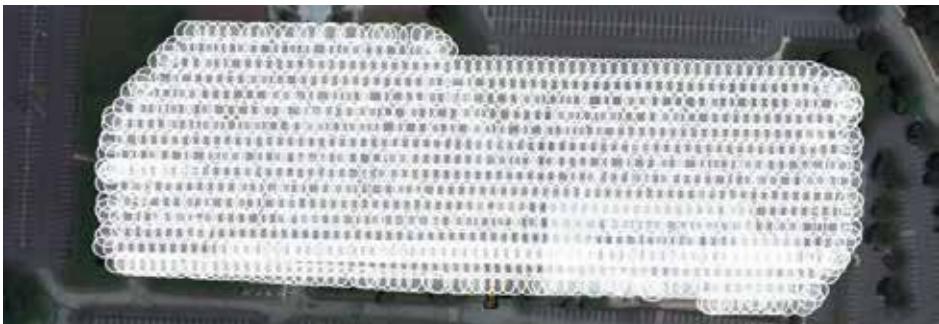
**Figure 6. Image showing every photo taken during the mapping of a roof. Each white circle is one photo.**

**Figures 6 through 9** are representative of a typical deliverable from an infrared sUAS scan of a roof and include the mapping sequence. Figure 6 contains over 1000 close-up overlapped individual images (every white circle is an image). Figures 7, 8, and 9 show an individual image, a stitched infrared image, and a stitched digital image, respectively. These images collectively provide a visual representation of the extent of leakage within the roofing assembly. The stitched infrared image in Fig. 8 shows an existing roofing assembly with numerous large thermal anomalies (lighter yellow areas) associated with roof leakage. The image makes it clear that the water leakage is pervasive and that much of the leakage originates around mechanical units and other penetrations through the roof.

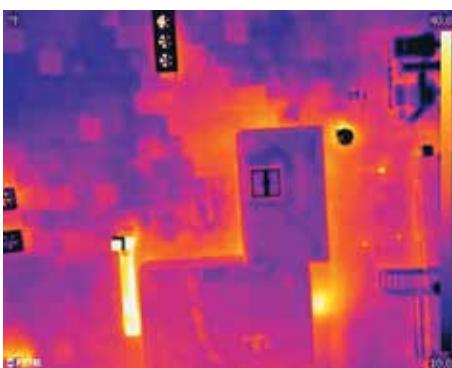
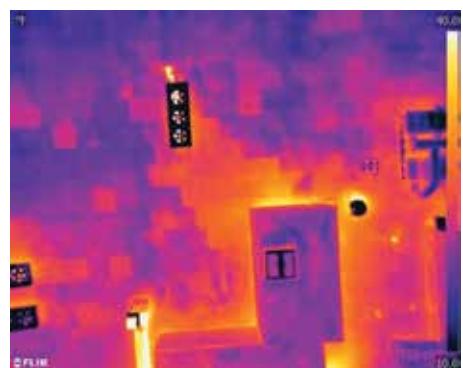
**Figure 7. Sequence of infrared images in one area 50 ft above the same roof shown in Fig. 6, showing the extent of overlap required to create a stitched infrared image.**

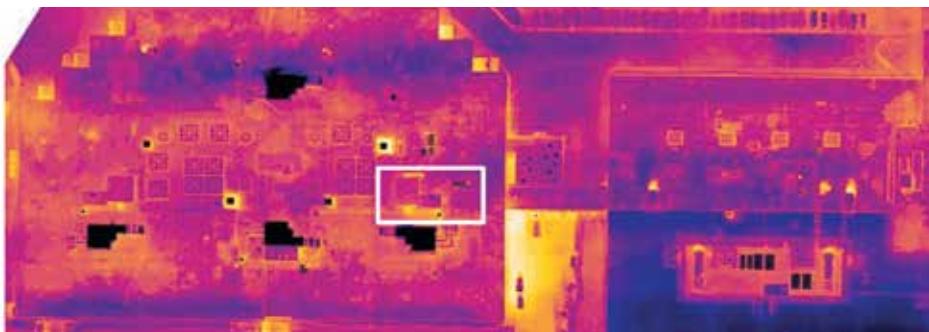
**Figure 8.** Fully stitched digital infrared image of the roof. The white box indicates the location where the three 50-ft images in Fig. 7 were taken.

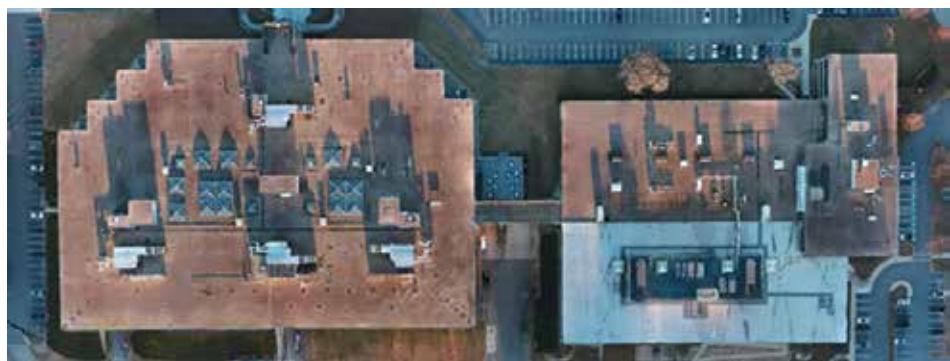
**Figure 9.** Fully stitched digital image of the roof.
