The Retrofit Dilemma: Balancing Deep Energy Goals with the Reality of an Existing Building

ABSTRACT

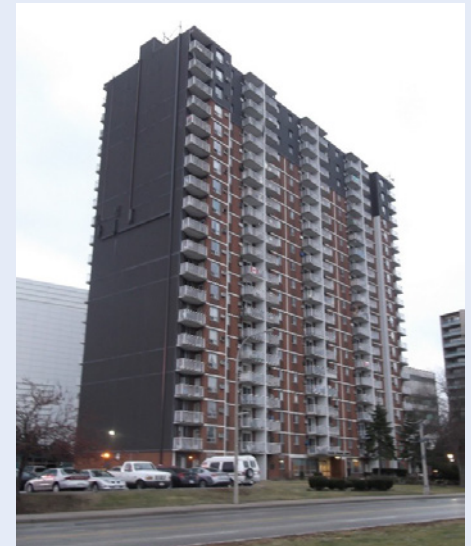
PHOTOGRAPH 1. 255 Riverside Drive (Raymond Desmarais Manor) before the deep energy retrofit.

In 2018, Raymond Desmarais Manor was a 43-year-old through-the-wall (TTW) brick building that both looked and performed its age. With significant capital expenditures on the horizon to maintain the building (**Photograph 1**), the owner, Windsor Essex Community Housing Corporation, saw an opportunity to make a change for the better. From that point on, this 20-story, 300-unit high-rise nonprofit housing building began its transformation guided by the EnerPHit standard—the most rigorous energy standard for existing buildings today.¹ EnerPHit is considered the most rigorous energy retrofit standard because it applies the stringent principles of Passive House to existing buildings, with strict performance-based criteria for energy use, airtightness, and thermal comfort, ensuring deep energy savings while accommodating the limitations of retrofit projects. This journey would lead to drastic changes to the interior building systems and, fittingly, a drastic change to the building exterior—worthy of its iconic location on the Detroit River, next to Caesars Palace in Windsor.

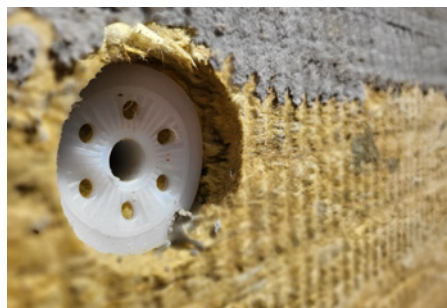
PHOTOGRAPHS 2 & 3. Photographs 2 and 3. Stage 1 fastener through mineral wool insulation, countersunk to allow for insulation plug and stage 2 fasteners installed over the fully cured base coat.

The quantity and placement of fasteners can significantly affect the thermal performance of a wall assembly by introducing thermal bridging. To mitigate this, a thermally broken anchor system was implemented. In the first stage, fasteners were installed with countersunk plastic sleeves, which were then fully covered with a 25 mm cap of mineral wool insulation to minimize thermal conductivity across the assembly (**Photograph 2**). The second stage employed flush-mounted sleeves, each capped with a small insulating plug positioned directly over the screw head (**Photograph 3**).

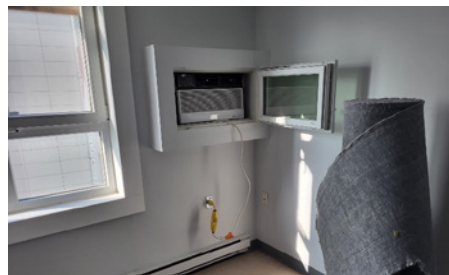
PHOTOGRAPH 4. Completed window enclosure for the through-the-wall A/C system.

The final installation, which can be seen in **Photograph 4**, is functioning well, with some resident education required to ensure that during the winter months, the unit is disconnected and the window closed and latched. It is interesting that, to ensure that the window cannot be closed while the unit is running, it was decided to leave the electrical connection running through the window opening, in lieu of running it through the base of the new enclosure—a simple but effective failsafe.

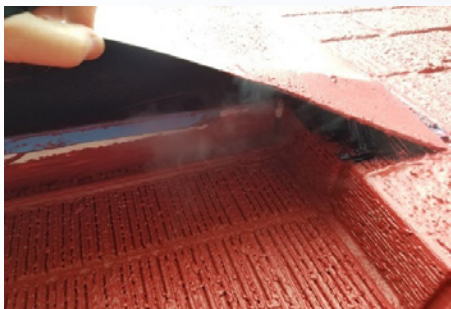
PHOTOGRAPH 6. Poorly bonded transition membrane, with tracer gas leak during diagnostic airtightness testing.

One of the most frequent issues during construction was at the transition membranes, where insufficient pressure rolling prevented full adhesion, and poorly executed cuts (especially at inside and outside corners) left unsealed gaps. These gaps were uncovered during diagnostic airtightness testing, where the building interior was pressurized and tracer gas was released to locate leaks. An example of one such leak is shown in **Photograph 6**.

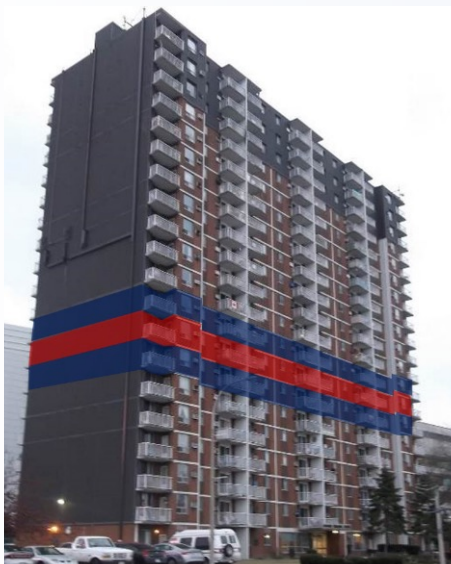
PHOTOGRAPH 7. Sample of guarding for a whole-floor test, with the test floor in red and the guards in blue.

The plan at Riverside Drive included testing each floor by guarding the floor above and below, as shown in **Photograph 7**, and moving sequentially either up or down the building. The testing is somewhat invasive for the residents, requiring that they not enter or exit the test floor, that their unit doors and all doors within the unit remain open, and that all exterior doors and windows remain closed and latched for the duration of the test, which

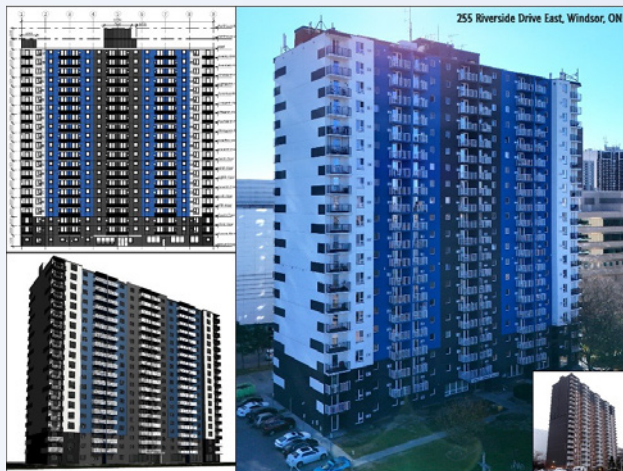
PHOTOGRAPH 8. Original to rendering and design to construction completion—the transformation of 255 Riverside Dr. East.

In the case of Raymond Desmairais Manor, the final decision to certify or not remains to be made. However, with or without it, the seniors who occupy the building can enjoy a significantly improved indoor environment—free from cold exterior walls and drafts and a with noticeable reduction in noise from busy Riverside Drive. Combined with significantly lower utility costs, the final product is one that balances results and reality (**Photograph 8**).
