## CONVENTIONAL AND NONCONVENTIONAL REPAIR OF CURTAIN WALL SYSTEMS

KAMRAN FARAHMANDPOUR,  
FRCI, RRC, RWC, REWC, RBEC, PE, CCS, CCCA, FNAFE

*BUILDING TECHNOLOGY CONSULTANTS, PC*

# Building Envelope Technology Symposium

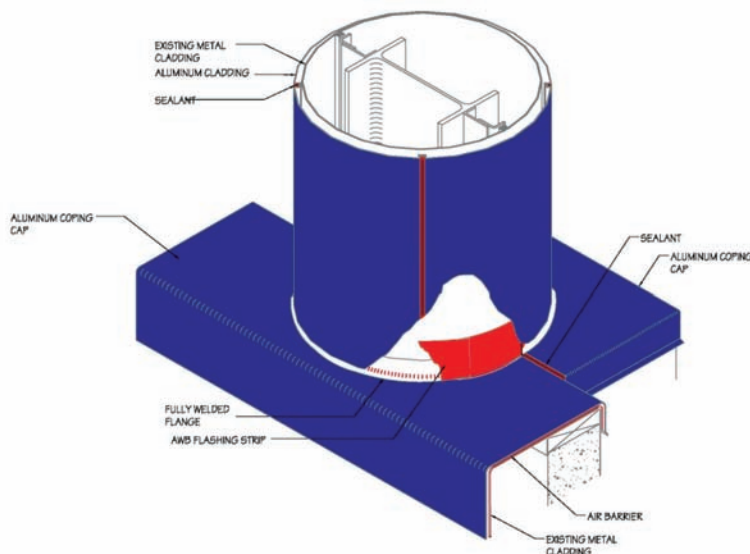
**Figure 4 – Buttress base detail.**

Figure 4 depicts the configuration of new metal cladding at the seventh-floor terrace buttresses. The buttresses were treated similarly to other metal-

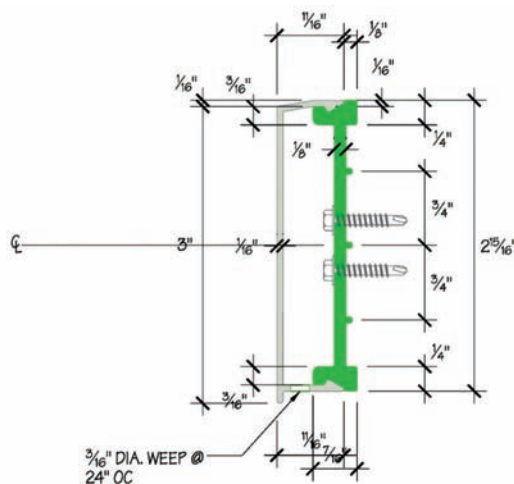
**Figure 5 – Typical extrusion profile.**

All in all, the design required 19 custom-extruded profiles. Figure 5 depicts the design details for a pressure bar and its companion cap. Those profiles were carefully designed to provide for sealant geometry and grooves in the components to allow field technicians to properly locate fasteners. In addition to the custom-extruded profiles, many of the metal cladding components were to be custom-fabricated and prefinished. The specifications required prefinishing of all exposed aluminum components using a fluoropolymer coating meeting requirements of AAMA 2605. The owners opted to maintain the original color scheme of the building. As such, custom colors matching the existing colors were specified for the aluminum finishes, as well as custom colors for the exposed sealant components.

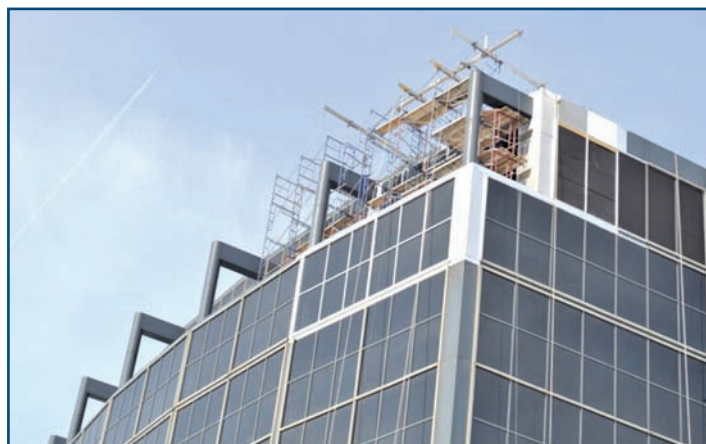
This allowed the use of the building davit system to erect swing-stage scaffolding over most of the façade. However, at the terrace areas, pipe scaffolding was installed to gain access to the building exterior (Photo 10). As is typically done with façade-repair projects, building entrances and entrance canopies were protected with temporary canopies.

**Photo 10 – Pipe scaffolding on setback terraces.**

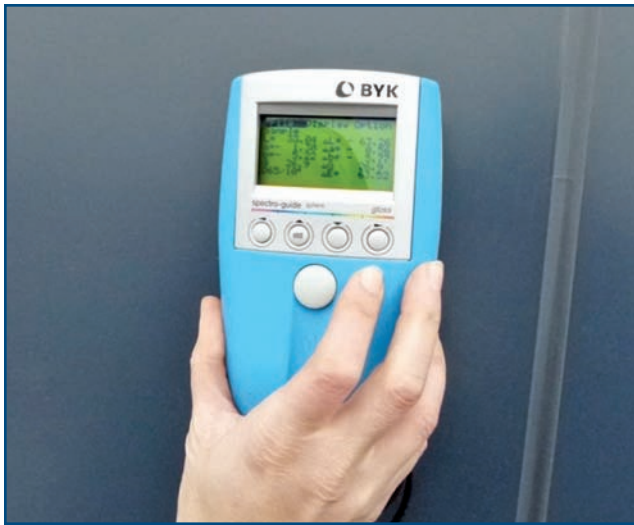
**Photo 11 – Measurements of finish gloss using a color spectrophotometer.**

A preliminary review of the prefinished components revealed inconsistent finish texture and gloss. This triggered a series of inspections and tests by the design team. The design team utilized a color spectrophotometer to quantitatively measure gloss of the finished components (*Photo 11*). The measured values were then compared to limits set by the specified standard (AAMA 2605) and the manufacturer's stated gloss value. The evaluation of the finishing gloss revealed that several curved panels were significantly out of the acceptable range of gloss. As such, those components were sent back to the finisher for refinishing. This issue caused some delays in installing those components and forced the contractor to revise its project sequence.
