## PLAYING AGAINST A STACKED DECK: RESTORATION OF A STONE FIN FAÇADE

**MATTHEW C. FARMER, PE,  
AND  
FREDERICK W. PETERS**

*WISS, JANNEY, ELSTNER ASSOCIATES, INC.*

# PLAYING AGAINST A STACKED DECK: RESTORATION OF A STONE FIN FAÇADE

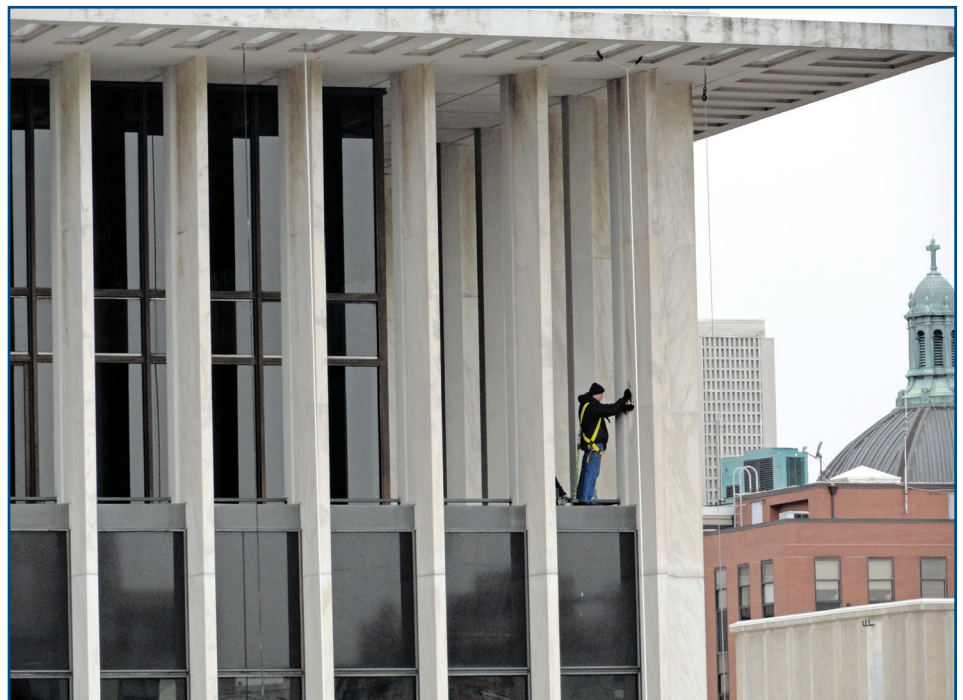
**Figure 4 – Marble fin panels continuing past the ninth-floor terrace.**

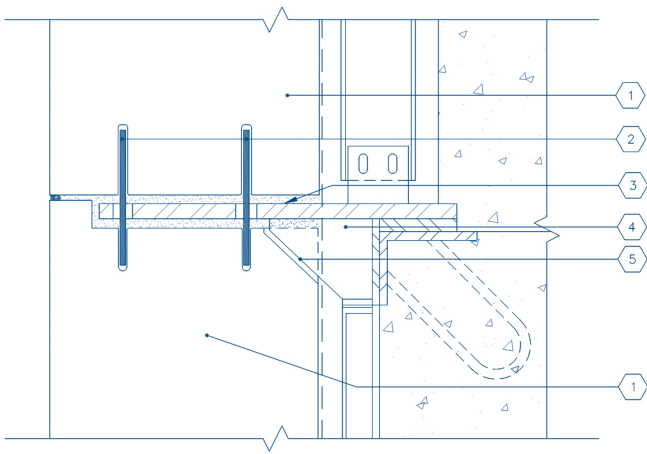
**Figure 5 – Section of the marble fin panel at gravity support at floor lines.**

support the gravity load of two fin panels. The bar has two  $\frac{9}{16}$ -inch-wide by  $1\frac{3}{4}$ -in.-long slotted holes cut for the dowels that secure the fin panels above and below to the bar. Two noncorrosive  $\frac{1}{2}$ -in.-diameter by 1-ft.-long dowels are shown centered in the slotted holes of the steel bar.

The marble fin panel directly below the stiffened bar is rabbeted to receive the bar and slotted to receive the plate; the space around the hardware is filled with mortar. The two marble fin panels at each floor meet at an intermediate joint between the floor lines. They are secured to each other at this joint with two or three steel dowels (depending on location) to create a rigid connection, but there is no attachment back to the structure (see *Figure 6*). The joints between fin panels at both the gravity support and the intermediate connection are filled with mortar, with sealant applied to the outer surface of the joints.

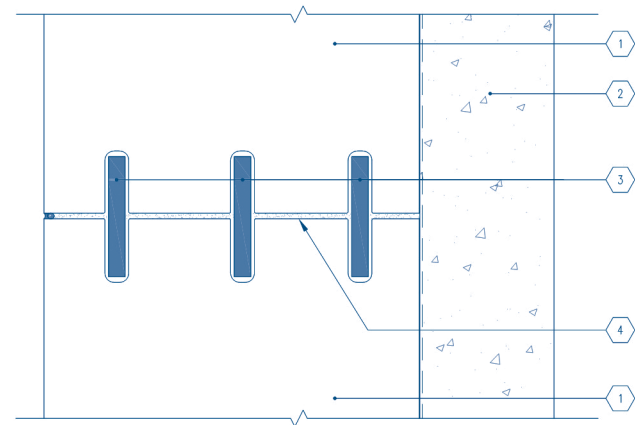
**Figure 6 – Section of the marble fin panel intermediate joint between floor lines.**

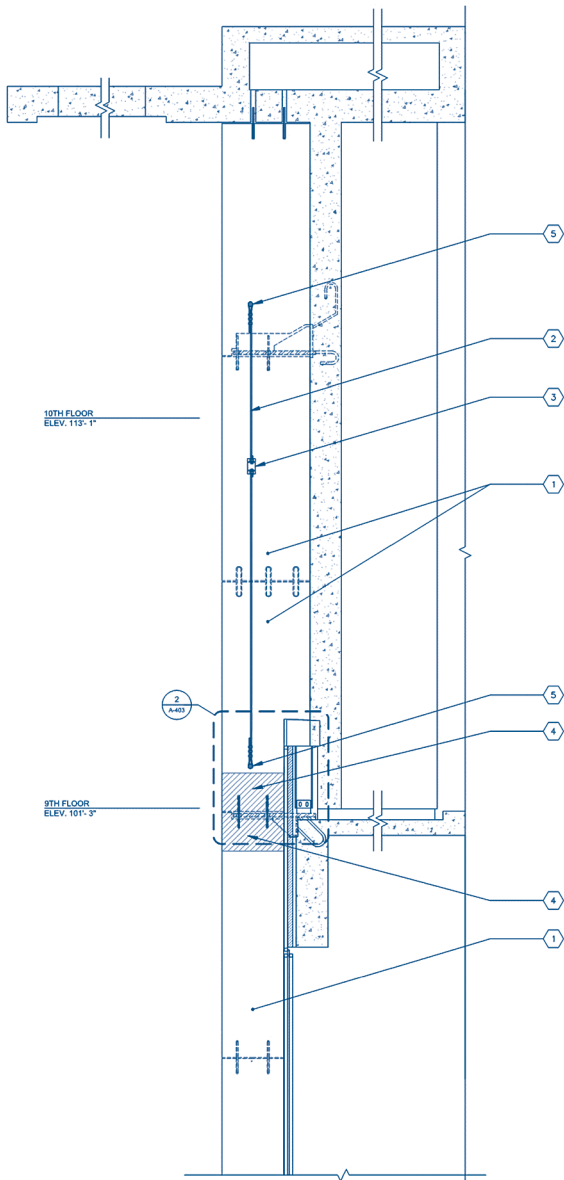
**Figure 15 – Conceptual drawing of proposed suspended panel support system.**

After considering several options such as material hoists, independent gantries, and other methods of removing the panels needed to effect the repairs, a novel concept was developed in which the undamaged panel supported by a damaged panel would be temporarily supported by the next highest gravity support connection. The undamaged panel could be “suspended” from the panel above the gravity support, transferring its weight to the gravity support above, allowing work to be performed on the damaged panel below (see Figure 15). Structural calculations of the gravity support connection demonstrated that there was sufficient capacity for the connection to temporarily carry the additional panel weight (a 50% increase in dead load).

1. Stone panel to be inspected to determine required repairs
2. Suspended panel support system (Figures 15 and 16)
3. Stone panel with damage above bearing
4. Holes to be drilled into stone to remain
5. New dowels inserted into new holes
6. New stone panel Dutchman to match
7. Steel bearing support anchorage of panels
8. Slot and rebate in existing stone panel
9. Bearing joint at stone panels. Fill with mortar.
10. Drill new holes into existing stone.
11. Stone panel damaged below bearing
12. New stone panel Dutchman

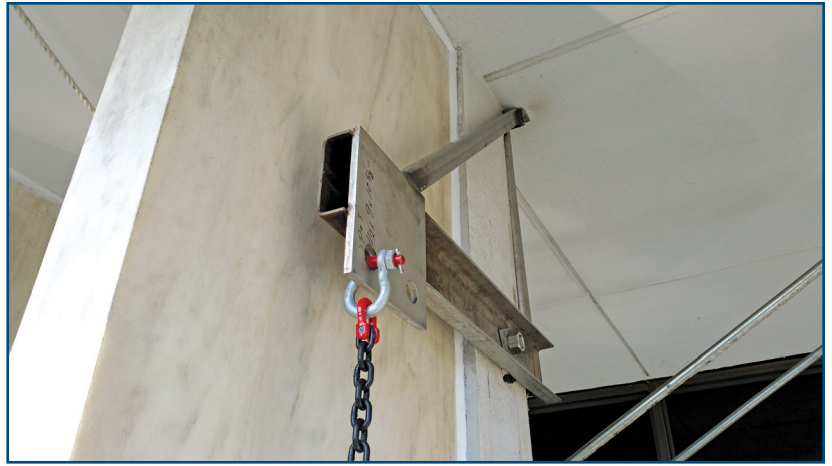
**Figure 16A (above) – Custom-built steel support frame installed on both sides of panel and anchored into the concrete column and overhang.**

panel was removed. The change was agreed to, and the work proceeded (see Figure 16). Chains were suspended from the columns at the tenth floor and secured to a pipe

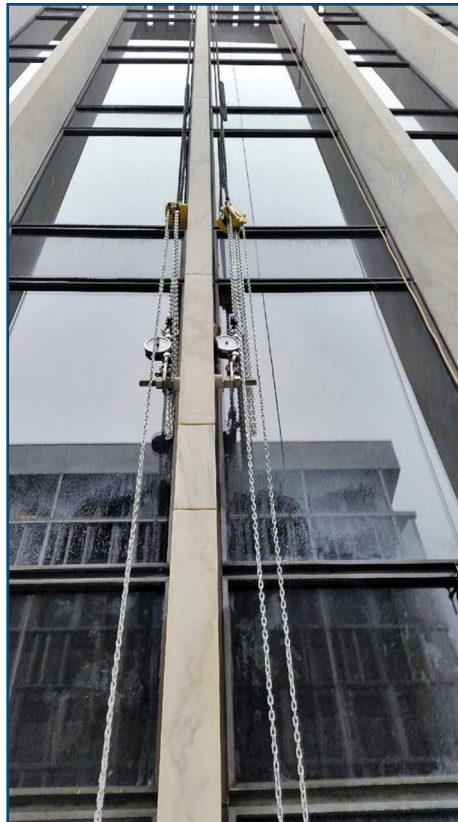
**Figure 16B (left) – Trial installation of stone support system, which included a steel frame (Figure 16A), chain, chain hoists, tensioner, and chain anchored to steel dowels installed through the stone.**
