30th RCI International Convention and Trade Show

INNOVATIVE REPAIRS TO TERRA COTTA PARAPETS AND CORNICES

STEVEN P. BENTZ, RBEC, PE, AND MICHAEL PAYNE, EIT

FACILITY ENGINEERING ASSOCIATES, P.C.

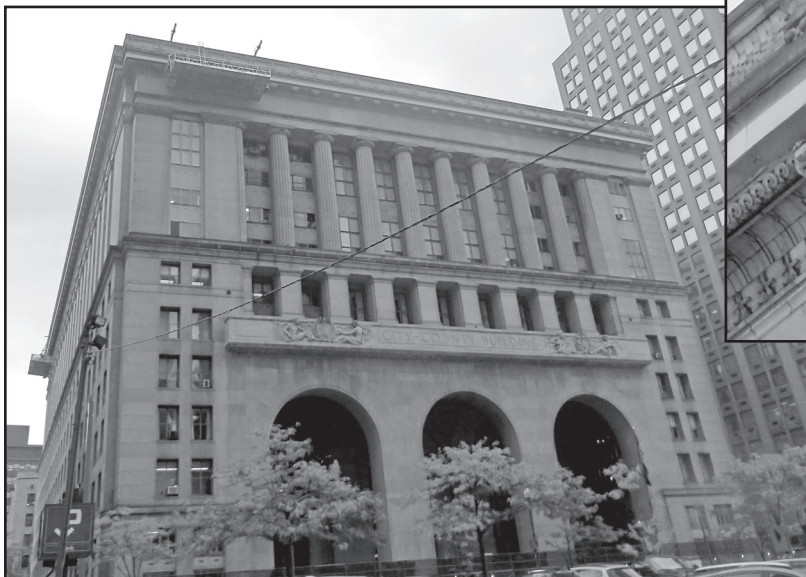
The subject property, seen in *Photo 1*, was a nine-story historical municipal government building constructed in 1913 and occupying an entire city block in Pittsburgh, Pennsylvania. The 144-foot-tall building was built with a structural steel frame and structural clay tile floor system. The exterior cladding was comprised of granite and terra cotta masonry, including an ornate terra cotta cornice and parapet (see *Photo 2*). In 1968, the building was recognized as an historical landmark by the city. Maintenance of the parapet and cornice had been deferred for many years.

Photo 1 – Façade overview of the subject building.
