# ACCESSING THE ARCH

By Remo Capolino, RRC, PE;  
and Christine Freisinger, SE, PE

**Location:** St. Louis, Missouri  
**Client:** National Park Service

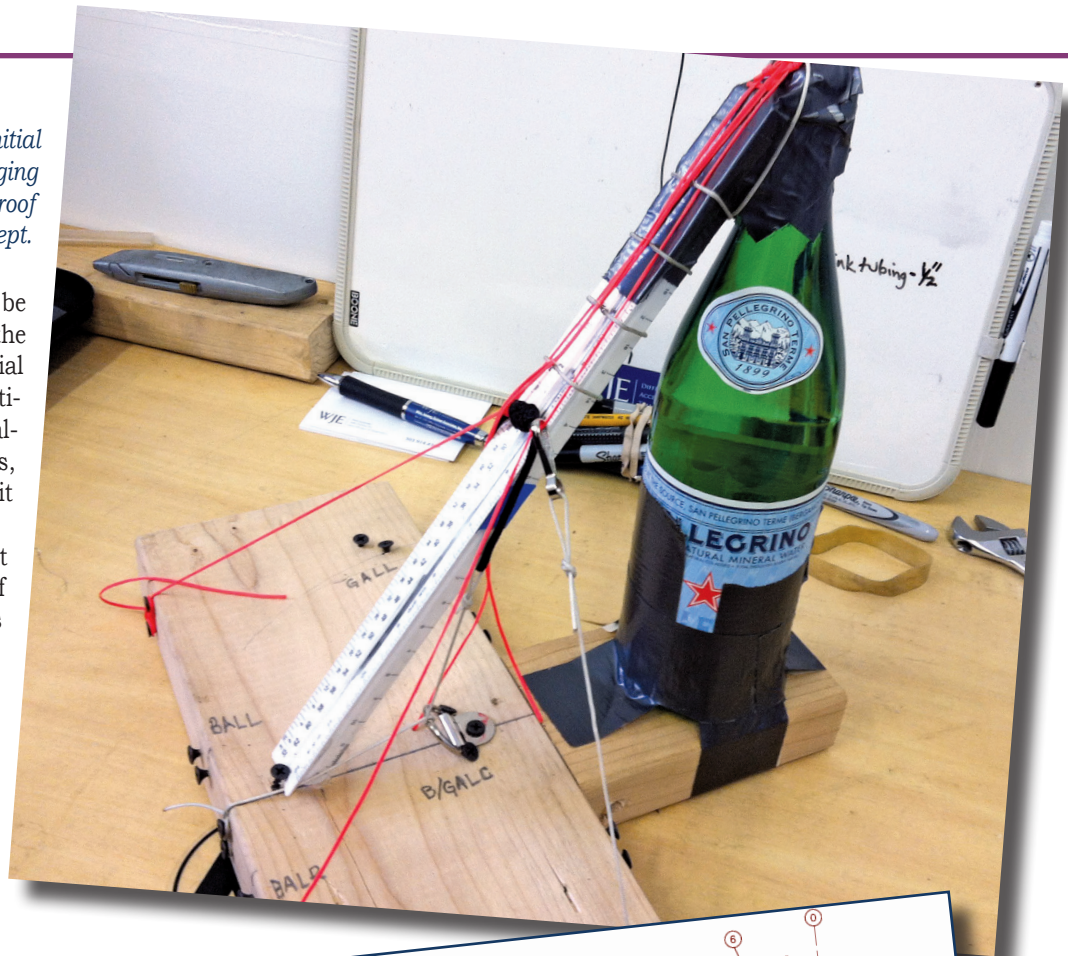
The WJE Difficult Access Team custom-designed an industrial rope access (IRA) system specifically for this project. Like many things large and complicated, the rope access system design started small and simple in the form of a rough model built in a home workshop. An engineer's scale was used to simulate the triangular shape of the structure, then string and wires were used to simulate the rigging that needed to be installed (Figure 2).

*Figures 2 – Initial mock-up of rigging concept and proof of concept.*

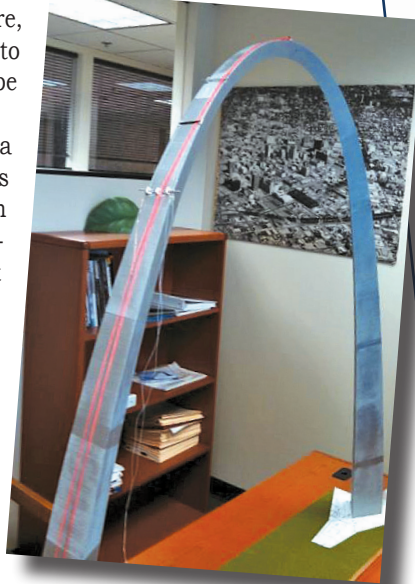
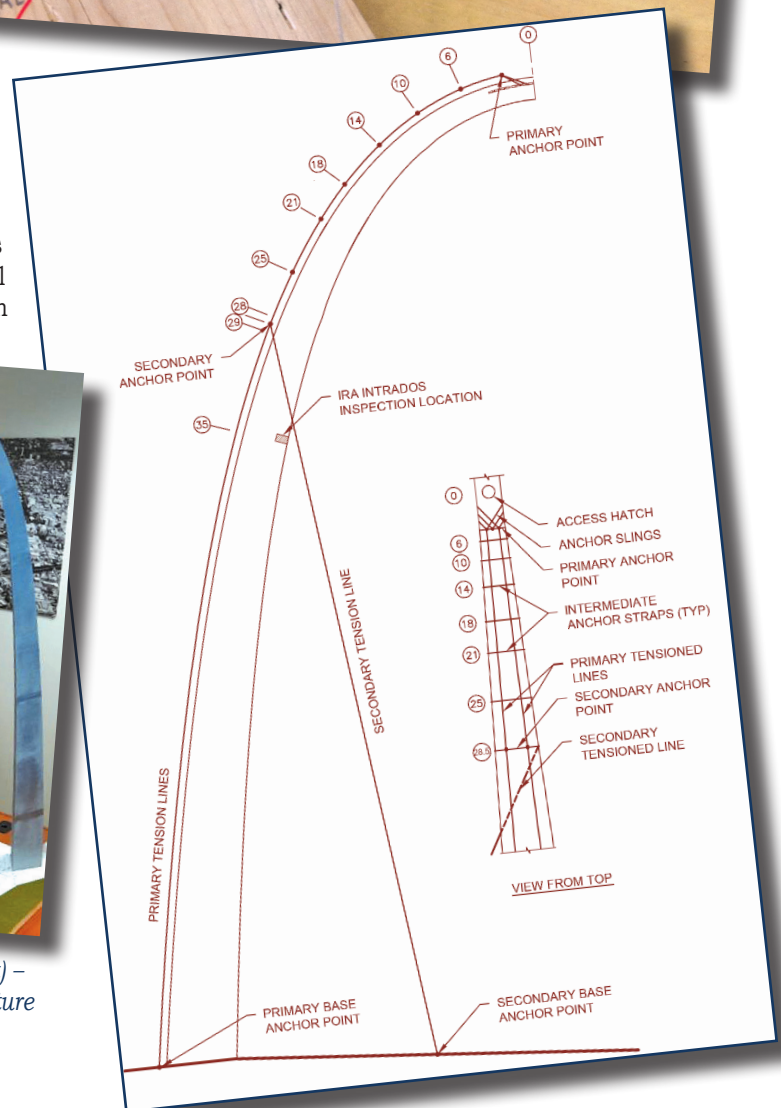
As the design progressed, a three-dimensional scale model was printed to replicate the Gateway Arch and to assure the system would provide access to the areas of interest during the site investigation (Figures 3A and 3B).

*Figures 3A (above) and 3B (right) – 3-D printed scale model of structure showing the custom IRA system.*
