Journal of the Roof Consultants Institute

Interface

November 2000
Vol. XVIII, No 11
\$7.00

**INSIDE: EIFS,
CURTAIN WALLS,
&
MASONRY**

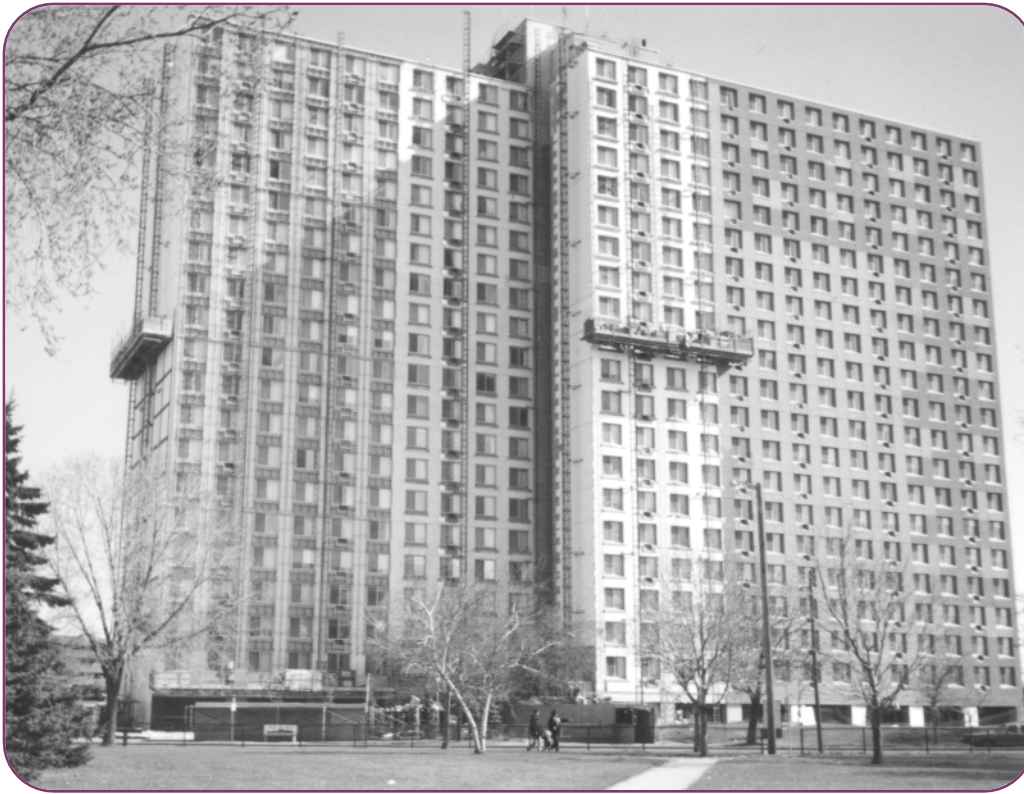
Figure 8—Elevation showing numerous windows.

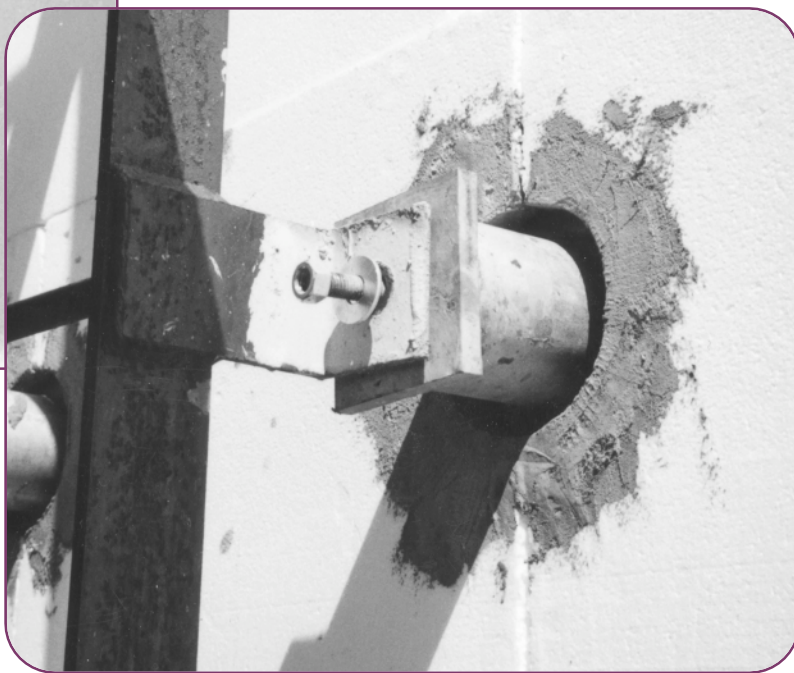
Figure 12—Stand-off ladder bracket.

Stand-off Mounting Hardware for Appurtenances—Based upon numerous investigations of buildings having distressed EIFS applications, an attempt was made to provide specific details to support and mount various appurtenances through the EIFS assembly and onto the building structure. These appurtenances included fixed ladder brackets, sheet metal downspouts, and communication antennae. Each of these items could produce an undesirable penetration or opening through the new EIFS lamina if not detailed properly. Accordingly, special fabrications were utilized to create stand-off mounting hardware that secured the appurtenance with minimum disturbance of the EIFS lamina. See *Figures 11 and 12*.

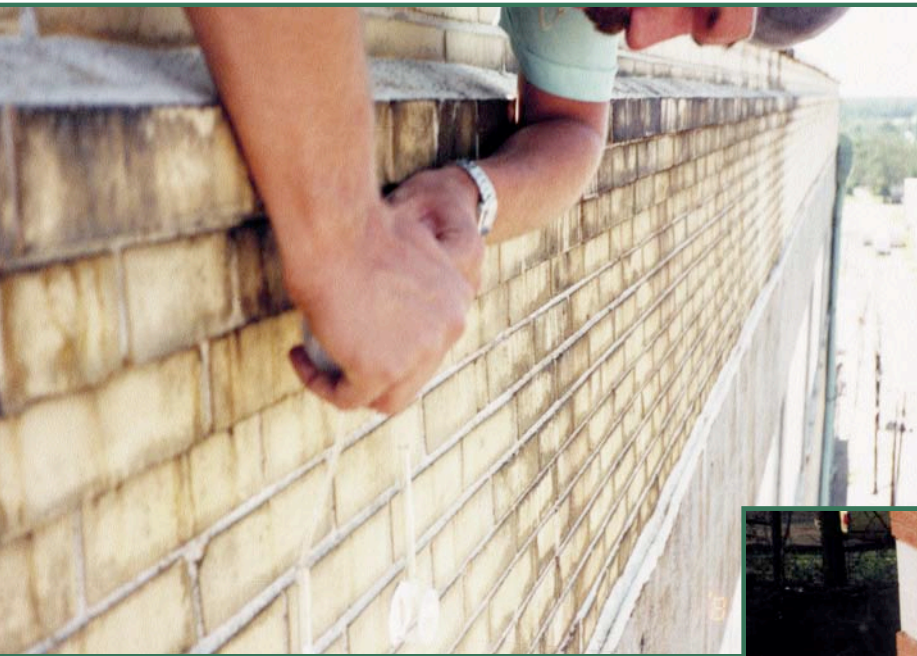
Figure 5—One method for determining the rate of water absorption into brick masonry construction is the RILEM tube test. Unfortunately, the test results are often misunderstood or misapplied. While quite valid for evaluating water-repellent treatments, the test is often meaningless for evaluating a chronically leaking wall.

One method for determining the rate of water absorption into brick masonry construction is the RILEM² tube test (Figure 5). Unfortunately, the test results are often misunderstood or misconstrued. Since, as stated earlier, brick masonry is known to absorb water, confirmation of such behavior by testing is of marginal utility. Absorption rates on the brick surface are different than within the mortar joint region. Head joints will absorb at a different rate

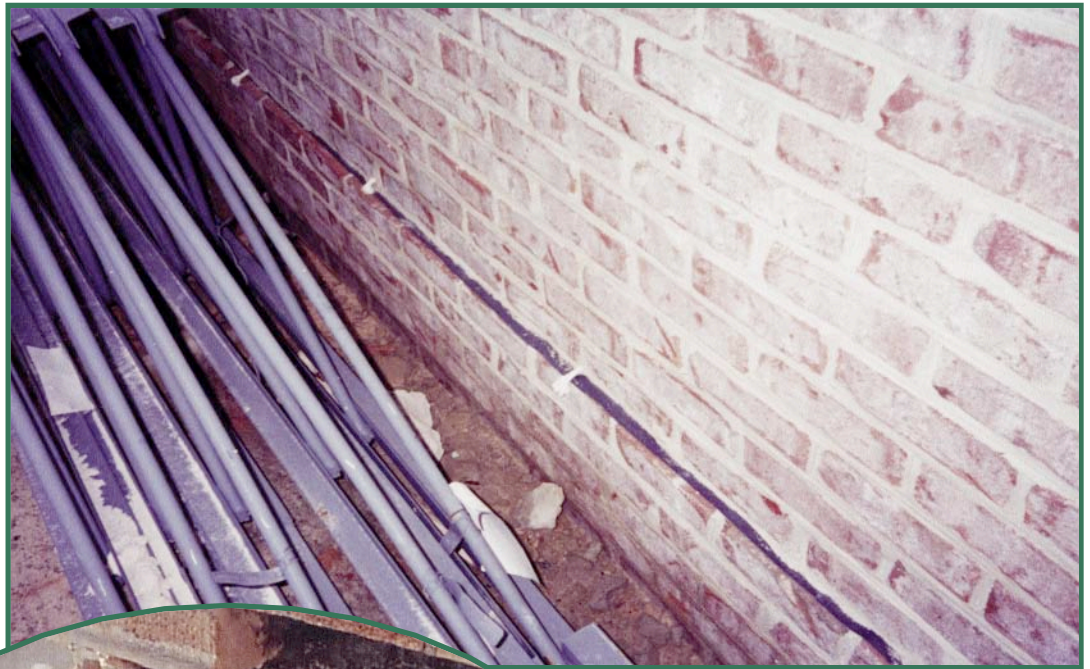
drainage, but rope wicks can also be used to attract water from the cavity⁵ (Figure 8).

Above: Figure 8—Weep holes may be detailed with rope to attract water from the cavity of this wall.

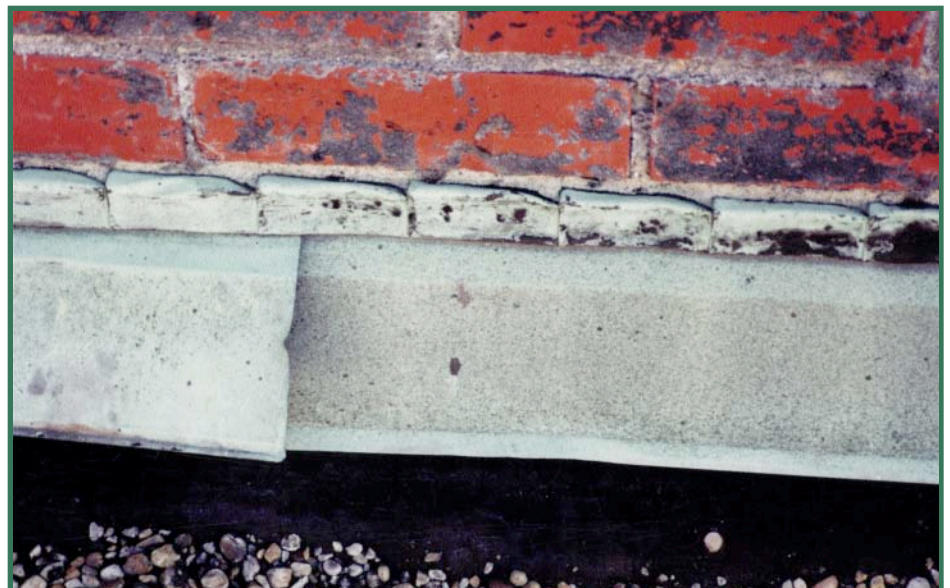
Historically, copper was the product of choice to direct water from a cavity (Figure 10). The material is easy to form and work. Joint work (miters, corners, laps, etc.) could be effectively closed with block tin solder.

Figure 10—Historically, copper was the product of choice as flashing. The material is easy to form and joints can be closed with block tin solder.

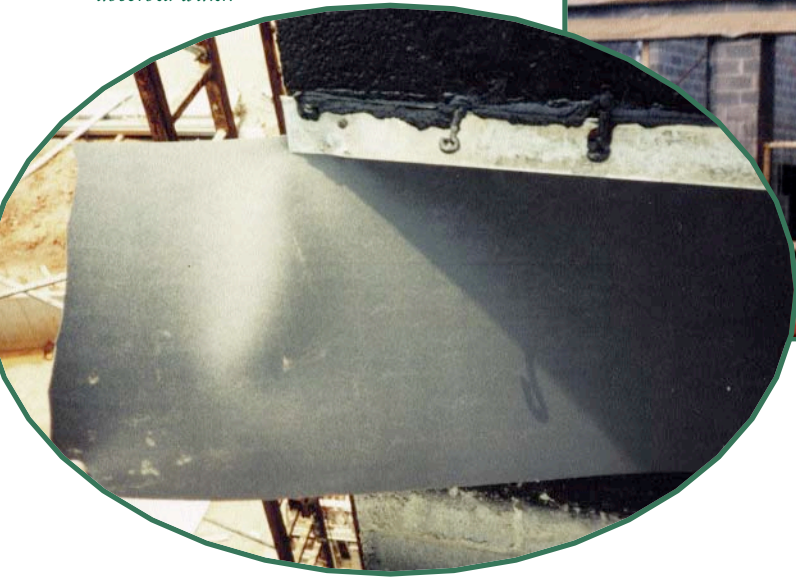
Polymeric membrane products have been successfully substituted for conventional thru-wall metals (Figure 11). These membranes are usually PVC (polyvinyl chloride), although long-term durability in such application has been questioned. Asphalt-coated copper is also in wide use as a thru-wall component (Figure 12). It is easy to shape and can offer functional diversion of water.

Below: Figure 11—Polymeric membrane products have been successfully substituted for conventional thru-wall metals (such as copper). Seaming along laps is still necessary for absolute removal of absorbed water.

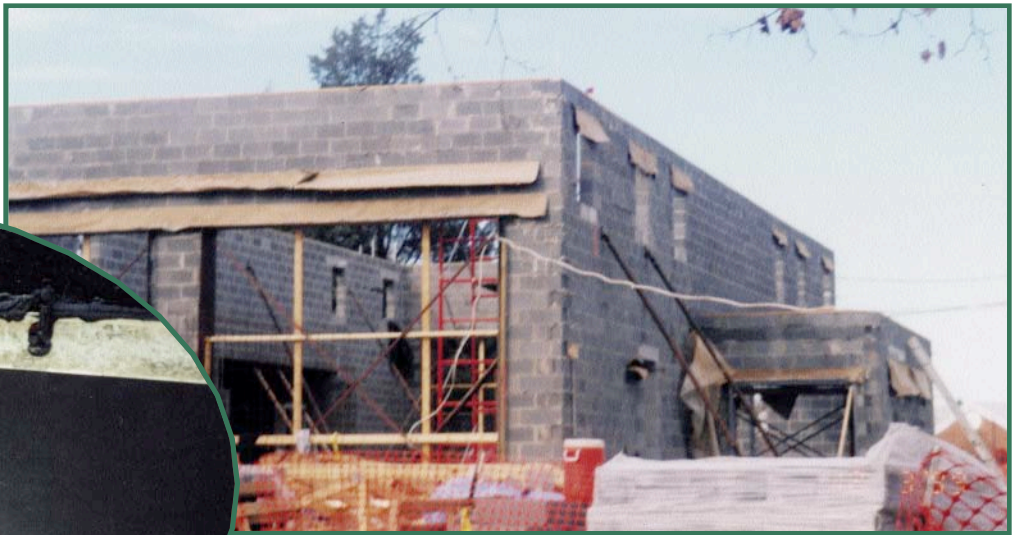
Figure 12—Asphalt-coated copper is now in wide use as the thru-wall flashing. It is easy to shape and can offer functional diversion of water when formed as a continuous component.

joints must be seamed in order to “turn water.” Failure to join the thru-wall materials in a continuous fashion may result in leakage. The difficulty in locating the actual leak culprit will be arduous once the masonry units are installed. It is far better to do it right the first time.

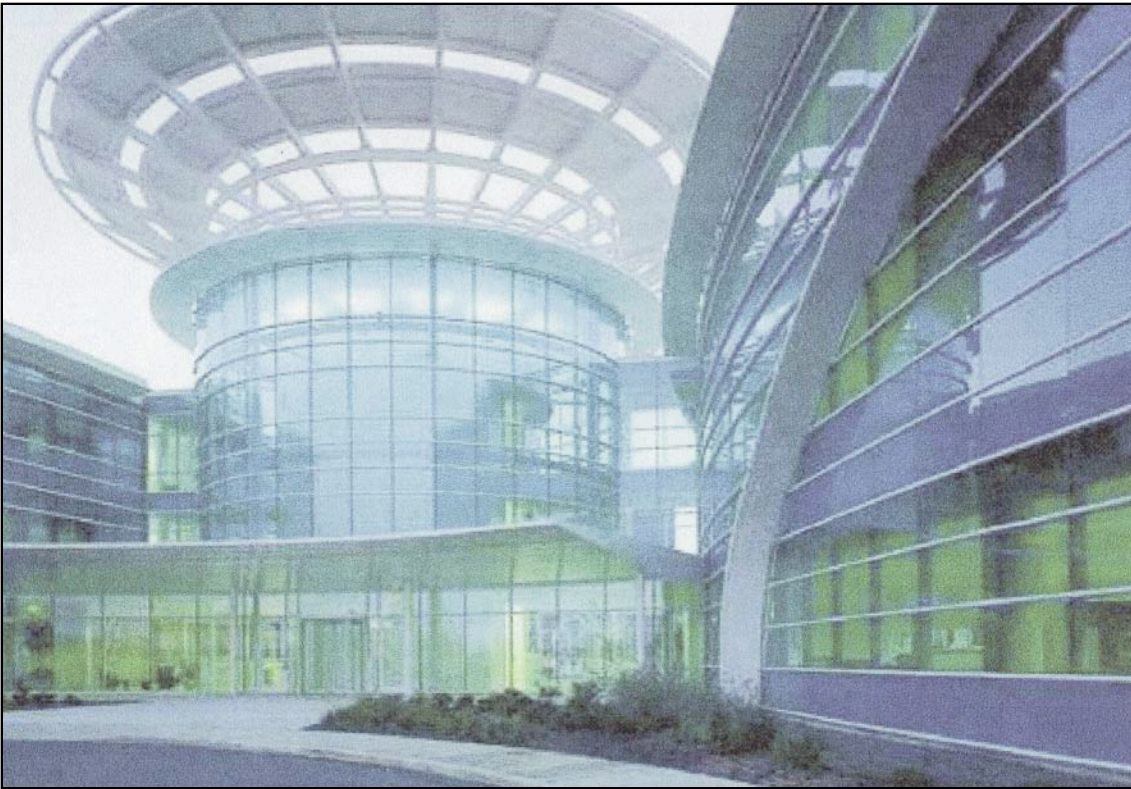
Figure 2—Applied Industrial Technologies, Cleveland, OH. Architect: GSI Architects, Cleveland, OH. Contractor: Turner Const. Co., Cleveland, OH. Glazing Contractor: Architectural Product Sales Co., Brooklyn, OH. Curtain Wall Framing: Vistawall CW-600 and W-250.

Some curtain wall systems combine the dry glazed and face barrier systems together to provide additional design flexibility (Figure 2). Variations of these systems omit the exterior exposed metal from either the vertical members or the horizontal members.

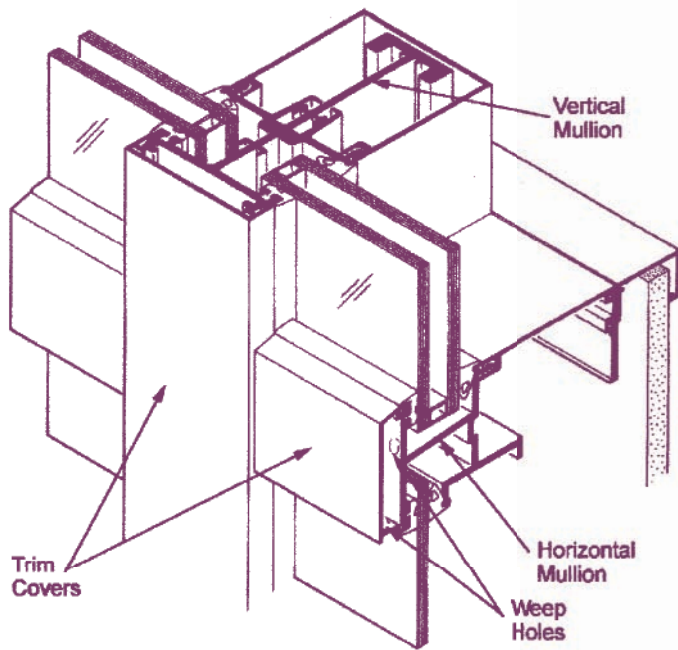
Figure 3—US Aluminum Series 3600 Curtain Wall System. ©U.S. Aluminum

Performance of the dry-glazed curtain wall system relies on sealant at the internal portions of each horizontal-to-vertical frame joint and at each expansion joint of the main frame components. An exploded view of one manufacturer's design is shown in Figure 3. Note specifically how this system is designed to control water. Each vertical mullion runs continuously, with expansion joints intermittently spaced, usually at every other floor. The horizontal mullions are cut to fit between and are attached to the vertical mullions. Sealant is installed at each of these metal-to-metal joints (detail at Figure 4) so that water flowing down the vertical mullion will be diverted into the horizontal. Holes in the outer face of the horizontal mullion allow this water to drain into the horizontal trim covers, and holes in the bottom of the trim cover allow this water to weep out to the building exterior.

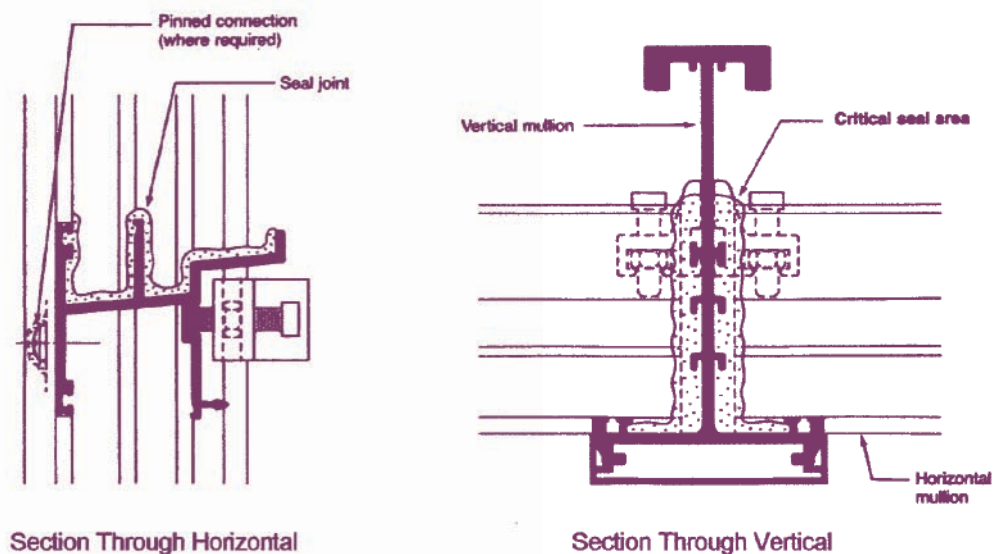
Figure 4—US Aluminum Series 3600 Curtain Wall System. ©U.S. Aluminum
