DESIGN & RENOVATION OF A HIGH-RISE RETROFIT EIFS CLADDING

A C A S E S T U D Y

BY WARREN R. FRENCH, PE, RRC, CCS

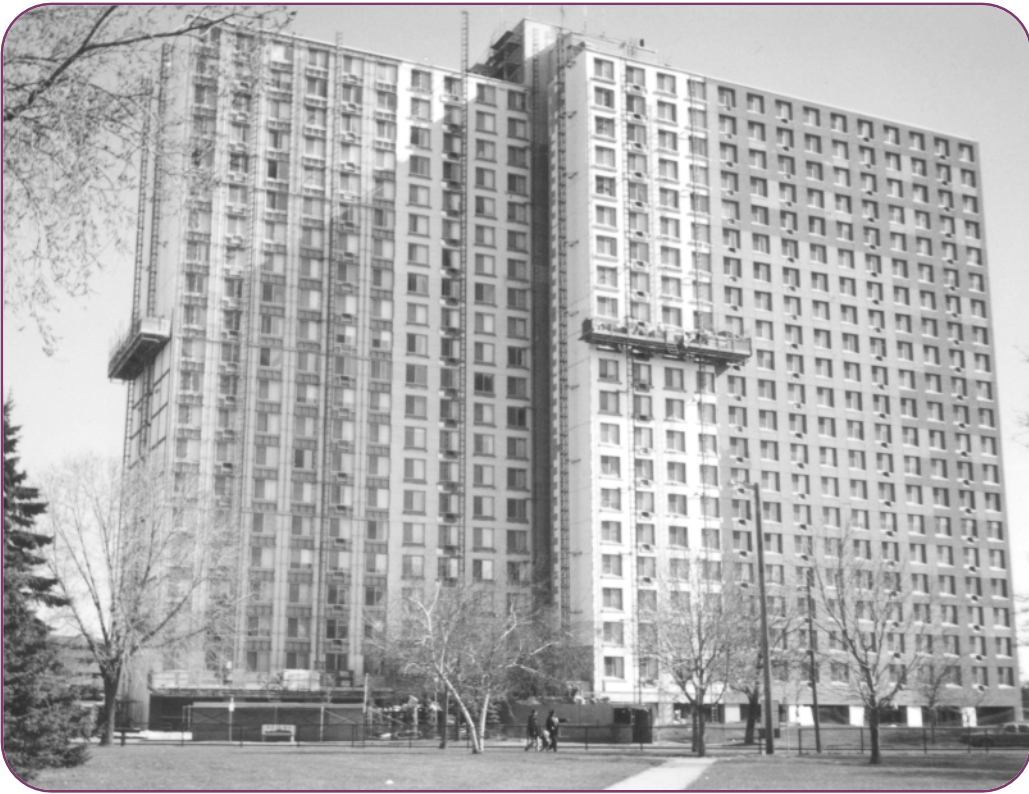
Main entrances occur along the North and South elevations at the offset. The endwalls at all locations feature a vertical recess running the full height of the building. At the East Wing, east endwall, and the West Wing, west endwall, the notch occurs at the building centerline and corresponds to the stairwells at each end. At the half-width endwalls, the notch occurs adjacent to the continuation of the offset building wing. See Figure 8.

Figure 8—Elevation showing numerous windows.
