EVALUATION OF Liquid-Applied Waterproofing Systems:

CASE HISTORIES

By Kami Farahmandpour and Terry Willems

Case 1 - Cincinnati Museum Center Plaza Fountain

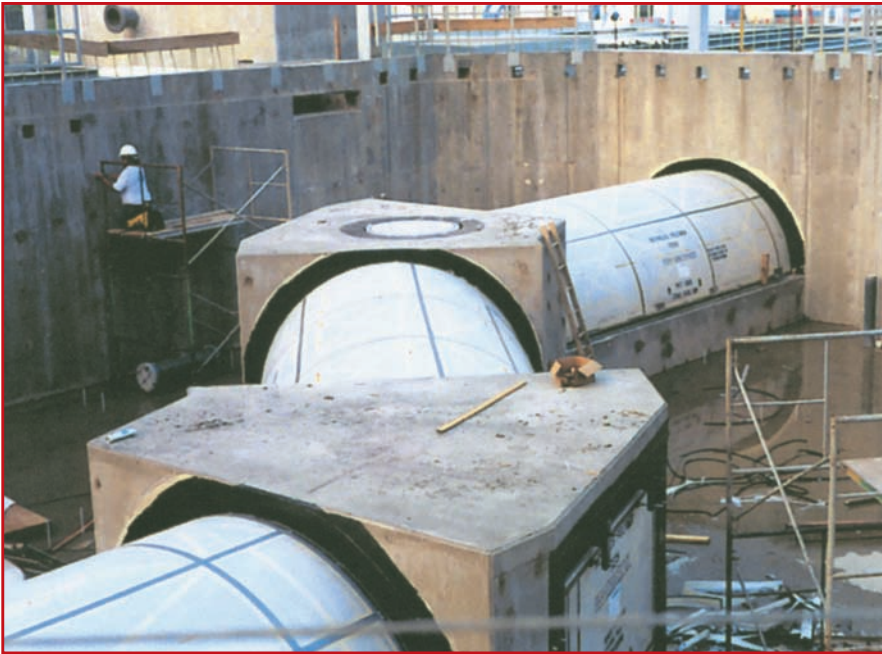
Figure 9 – One of the large marine tanks at Newport Aquarium during construction.

The Newport Aquarium in Newport, Kentucky, was constructed in 1998. The aquarium features several large concrete marine tanks. The marine tanks consist of reinforced concrete walls and floors cast in place using a silica-fume enhanced concrete mix (Figure 9). The floor slabs were cast directly over ground without the use of a vapor retarder. A cementitious pargel coat was applied over the cast concrete surfaces to fill surface irregularities such as bugholes.

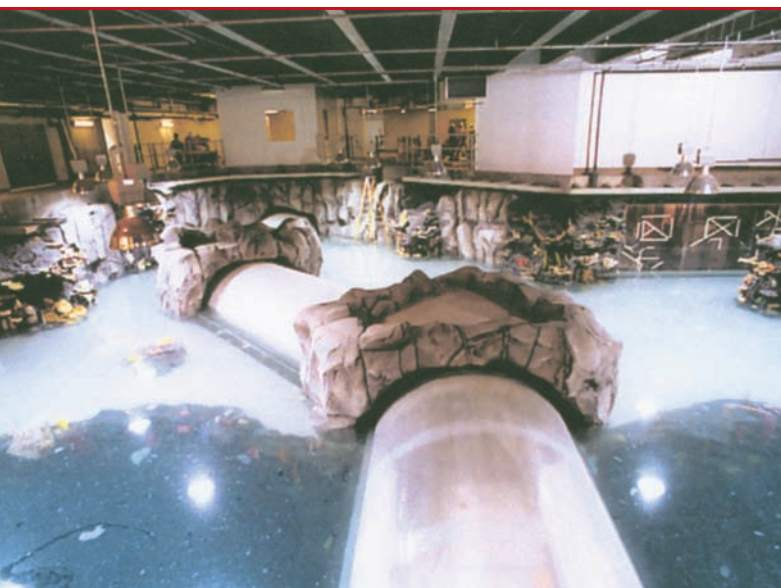
Figure 11 – A marine tank being filled with water.
