SMARF BUILDING CAPE CANAVERAL AIR FORCE STATION, FLORIDA

*Seven
Years
Later*

BY RICHARD (“DICK”) P. CANON, RRC, PE, FRCI
BLAKE S. JOPLIN, EIT
S. THOMAS WATSON, MSCE, EIT

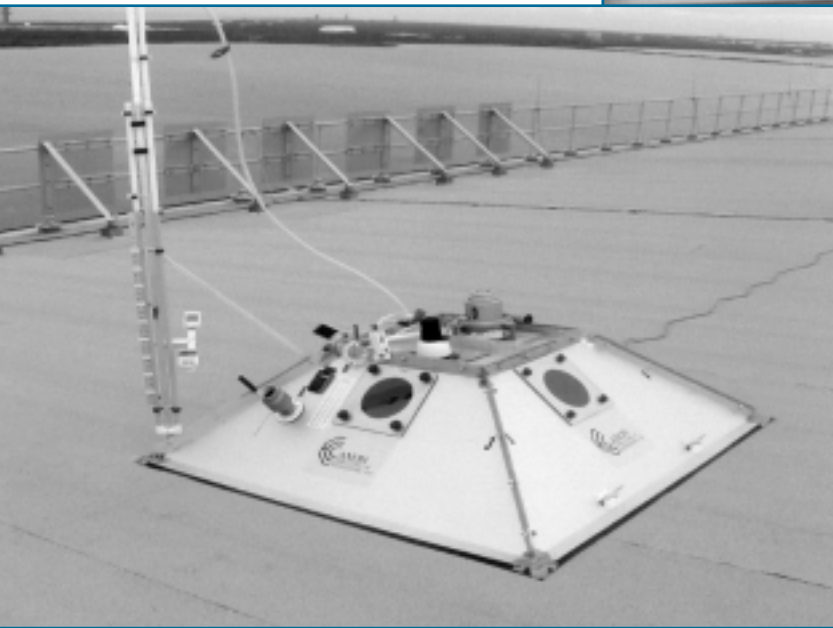
Below: Photo 6: Negative pressure chamber in place. Control valve is at "A." Manometer is at "F." Vacuum is at "D."

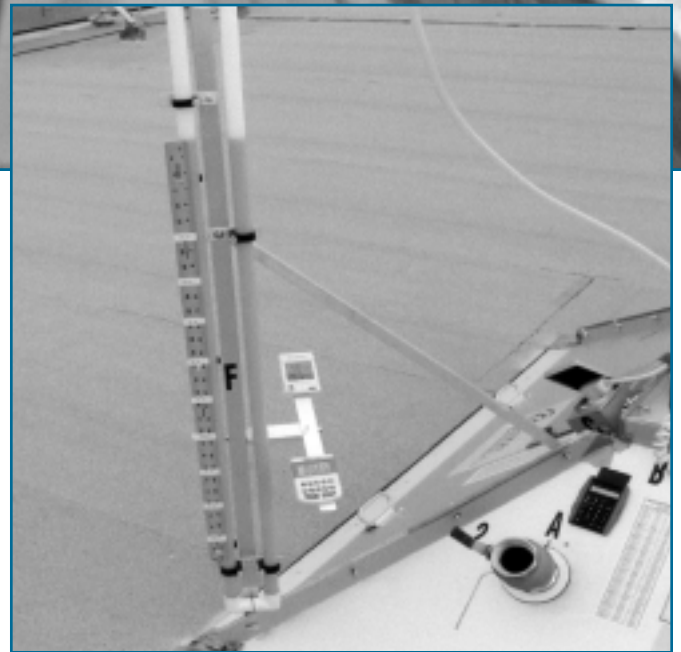
Above: Photo 7: Manometer ("F"), with timer and thermometer. Control valves at "A" and "B."

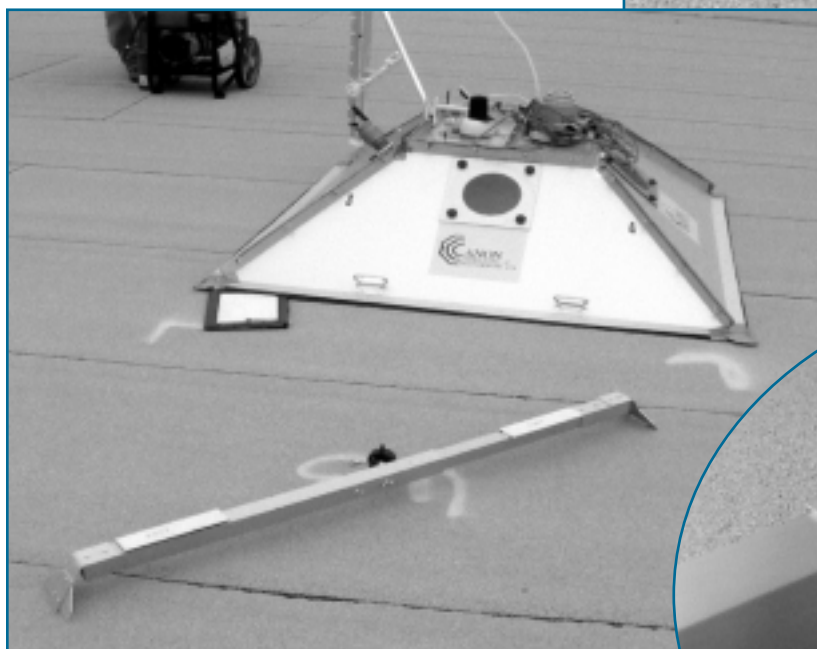
Above: Photo 9: Chamber placed to the side of the test site to position rigid metal bar with digital dial indicator attached.

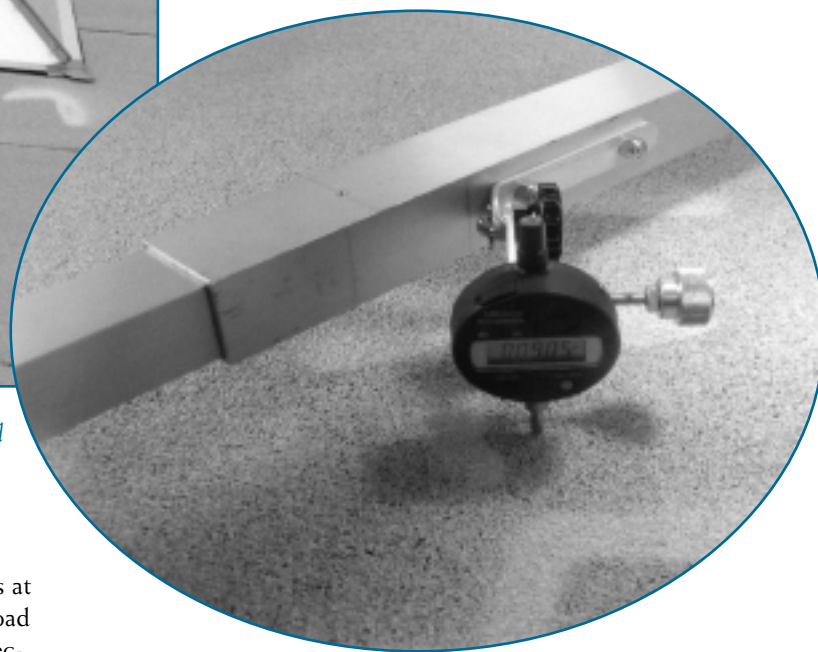
Below: Photo 10: Digital dial indicator in position.

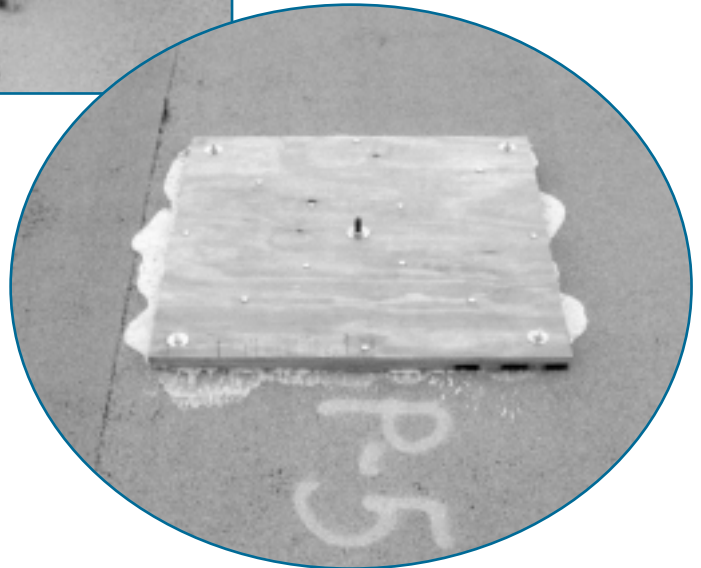
Below: Photo 12: Plywood panel in final position for testing. Insta-Stik cured for approximately 20 hours before testing in relatively cold weather ($\pm 35^{\circ}\text{F}$ to $\pm 50^{\circ}\text{F}$).

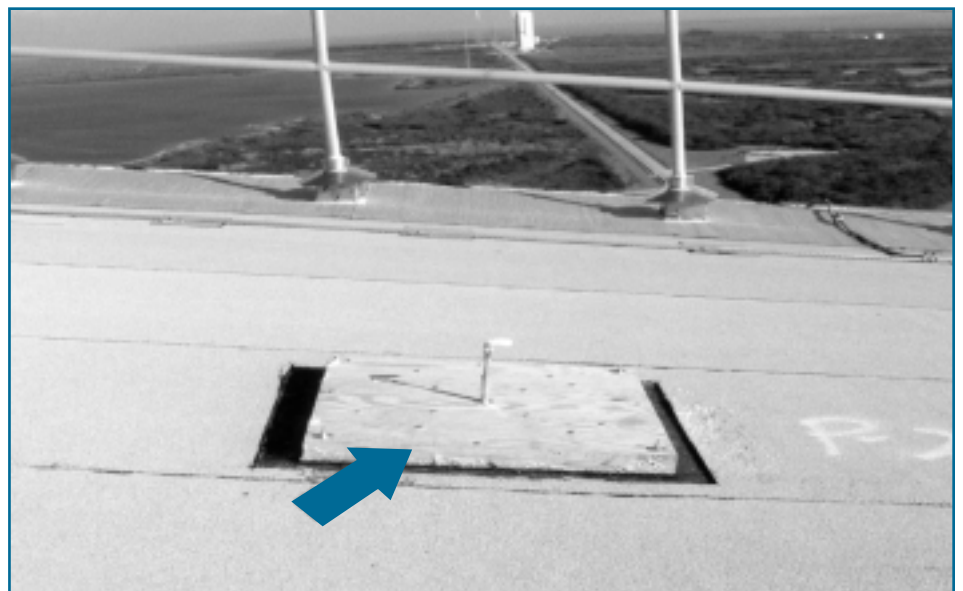
Below: Photo 13: Membrane trimmed away from edge of panel down to the top of the Dens-Deck. Eyebolt is in place and ready to attach pull device.

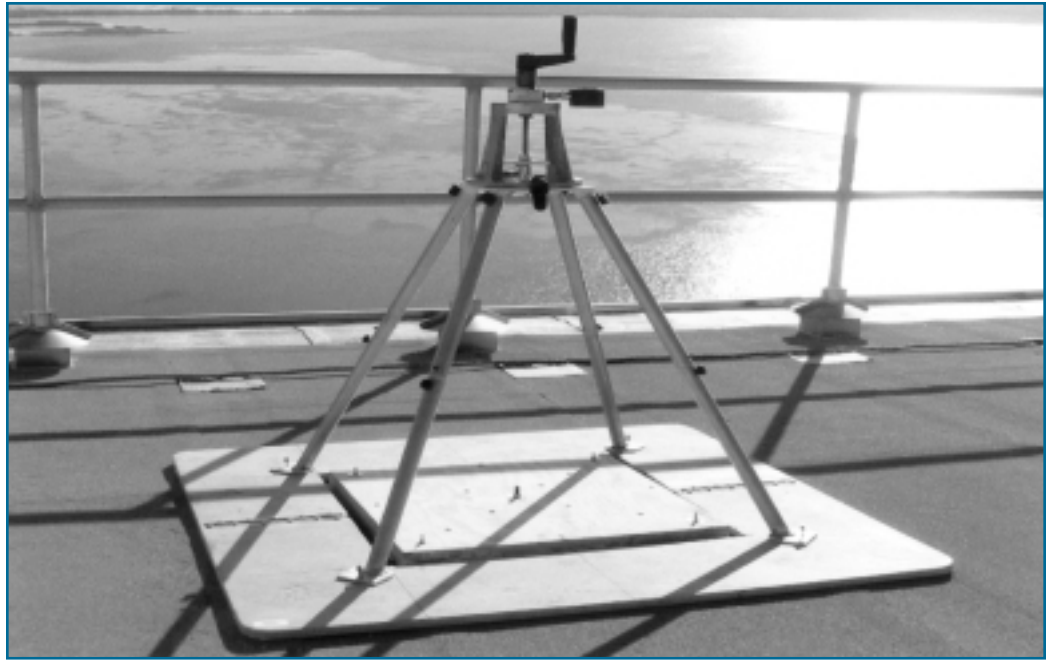
Photo 14: Plywood "collar" under legs of quadrapod test stand to distribute load. Digital readout pull test apparatus in place on top of stand. (Connecting chain and eyebolt are not in place in this photo.)
