# RISING *TO THE* CHALLENGE:

## Roofing Rehabilitation of the New York State Capitol

By  
James Jamieson, AIA,  
and  
Niklas Vigener, PE

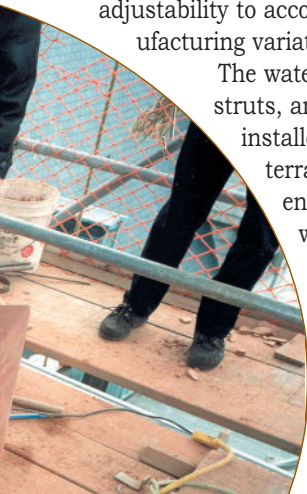
**Reconstruction of roof rake in preparation for waterproofing membrane and terra cotta barrel tiles.**

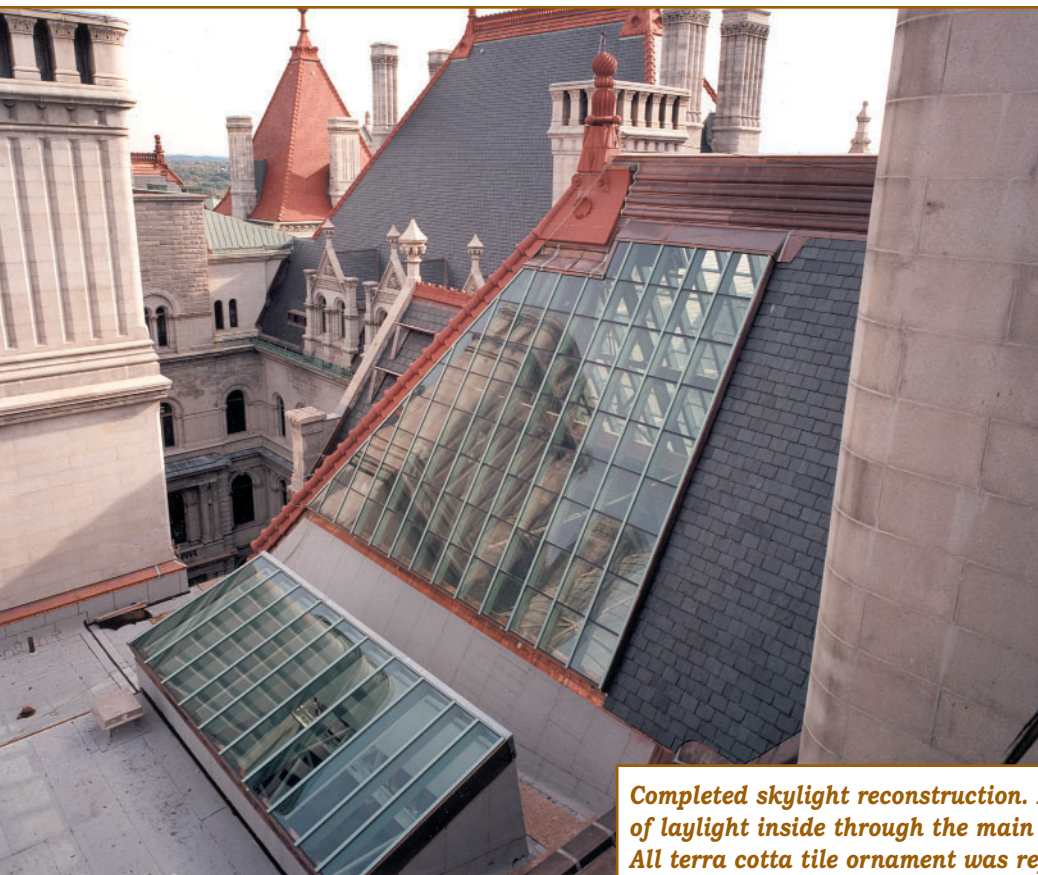
**Completed skylight reconstruction. Notice top of laylight inside through the main skylight. All terra cotta tile ornament was replicated.**
