THE WHATCOM MUSEUM OF HISTORY AND ART

BELLINGHAM, WASHINGTON

By David A. Rash, RRC

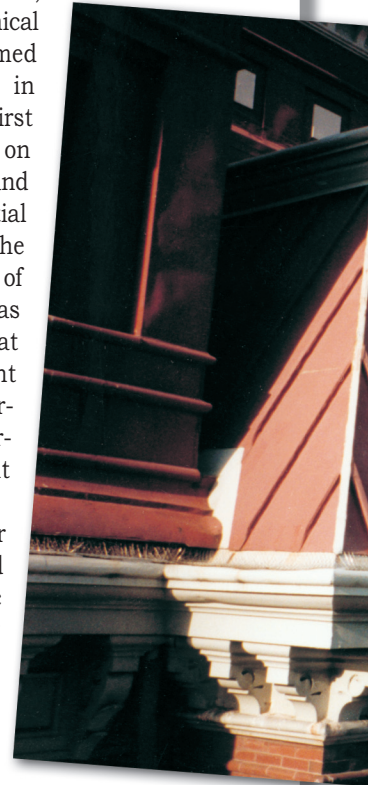
Rust stains on the leading edges of virtually every white-painted trim surface were another indication of significant failure of various metal roofs and cladding.

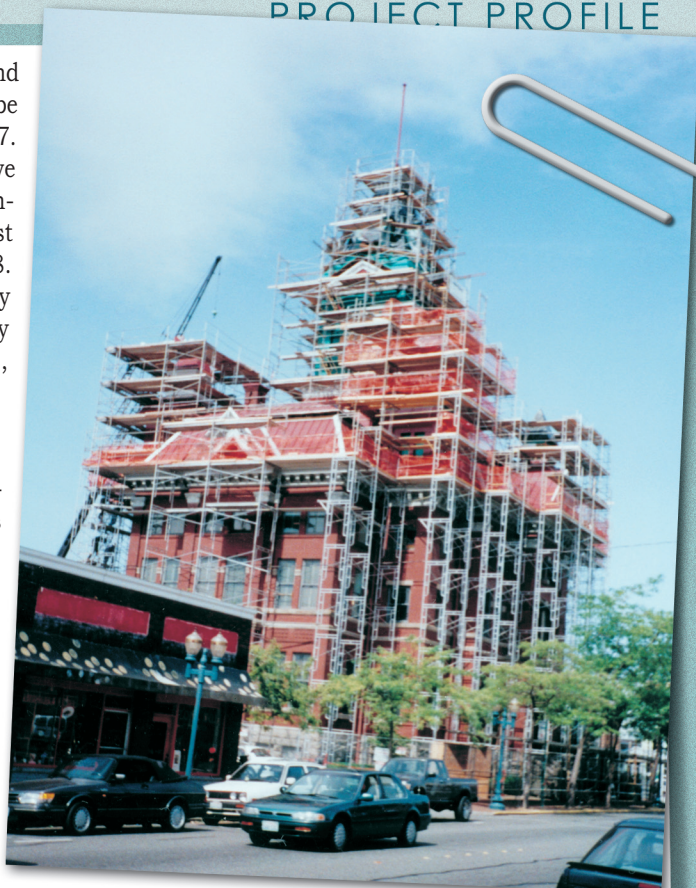
Although some work on the building envelope occurred below the roof line at the main building cornice, full scaffolding was erected, primarily for the replacement of the roof.

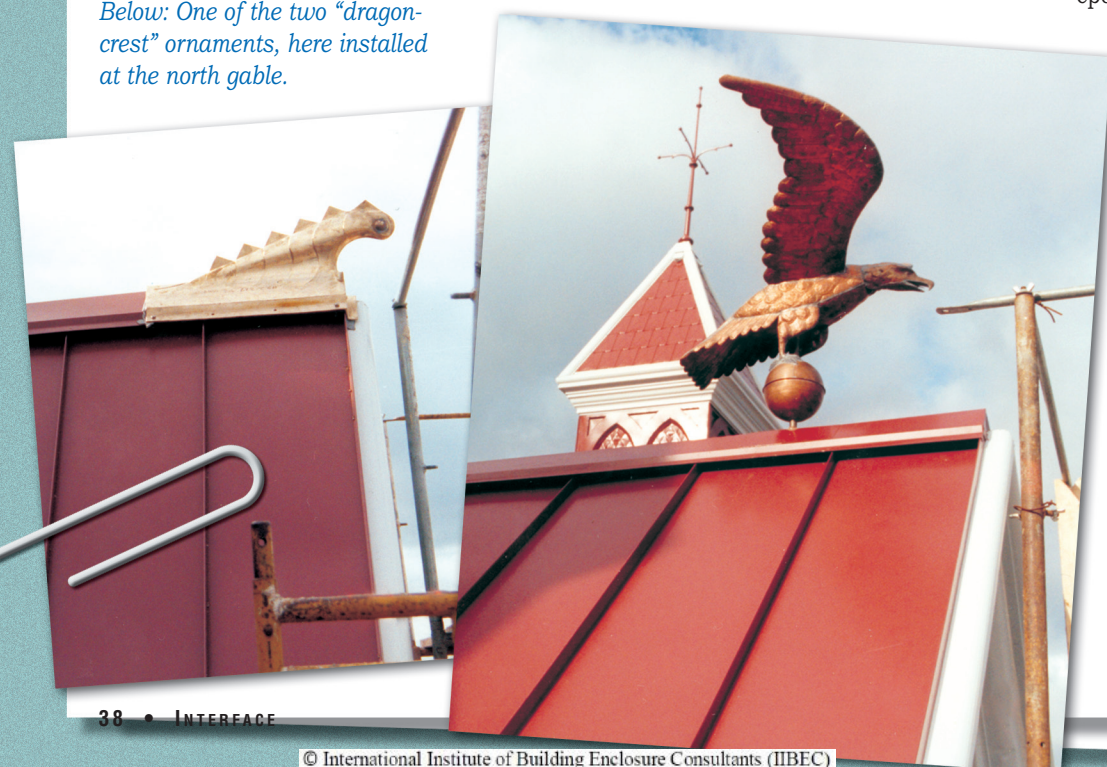
Below: One of the two "dragon-crest" ornaments, here installed at the north gable.

Left: One of the two eagle ornaments, here installed at the east gable.

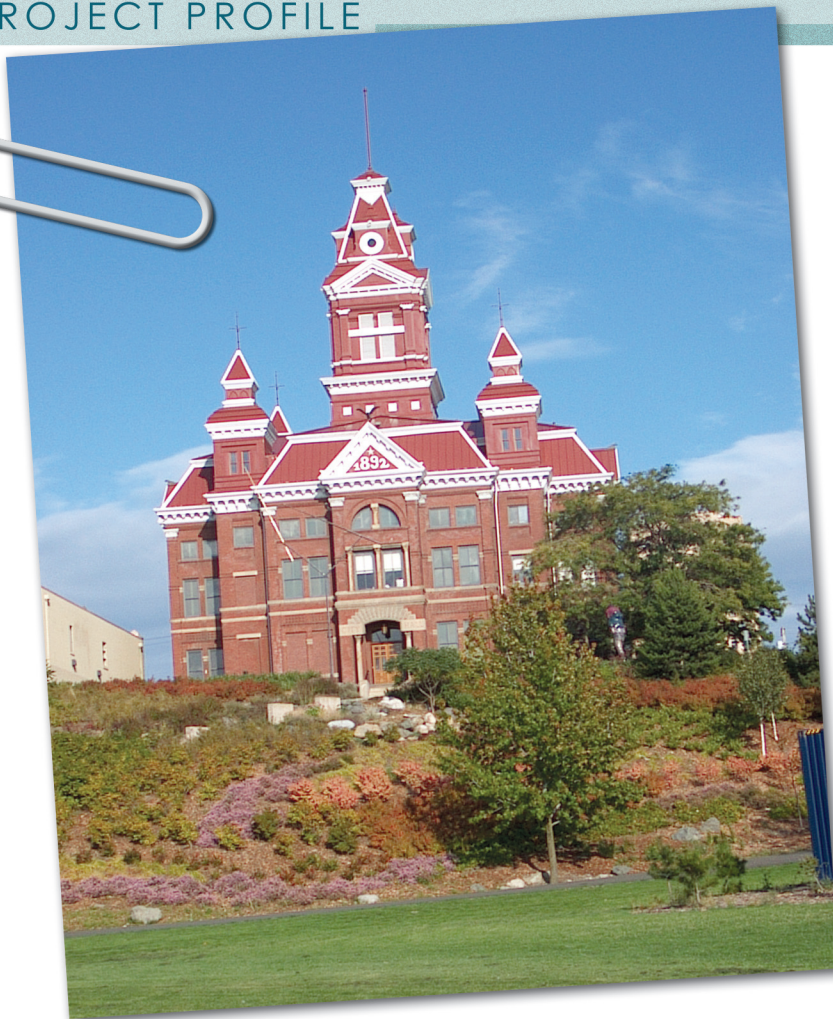
Recent completion of the Maritime Heritage Park to the immediate west of the old City Hall allows the building and its rehabilitated roof to be seen to good effect from the waterfront as envisioned by the city fathers in 1892. Also, note that the west eagle has not gone missing a second time.
