THE WHATCOM MUSEUM OF HISTORY AND ART

BELLINGHAM, WASHINGTON

By David A. Rash, RRC

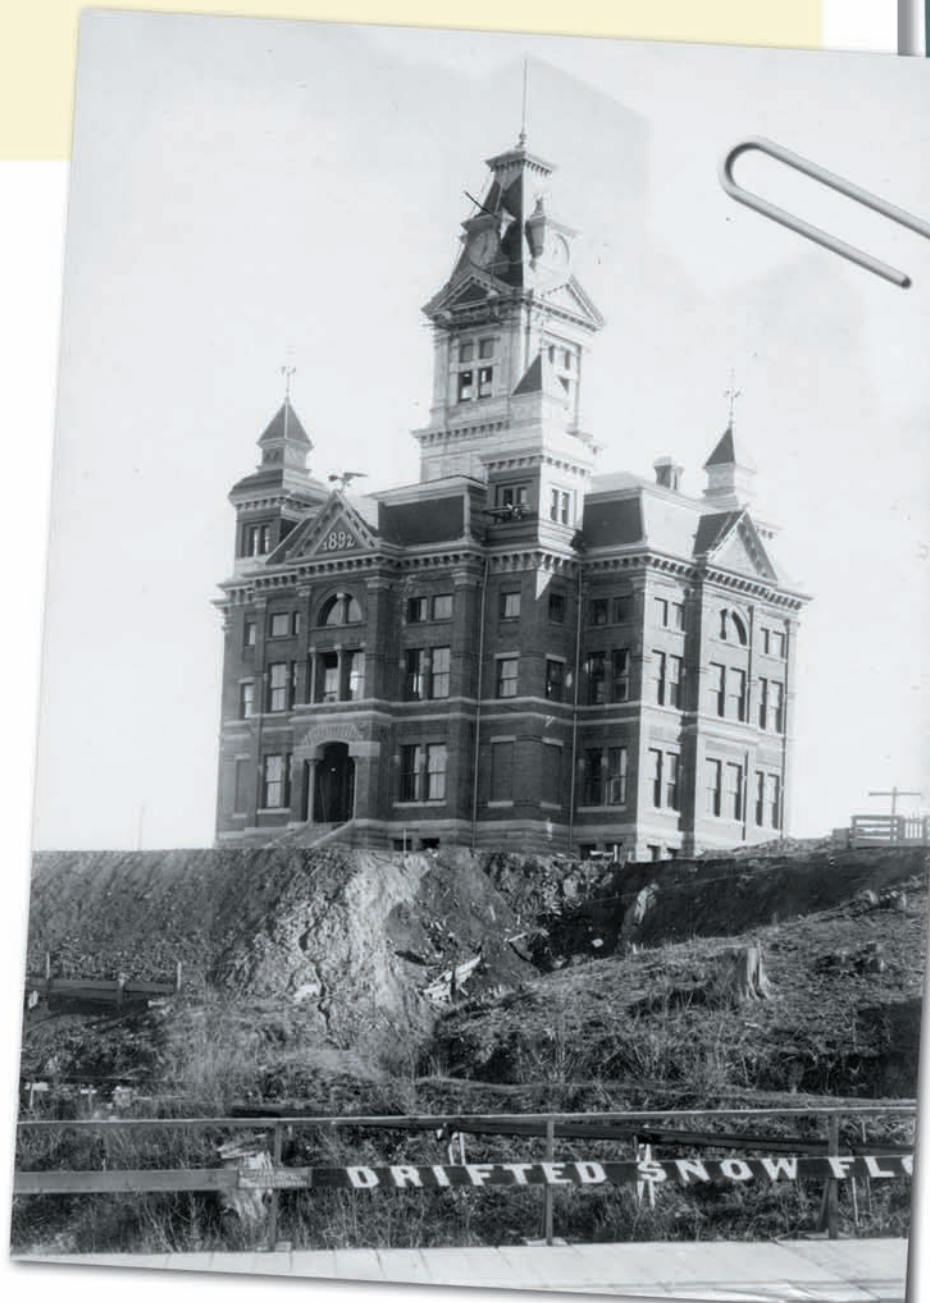
As the New Whatcom City Hall approached completion in 1893, the elaborate metal roof received its first coat of paint with the painters at work on the west side of the central clock tower in this first ever photograph of the building. (Courtesy, Whatcom Museum of History and Art, Bellingham, WA, 1893.)

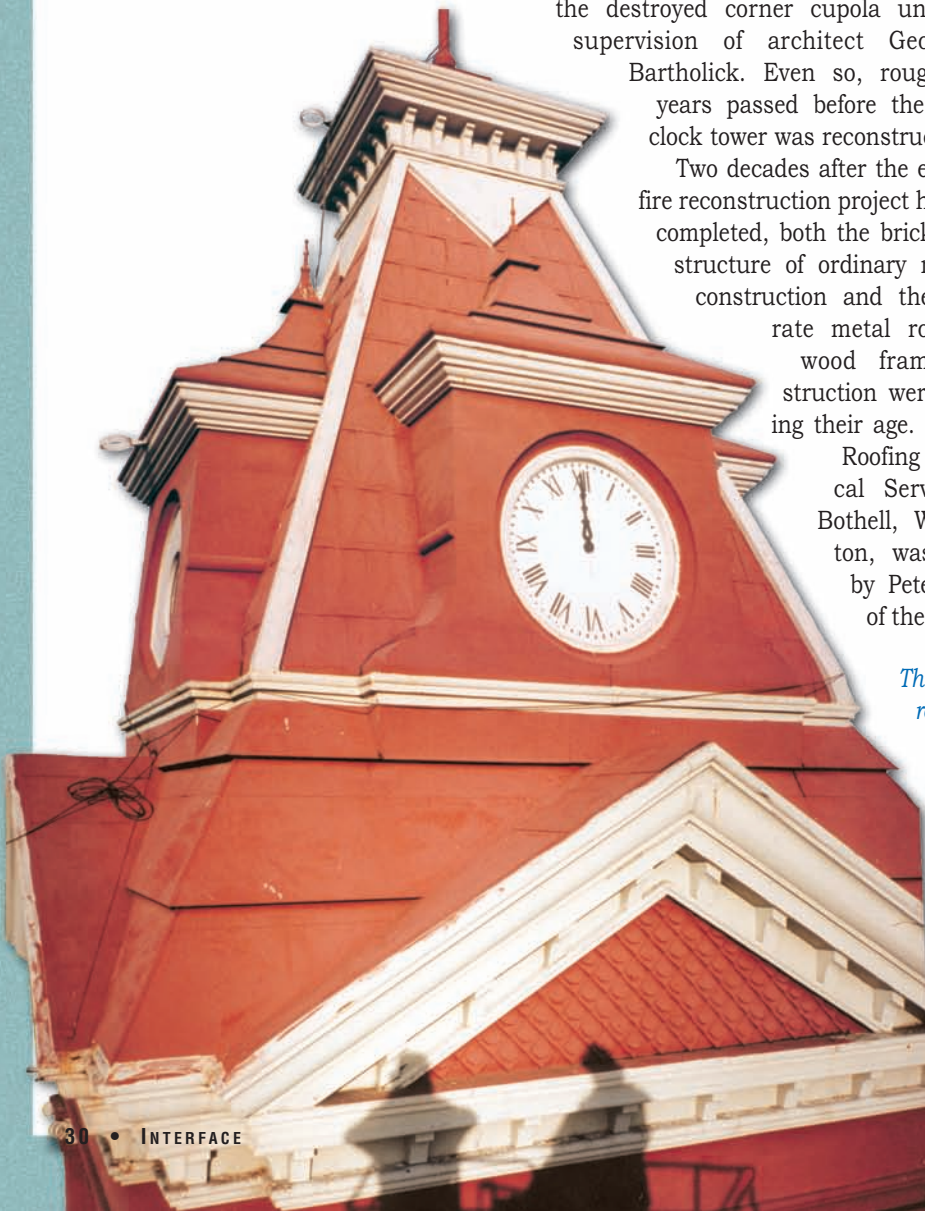
The lower section of the central clock tower roof had gable roofs clad with flat seam panels that intersected with a three-coursed Bermuda-type roof. The end gables themselves featured pediments with "fish-scale" infill and cornices supported by concave corbels. The upper section of the central clock tower roof had metal-clad dormers housing the clock faces, each capped with an attenuated Bermuda-type roof. The dormers intersected with a steeply pitched hip roof clad with metal shingles which was capped by a corbelled cornice that in turn was capped with yet another Bermuda-type hip roof. The clocks were removed and reinstalled by the owner.

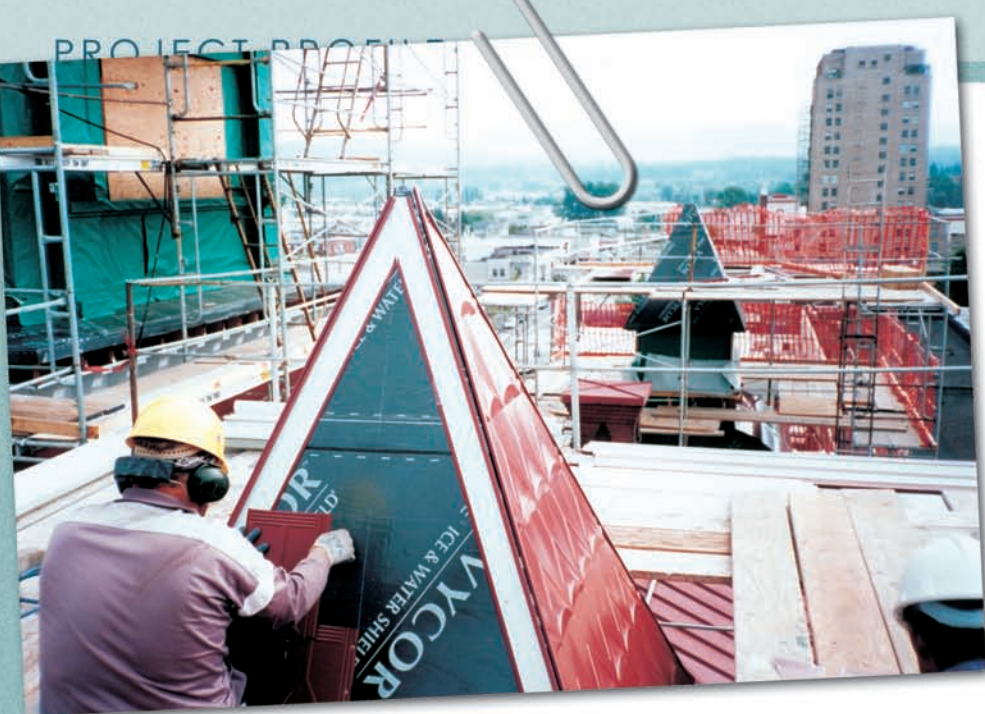
The foreground cupola is being shingled, while the background cupola has only the self-adhering waterproofing underlayment in place and breathable underlayment is being installed at the central clock tower.

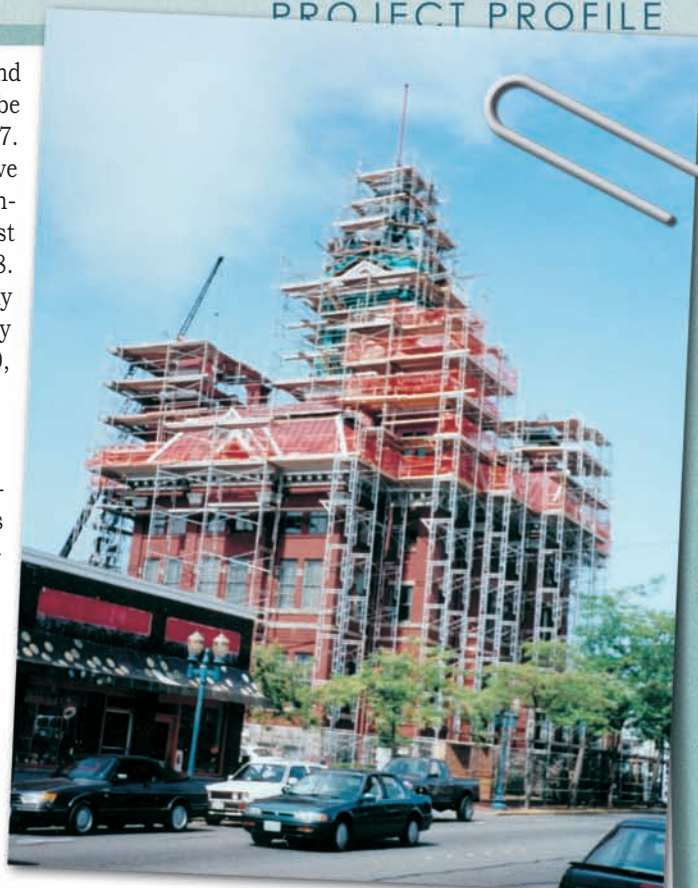
Although some work on the building envelope occurred below the roof line at the main building cornice, full scaffolding was erected, primarily for the replacement of the roof.

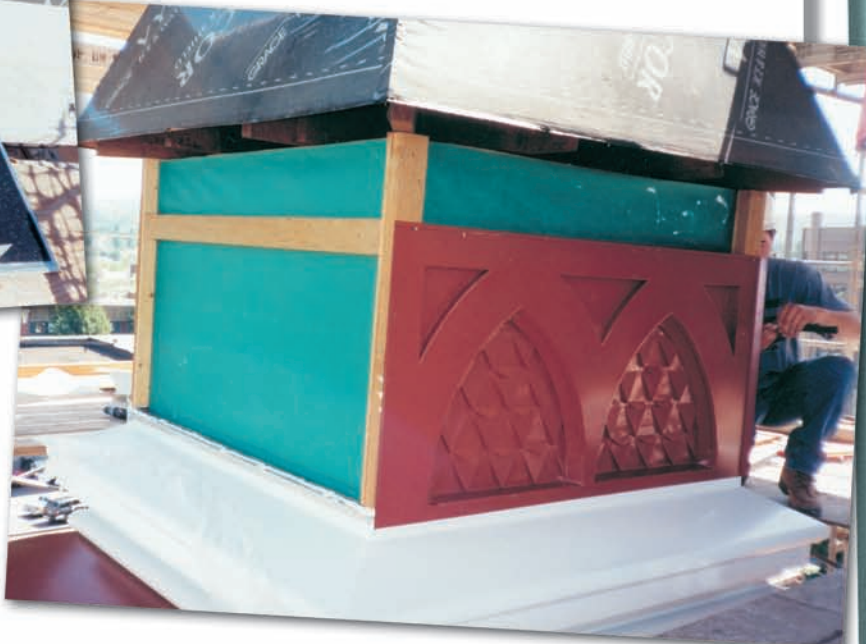
Right: "Fish scale" panels are being reinstalled at the northeast cupola with new wood blocking at panel perimeters. Note the use of breathable underlayment at the cupola wall and waterproofing underlayment at the pyramidal hipped roof above.

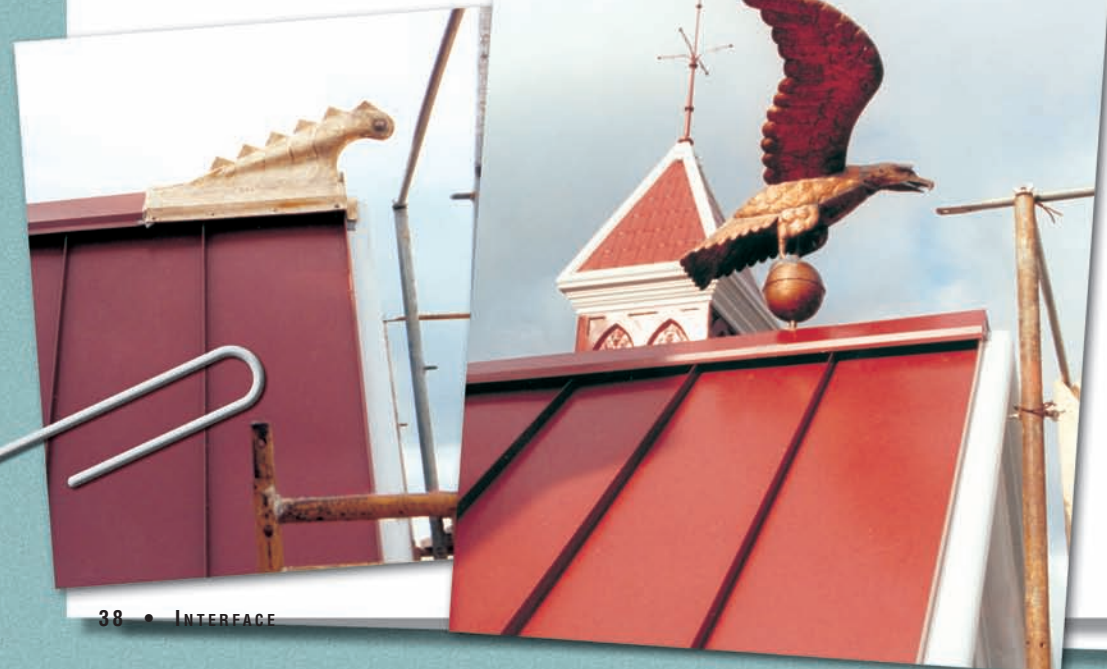
Left: One of the two eagle ornaments, here installed at the east gable.

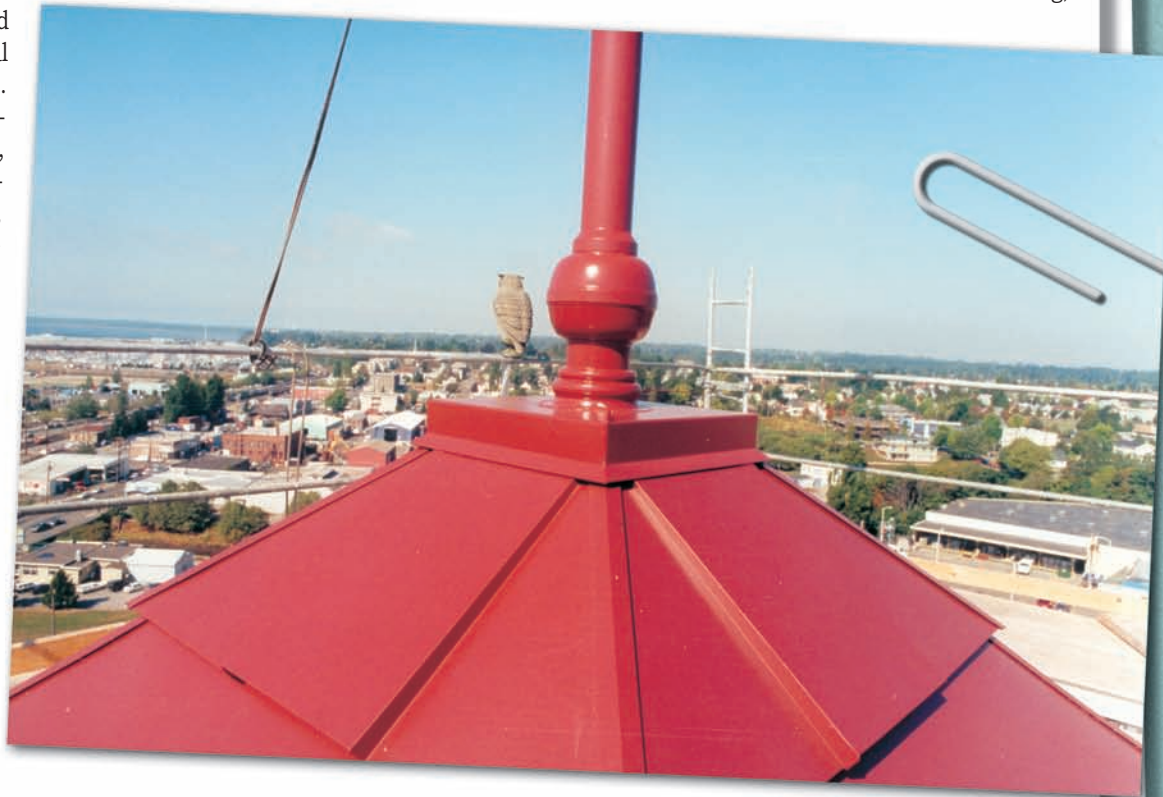
A particular highlight of the work was the completion of the uppermost Bermuda-style roof with its raised central panels that caps the central clock tower.

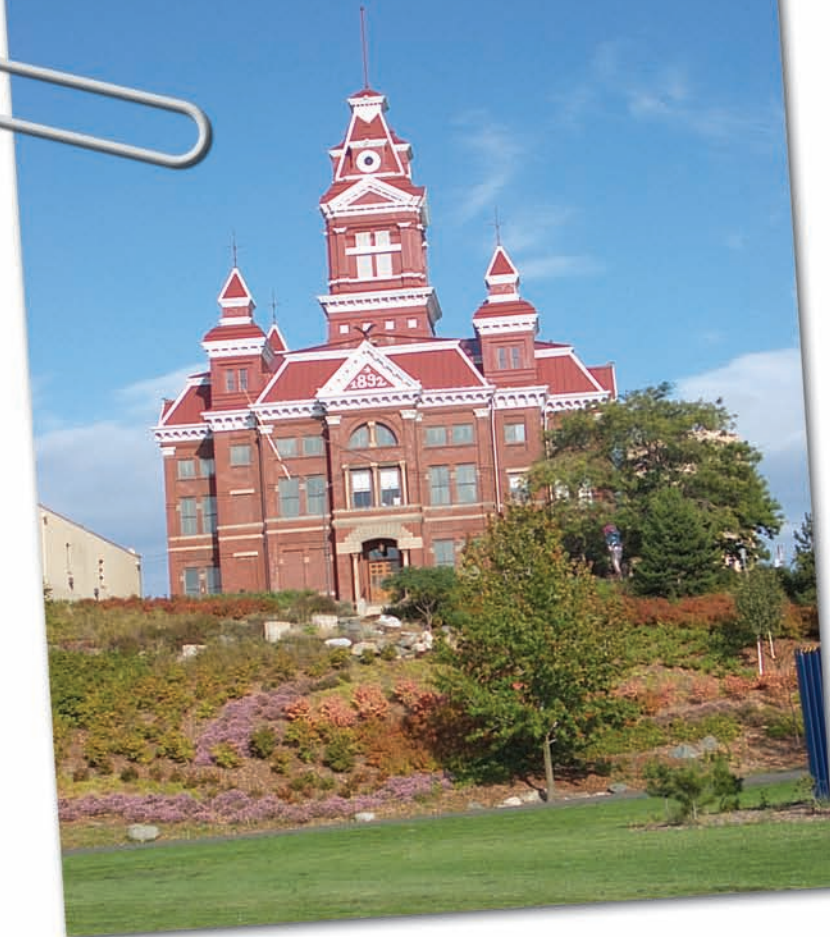
Recent completion of the Maritime Heritage Park to the immediate west of the old City Hall allows the building and its rehabilitated roof to be seen to good effect from the waterfront as envisioned by the city fathers in 1892. Also, note that the west eagle has not gone missing a second time.
