PRESERVING OUR BUILT ENVIRONMENT:

Restoration of EPDM Roofs Extends Service Lives

BY TIM SULLIVAN

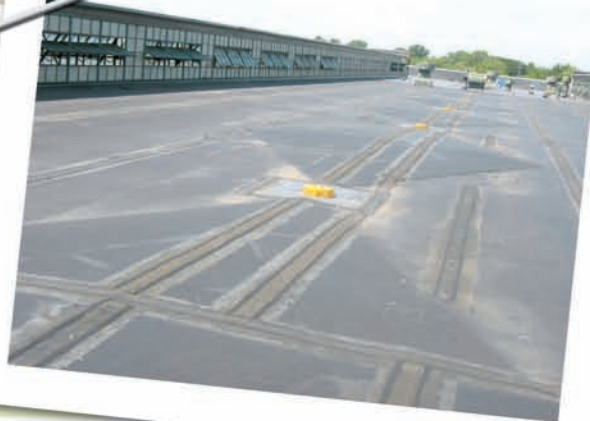
Northwest Garage in Milwaukee, WI.

The Northwest Garage is a large vehicle storage facility that was originally roofed with EPDM in 1994. Inspection of the 73,338-square-foot roof found the membrane to be in excellent condition, but the system had some minor design deficiencies,

which included minor areas of poor detailing and wind damage. No major seam failure was found, but some minor delaminations and bridging were observed. Rather than removing and replacing the roof, it was the recommendation of the owners' Registered Roof Consultant (RRC) to restore and enhance the roof system.

Other restoration measures were executed. The existing drains had been drastically sumped at three inches below the top of the roof surface, causing stretching of the membrane around the drains. The restoration involved raising the new drains for improved long-term performance. The garage parapet base flashings had been poorly executed, and the coping stone joints were badly deteriorated. The solution was to install plywood on the inboard side to reflash the wall and to install flashing over the coping to encapsulate the problem. Existing gutters above the low clerestory walls had not been properly attached, and the wind had pulled away from the existing securements. Work was completed to achieve additional securement of the gutters, as well as enhancement of the flashing on the gutter flanges. Similar measures were taken to repair wind damage observed on the high clerestory roof edges because the flashing was not clipped, and the wind had peeled it up.
