EIFS:

Practical Solutions for Addressing Damages to Existing Buildings

By Derek A. Hodgin, PE, RRO, RRC, RWC, CDT

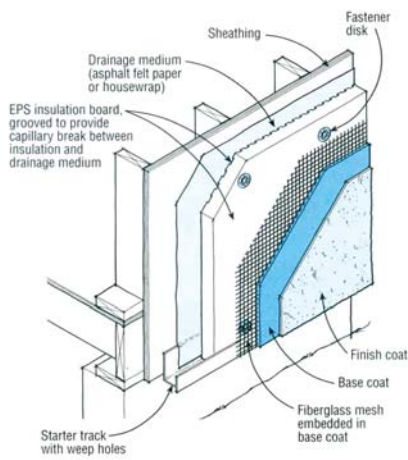
Figure 2

EIFS can be applied on wood-framed walls, provided the wall is designed to drain when the stucco cracks. The drainage plane relies on well-detailed sheathing wrap and flashing, and a grooved EPS insulation board.

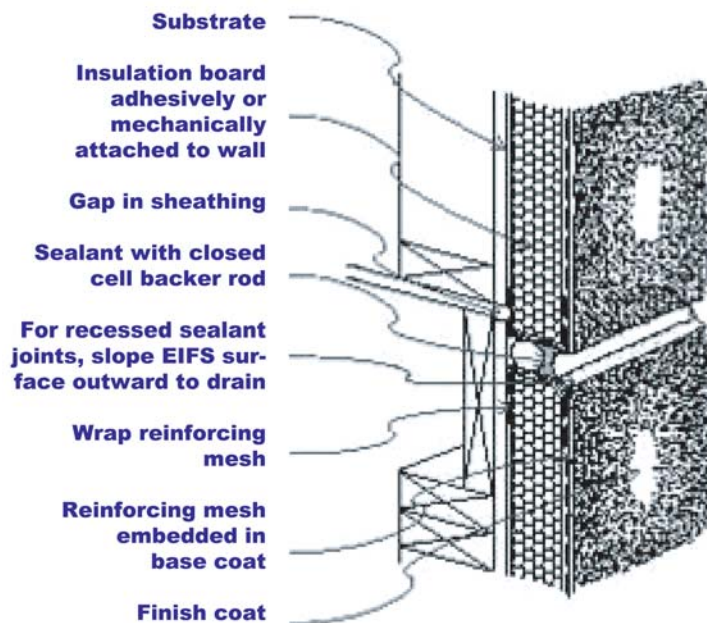
Figure 15

Expansion joints are required in the system where they exist in the substrate, where the system adjoins dissimilar construction, and at floor lines in multi-level, wood-frame construction (see Figure 15). The most common symptom of an omitted expansion joint is a linear bulge along a floor line. The bulge is the result of localized delamination of EIFS along the band joist. The band joist is typically a piece of dimensional lumber that is subject to cross-grain shrinkage as moisture content in the wood decreases.

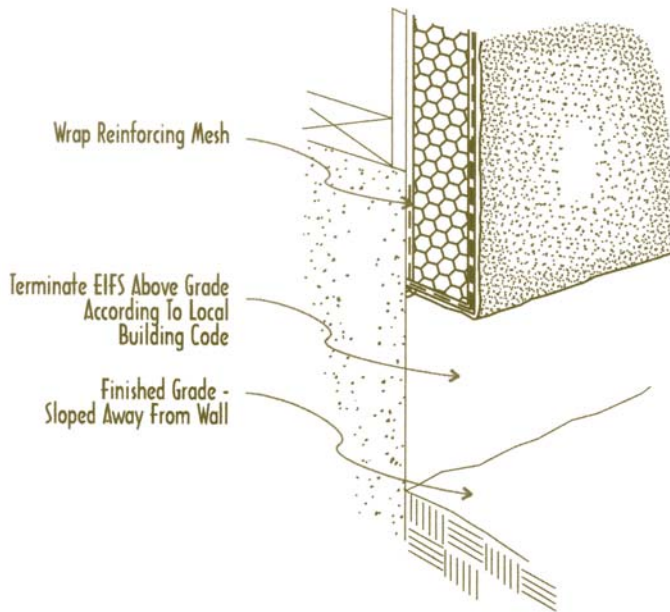
Figure 18

Depending on where one looks, EIFS should be terminated 6 to 8 inches above grade. Most building codes require a separation of 6 inches⁶, while most EIFS manufacturers and industry standards recommend a clearance of 8 inches between the EIFS and grade (see Figure 18). Unfortunately, this is not always the case. A limited number of EIFS manufacturers produced details showing their product extending below grade (see Figure 19). The author
