BERMUDA ROOF IN HARTFORD, CONNECTICUT

BY REMO CAPOLINO, RRC, PE

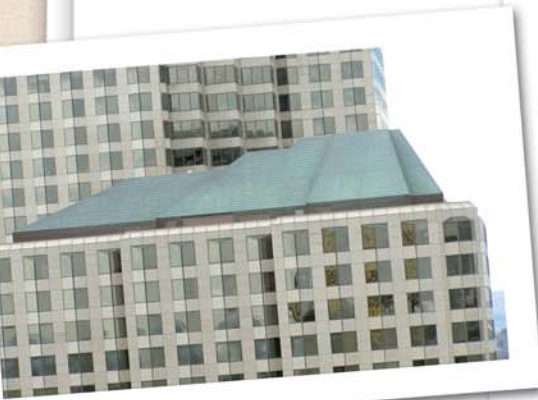
Photo 10: Photo of existing copper roofing.

After many iterations and life-cycle cost analyses, it was decided that the most environmentally friendly, cost-effective, and longest life expectancy would be realized with the installation of a new, Bermuda-style copper roof assembly to replicate the

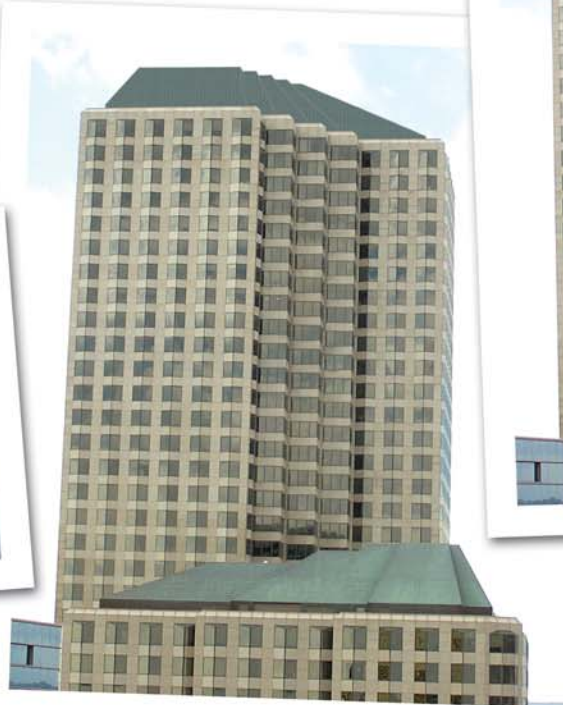
Photo 11: Rendering with Sarnafil Pacific Turquoise.

In order to facilitate a decision, renderings of batten and standing seam profile PVC roof assemblies were provided for the owner’s review and comments (see *photos 10, 11, and 12*).

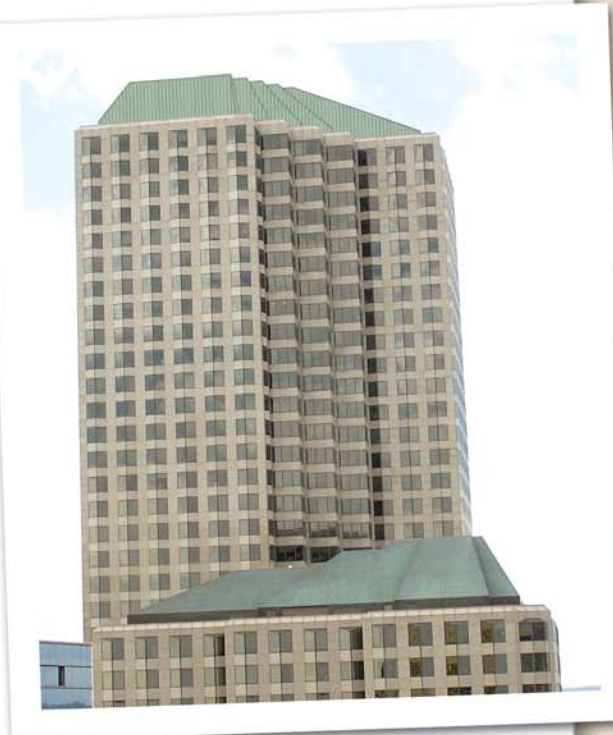
Photo 12: Rendering with Sarnafil Patina Green.

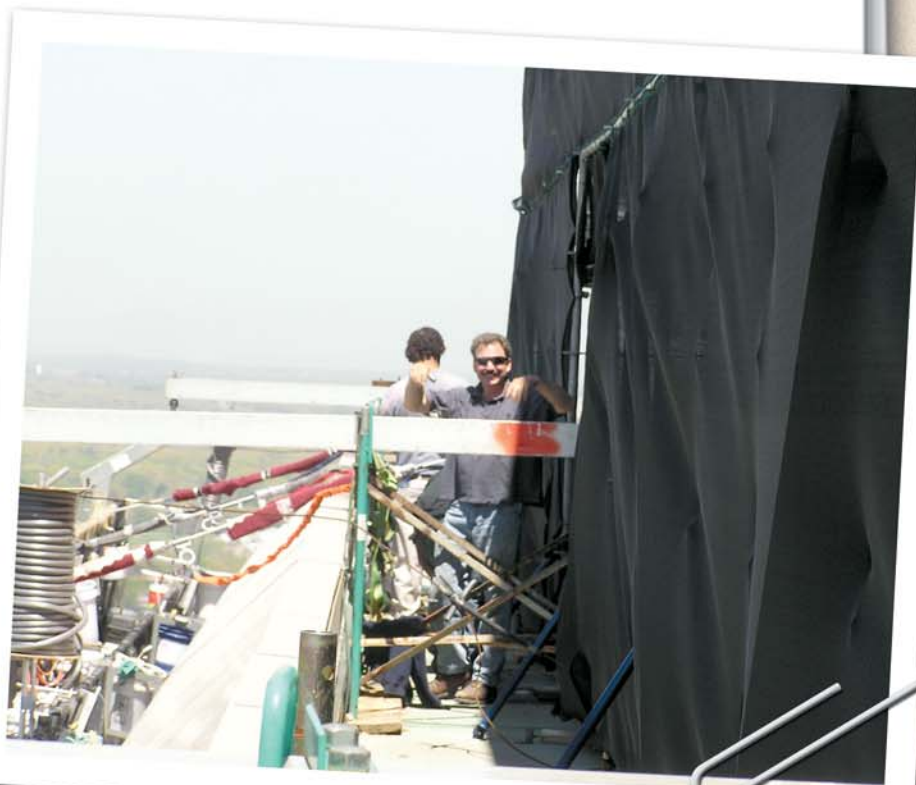
attention of all bidders during the bid process and was driven not only for the concern of the general public, but also for the safety of another contractor that was simultaneously removing and replacing all of the approximately 26.5 miles of exterior building sealant during the reroofing project. At any one time, the sealant replacement contractor had at least three hanging scaffold rigs on the building. These rigs had wire rope climbers, safety tie backs, and personnel safety lines, all of which were in the area of the copper roof removal and replacement, and which could easily be damaged or cut by any uncontrolled debris (see *Photos 16 and 17*).

Photo 16 (above): Sealant replacement contractor sharing work space with roofing contractor.

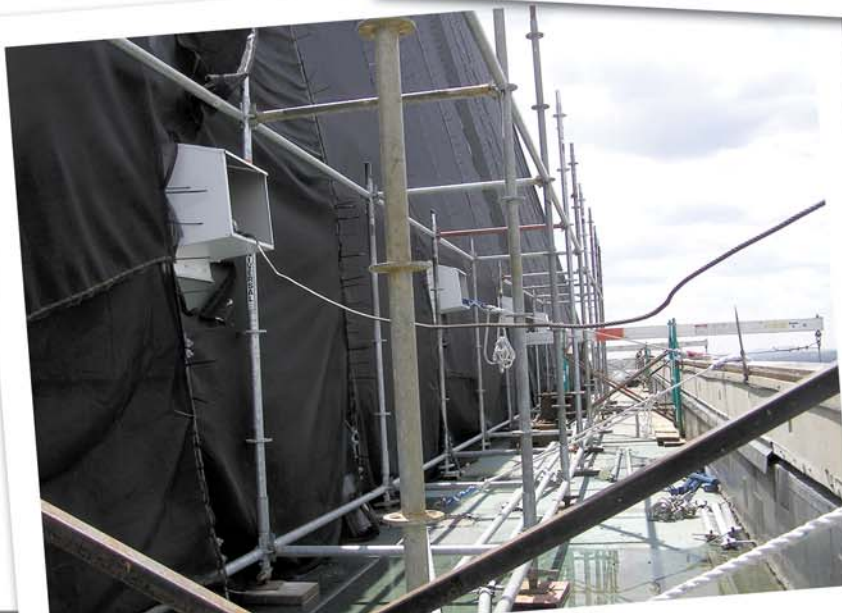
Photo 17: Scaffolding used by roofing and sealant contractor in congested work zone.

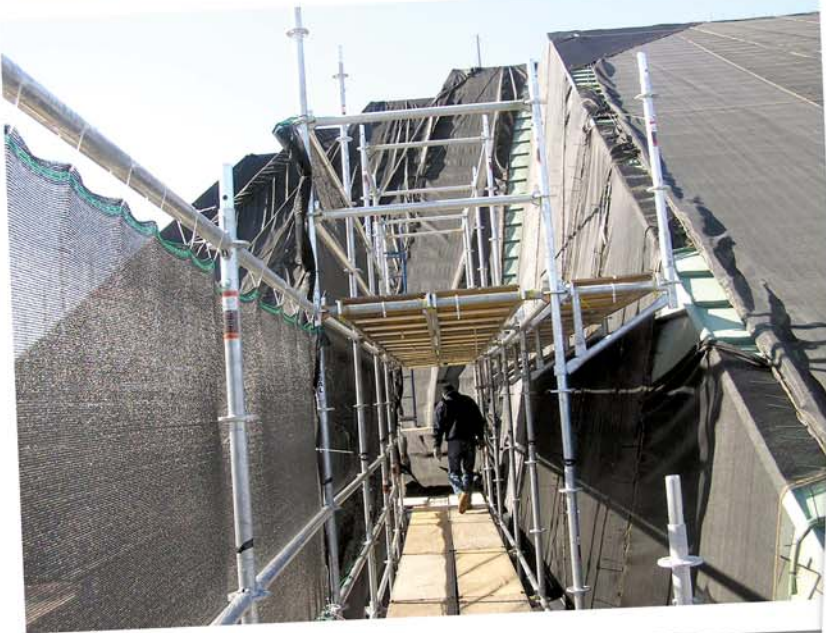
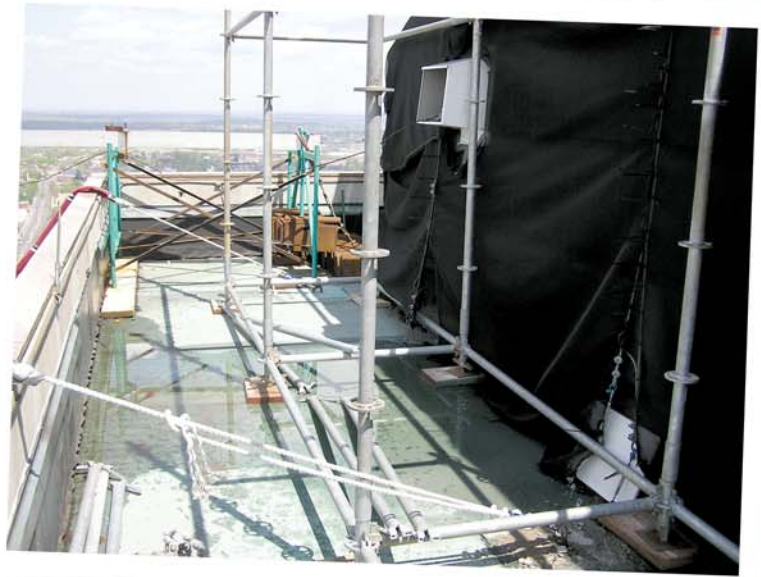
Photos 18 and 19: System scaffold used to provide worker access.

To the framing of the scaffold, work levels were installed where needed. A safety and debris netting was installed to the entire back of the scaffold, beginning from a minimum of 10 feet above the top work level and draping down to the base, to catch anything or anyone that might inadvertently try to “take the express” to the street below (see Photos 18 and 19).

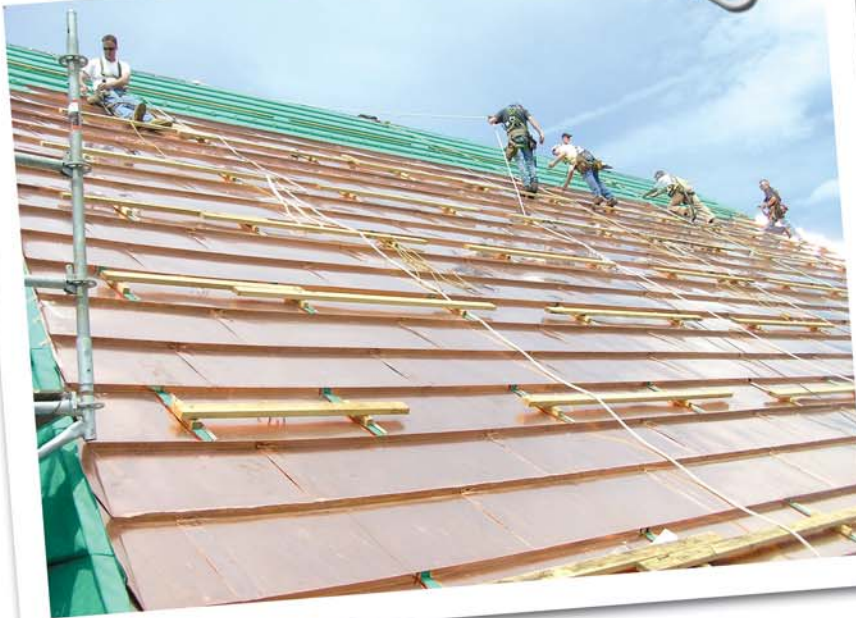
Photo 20: Wood brackets used to provide worker access.

scaffold was abandoned and specially fabricated roof brackets were used to support planks upon which the workers stood to install the new work. These brackets and their fastening to the building were designed to withstand the load of not only the worker, but also the weight of any materials that needed to be installed. See *Photos 20 and 21*. At some

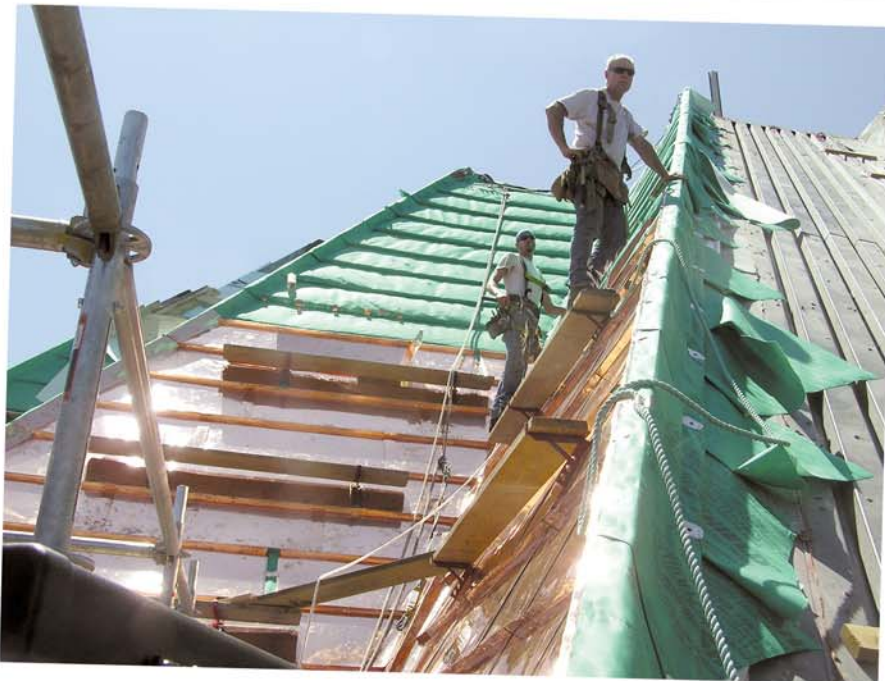
Photo 21: Specialty metal brackets used to provide worker access.

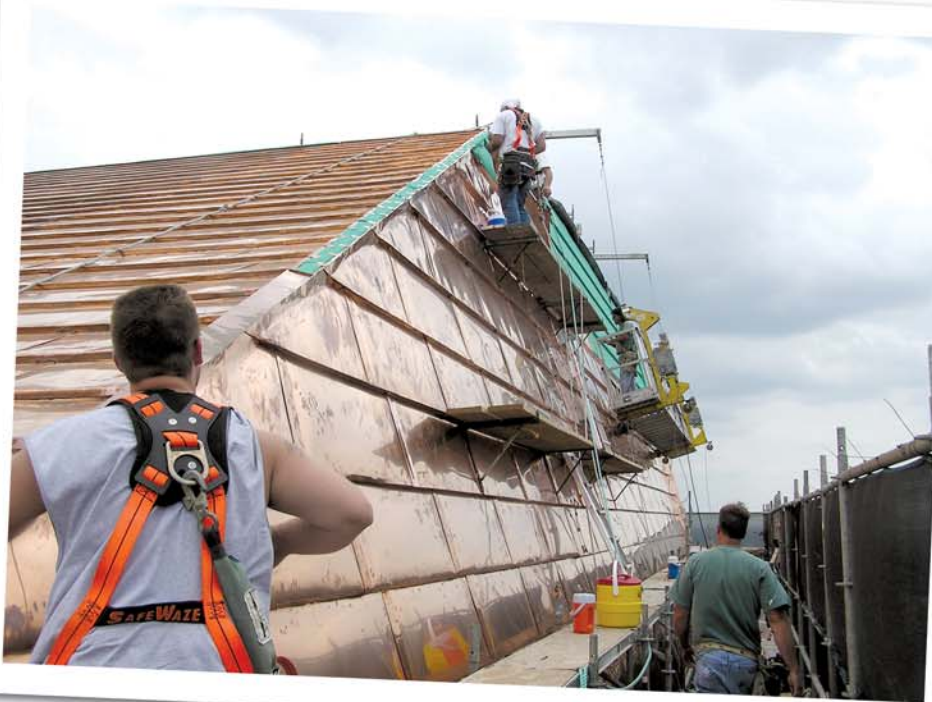
Photo 22:
Specialty metal brackets and hanging scaffolds used to provide worker access.

areas, the roof slope prevented the use of the specialty brackets and required the use of hanging scaffolds similar to those used on vertical walls (see Photo 22).
