"WINDS OF CHANGE"

IN ASPHALT SHINGLE SPECIFICATION AND APPLICATION

BY EDWARD L. FRONAPFEL, PE

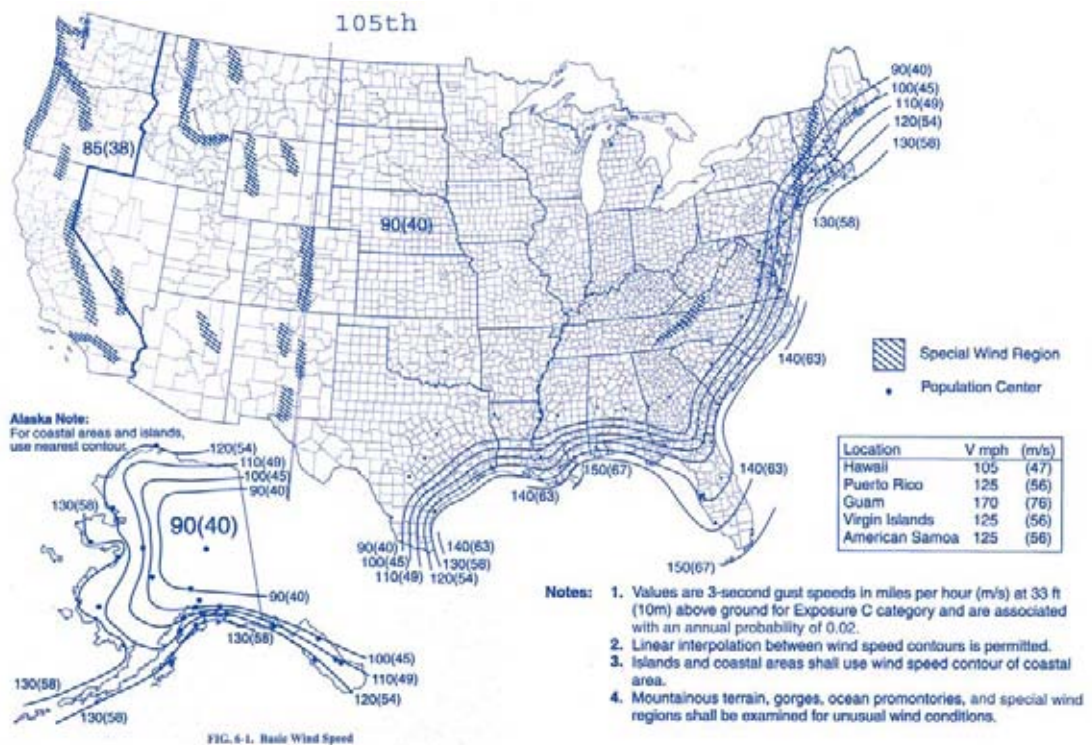
Figure 2. From ASCE Standard ANSI/ASCE 7-95, approved June 6, 1996.

International Residential Code and the International Building Code, the correct map was included (*Figure 2*). The map areas are unchanged from the 1995 ASCE document. However, common sense would dictate that the front range of Colorado, specifically parts of Douglas and El Paso Counties, should have been included and that the original map indicated the incorrect positioning of the wind zones.

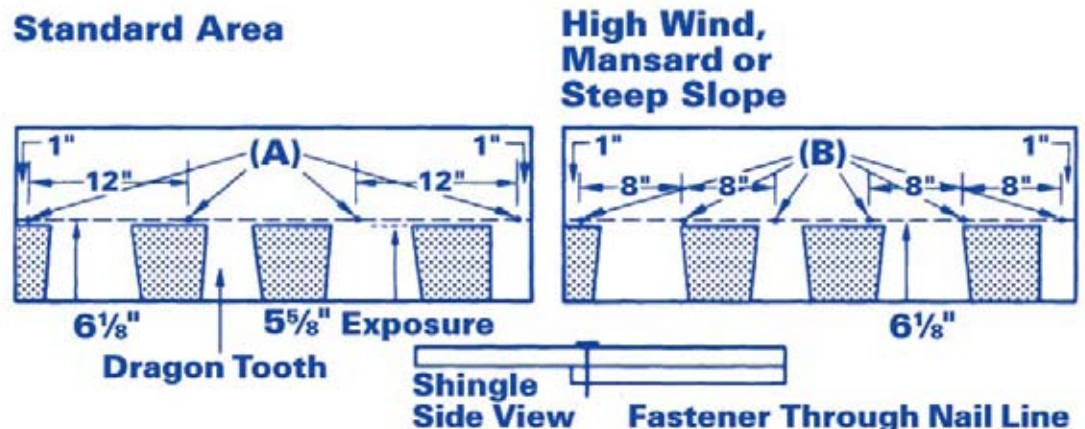
Figure 3: Manufacturer's installation instructions.
