# THE EXTERIOR RESTORATION OF 90 WEST STREET, NYC

RICHARD W. LEFEVER, PE, AND MARK ANDERSON, AIA  
*FAÇADE MAINTENANCE DESIGN, PC, NEW YORK, NY*

## PROJECT SUMMARY

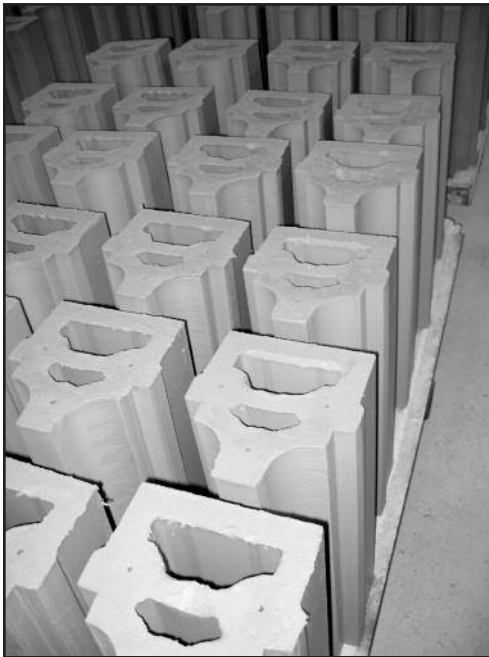
Figures 9A and 9B – New terra cotta was manufactured by extrusion and hand pressing.

- The large quantity of terra cotta replacement permitted many of the new pieces to be extruded, with the remainder being either hand-pressed or hand-sculpted by Boston Valley Terra Cotta. In all, 7,853 pieces of terra cotta were replaced.

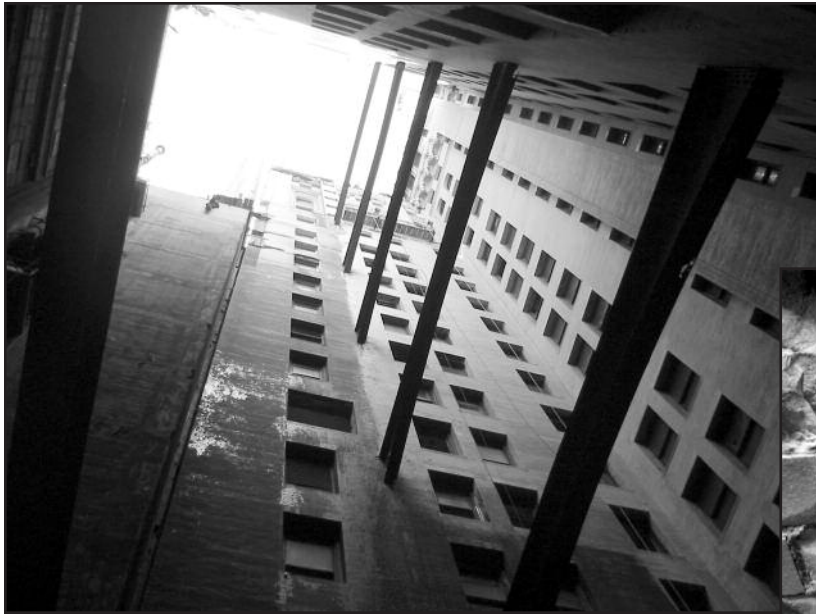
Figure 9C – The courtyard during the cleaning.

Figure 9D – Brick spalls due to heat of fire in the courtyard.

The brick was cleaned with “Light Duty” restoration cleaner (Prosoco) and the terra cotta was cleaned with Lemon Joy dishwashing liquid and warm water. Loose and unsafe areas of the façade needed to be removed and shored up before work could begin (Figures 6 and 7). Access to the façade was gained through an elaborate assortment of pipe scaffolding, swing scaffolding, and mast climbers.

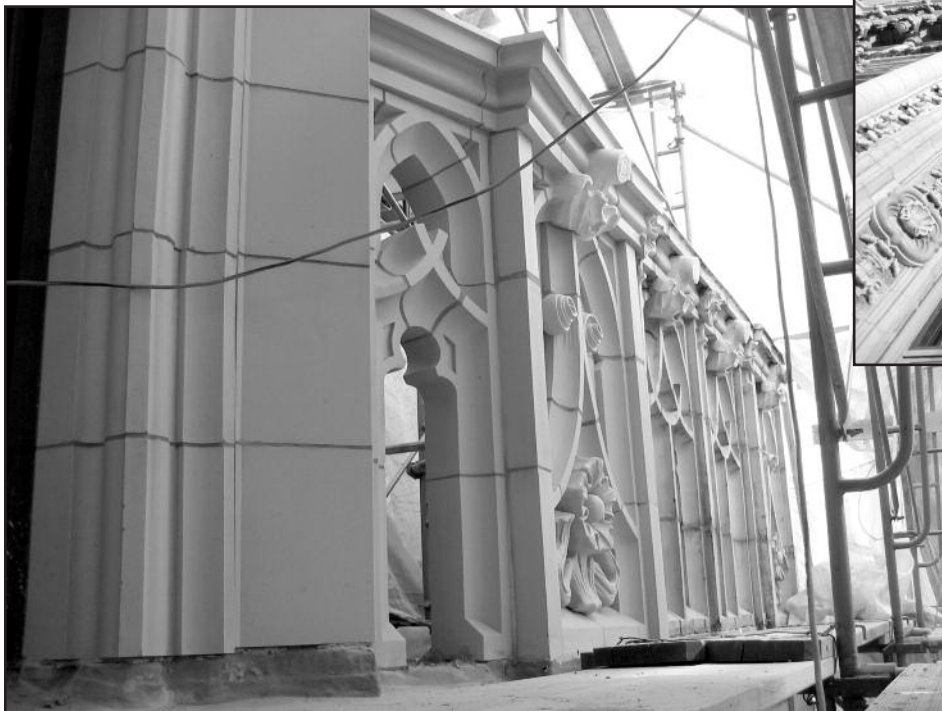
Figure 10 – New and existing terra cotta stones at screen walls.

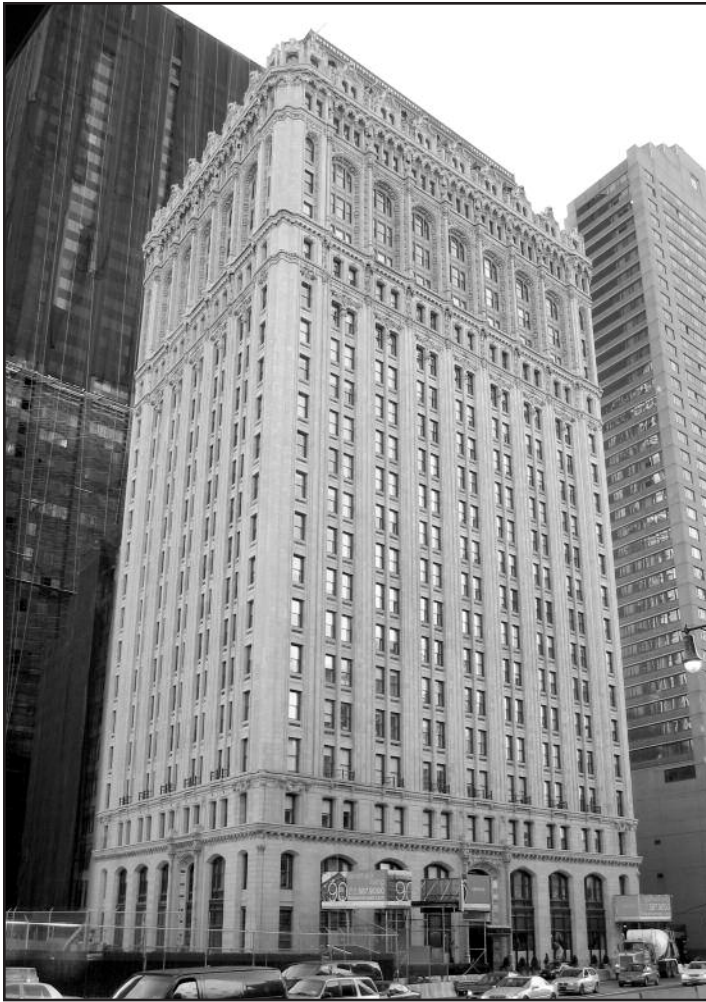
**Figure 12 – Completed restoration at north and west elevations.**

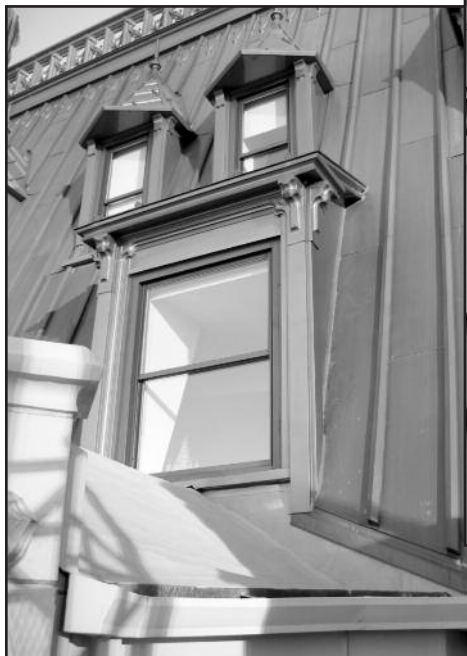
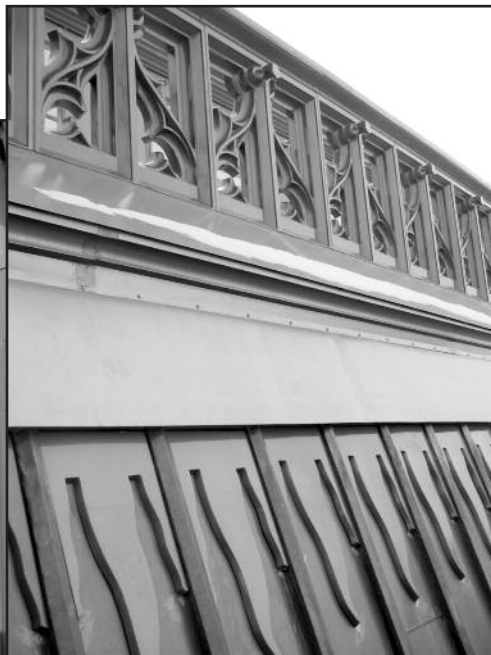
**Figures 15A and 15 B – Completed mansard roof with new fiberglass balustrade and icicles.**

- The copper mansard was removed down to its cinder fill substrate, and new batten-seamed copper was laboriously installed by Eagle One Roofing to match the original roof (*Figures 15 and 16*).
- The entire balustrade was replaced with custom fiberglass panels by Seal Fiberglass (*Figures 15A and B*).
- The 23rd floor dormers were replaced with copper, while the 21st and 22nd floor dormers were repaired with copper wherever necessary.

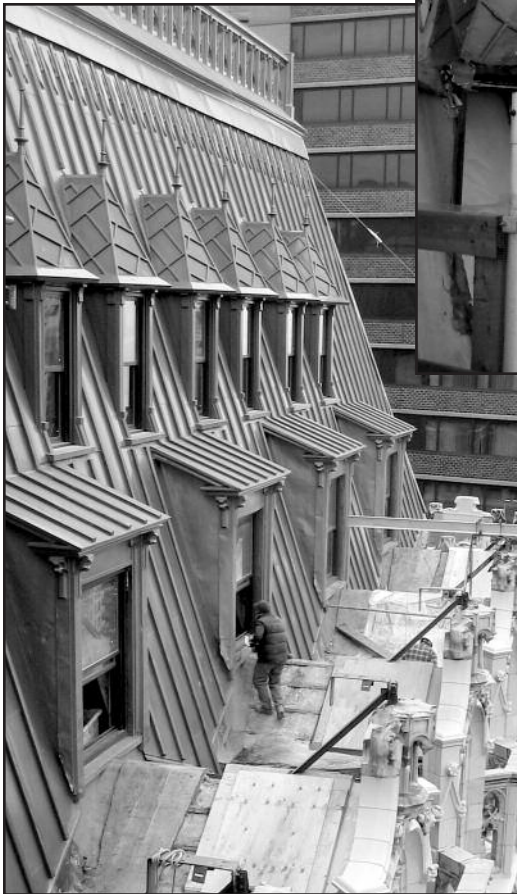
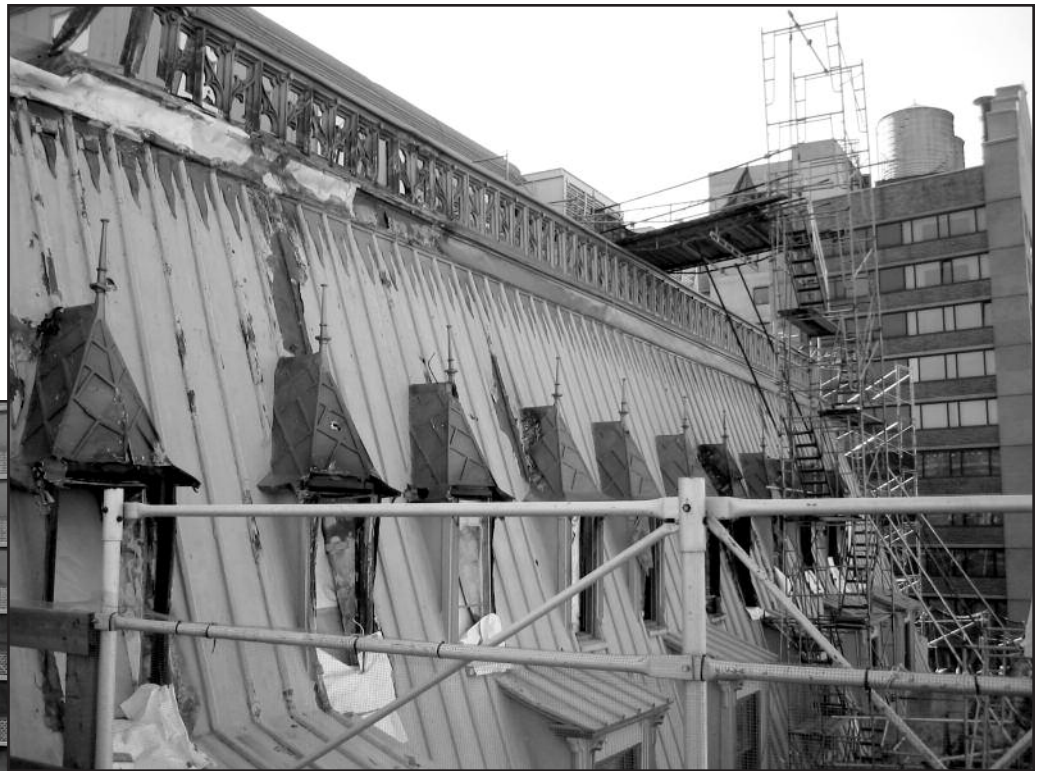
The original copper mansard roof and stamped copper balustrade had been repaired and coated with various sheet and liquid membranes numerous times prior to 9/11. Fire burned the coatings, deformed the copper, burned the underlying wood nailers, and exposed previously

unseen deterioration of the roof's attachment (*Figures 13A and B and 16A and B*).

**Figures 16A and B – West mansard roof before and after restoration.**

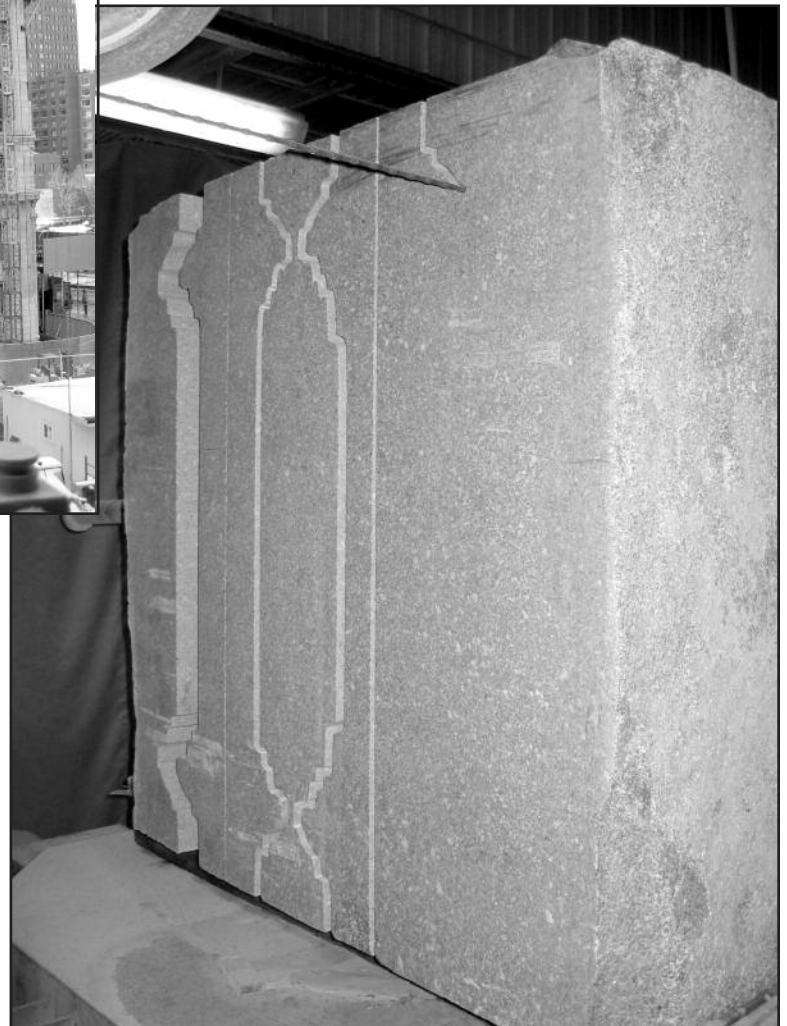
*Figure 20 - New granite was custom cut in Canada by computer-guided saws.*

Eighty percent of the north elevation granite base needed to be removed due to excessive impact and fire damage (Figures 17A, 17B, 18, and 19). New ornamental stone was expertly cut and carved in Canada and Italy (Figure 20).

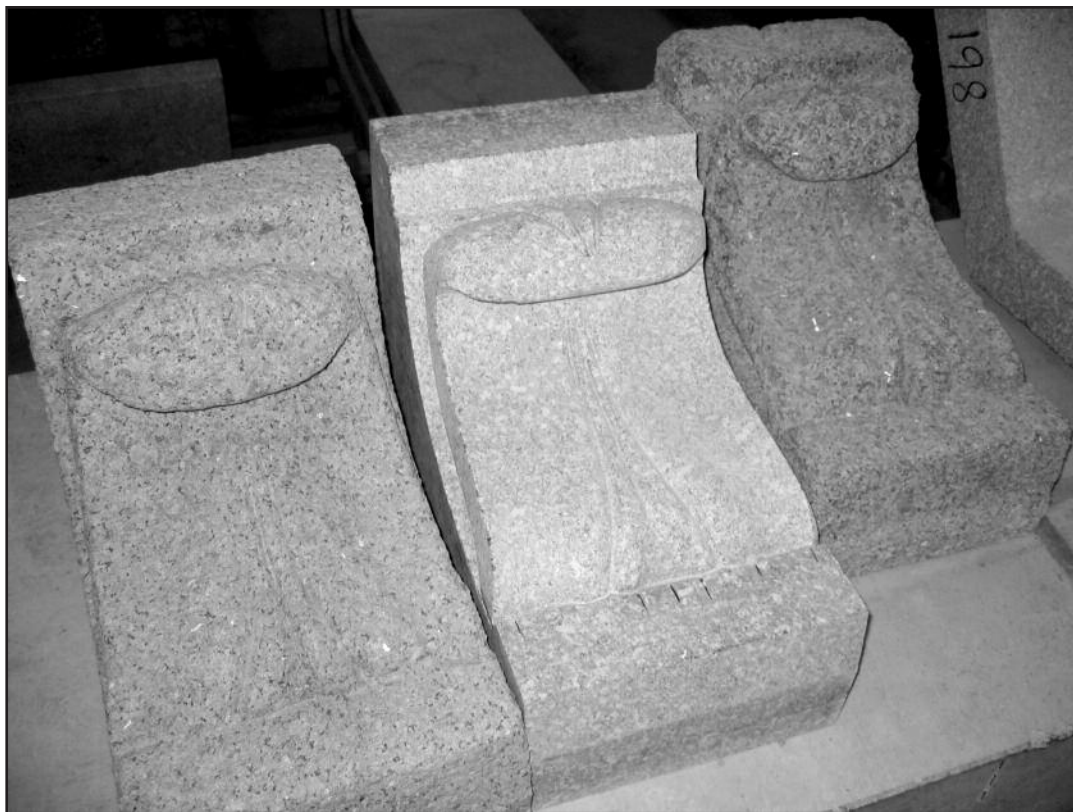
Figure 21 – Existing and new granite bracket during fabrication.

installation of both new and original stone, a first on such a large scale. A galvanized, welded steel tube skeleton was constructed of 3-in x 4-in tubes that new and existing veneer stones were attached to with stainless steel threaded anchors. New stone was cut approximately 3-in thick in a “hooker” pattern, which replicated the original stone configuration without additional joints as commonly seen on new panel systems (Figures 19, 21, 23, and 24).

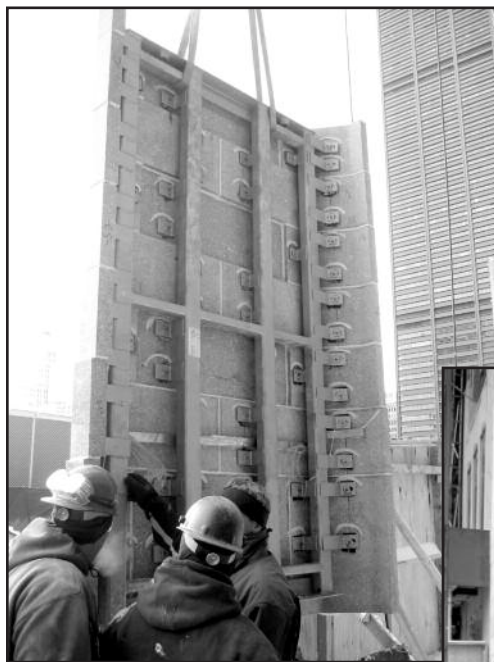
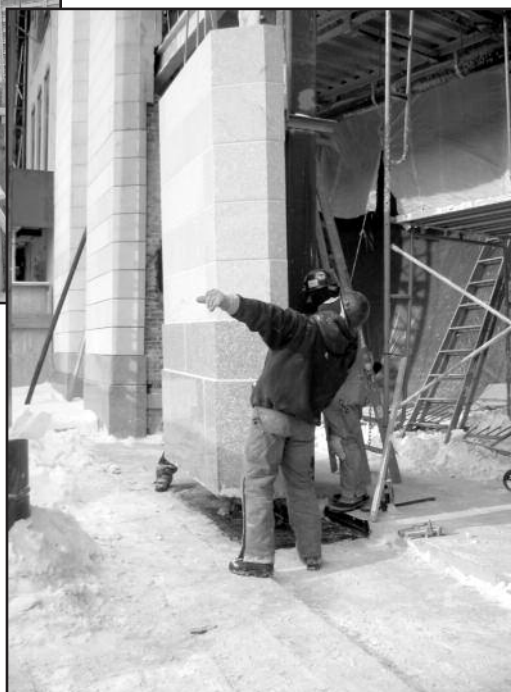
Figures 22A and 22B – New steel tube panels with stone facing installation.

An innovative, steel-framed panel system was employed to replace the heavily damaged granite base at the north elevation. This panel system met aesthetic (Figure 22) requirements, as it provided the

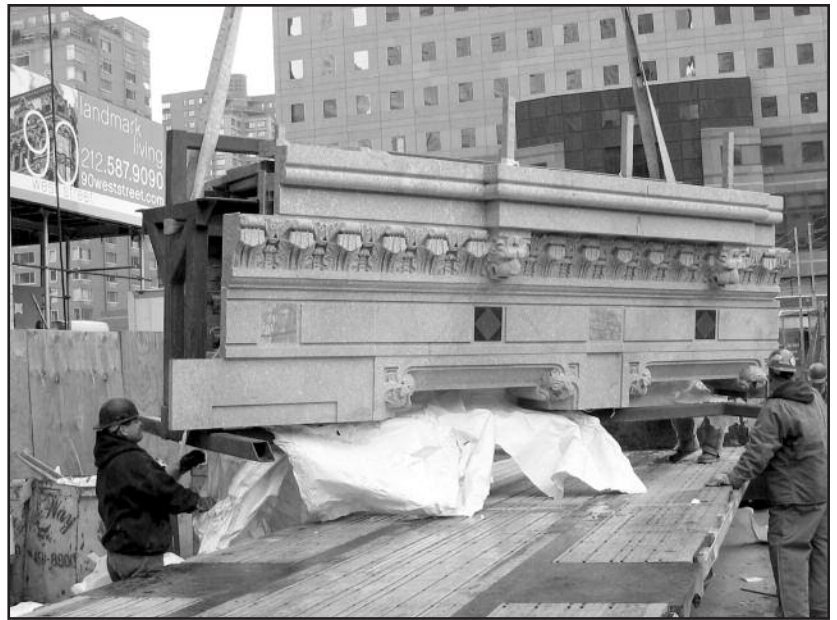
*Figure 23 – Granite panel hoisted from flatbed truck.*

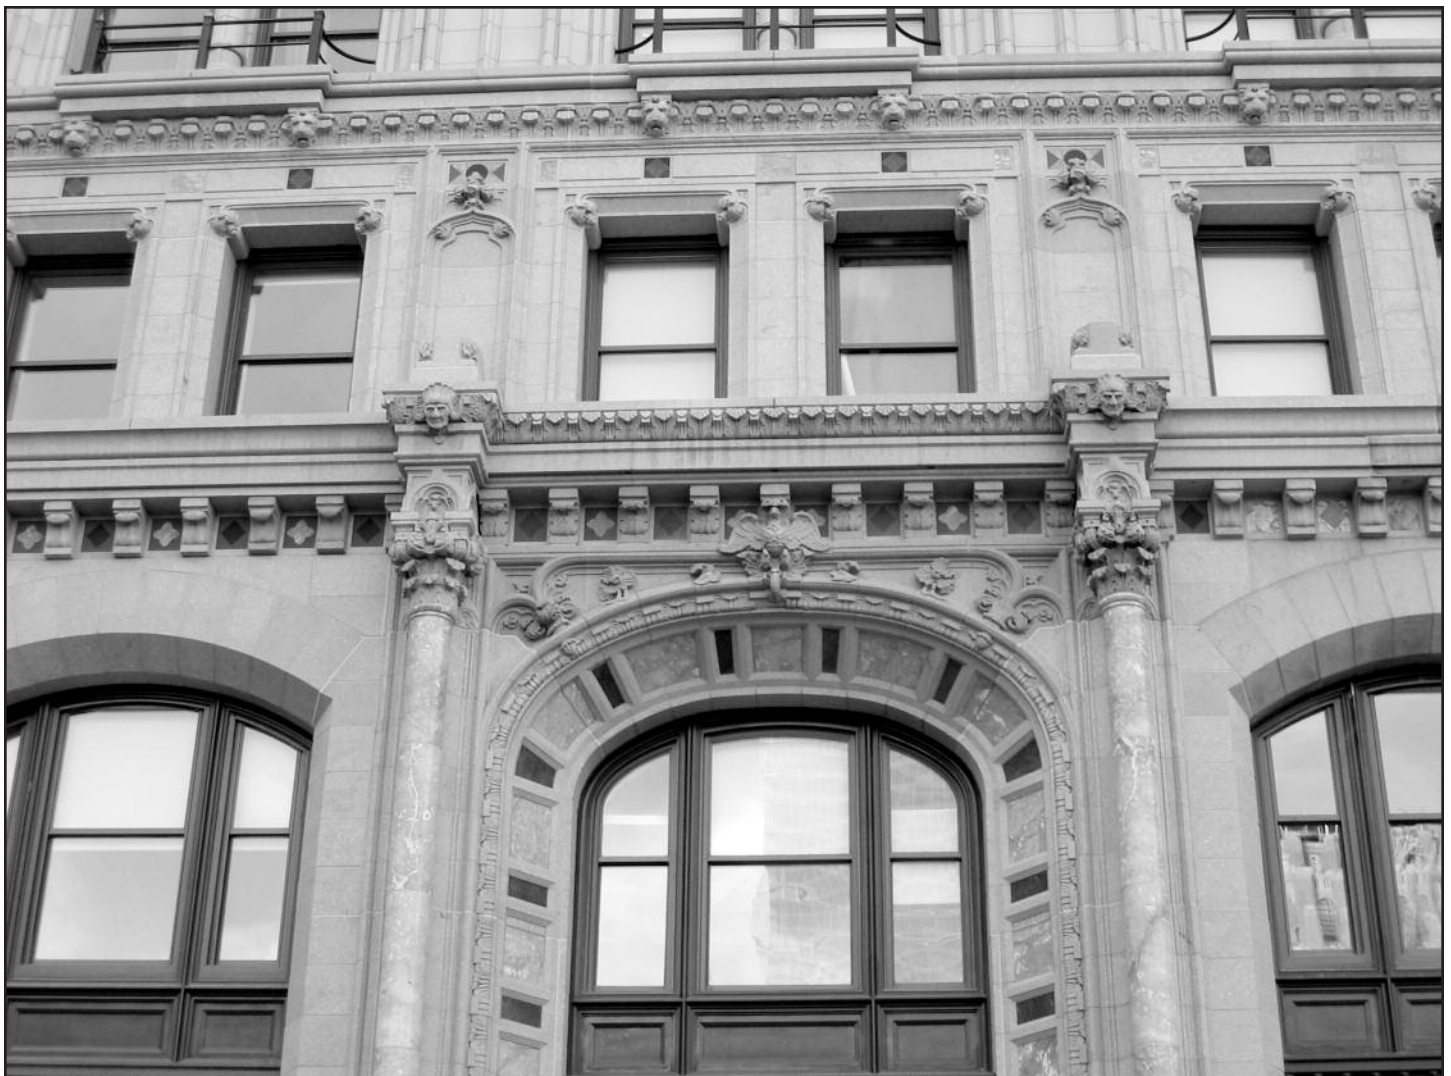
*Figure 24 – Completed project – northwest corner, December 2005. Completed north entrance arch where approximately 50% of the original granite was reinstalled after being refitted onto the new panels.*
