HISTORIC PRESERVATION FOR BUILDING ENVELOPES: ERDMAN HALL DORMITORY EXTERIOR REHABILITATION

JEFFREY S. LEVINE

LEVINE & COMPANY, INC., ARDMORE, PA

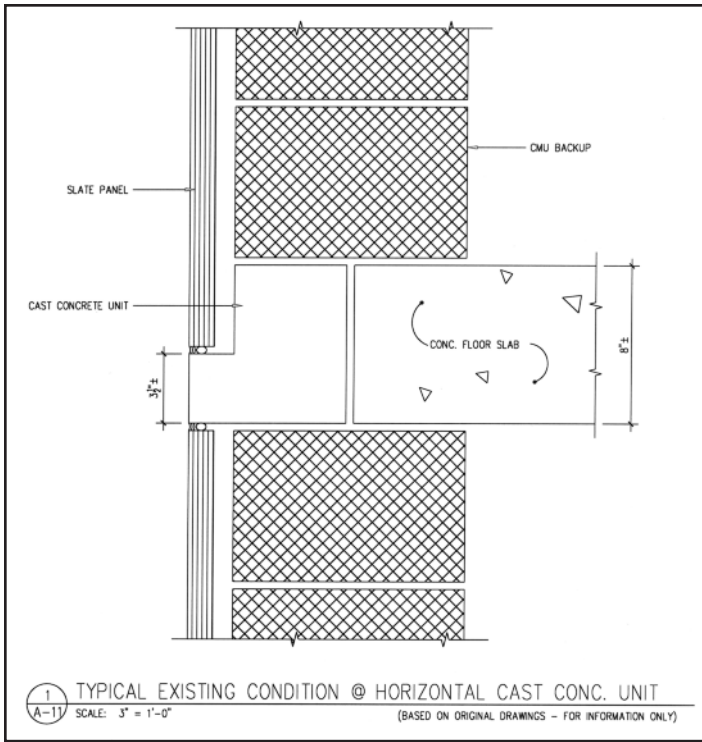
Figure 3 – Typical wall section.

In fact, one of the reasons Kahn only needed 16 sheets is that the building is put together in a relatively simple manner: a reinforced concrete frame and floor slabs with CMU infill and slate wall cladding (Figure 3). The slate wall panels were quarried in the soft-vein district of

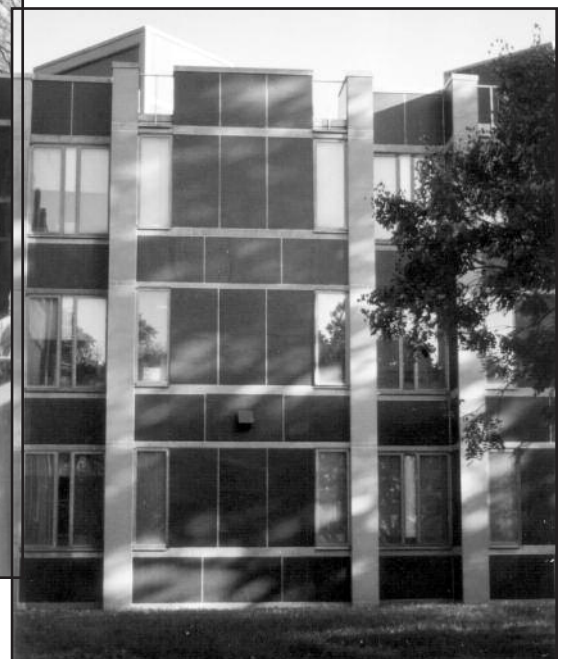
- Curbs at the openings (embrasures) in the parapet were raised approximately 4 inches to obtain an 8-inch base flashing height (Figure 16). This change, although visible from grade, is not recognizable as such because there is no reference point for comparison. That is, there is no “before” view and the 4-inch difference in height is not enough to capture the eye (Figures 17 and 18).

Figure 18 – Embrasures after rehabilitation.

had been done before, probably in the 1980s (Figure 19). To help mitigate the chance of leaks at the window heads below, the aluminum cladding was carried around to cover the slate panels on the parapet end walls as part of the rehabilitation (Figure 20). Again, this change is visible from grade, but the color and gloss match to the slate is so good that it is not noticeable (see Figure 18).

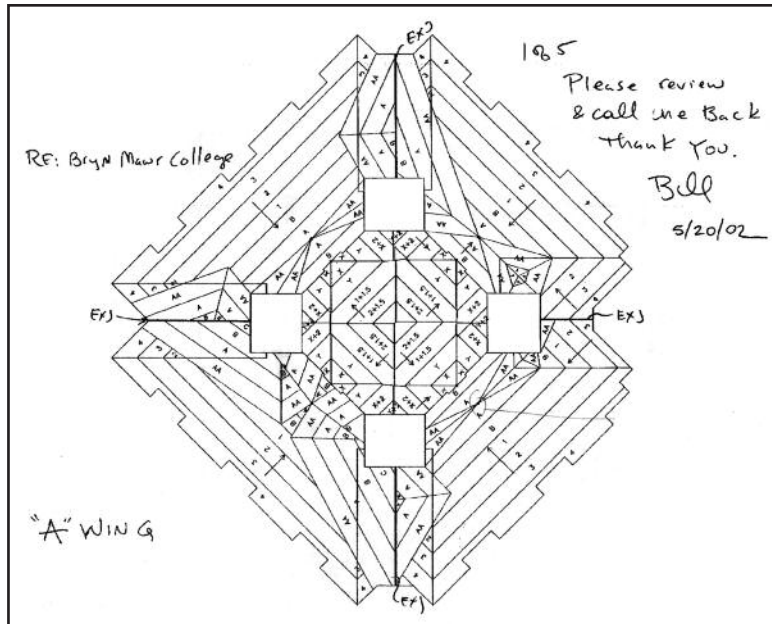
sives was chosen for re-sloping the concrete roof deck after some test panels and much debate about using mechanical fasteners. Lightweight concrete was also considered, but, in the end, it was felt that there was insufficient time available to wait for the concrete to cure fully. After several go-rounds, the final tapered insulation layout plan developed for re-sloping the 10,000 square feet of roof deck in each wing vastly improved each roof's drainage (*Figure 24*). In the end, however, ponding could not be completely eliminated, due primarily to restrictions imposed by curb heights at the embrasures in the parapet. The slight bit of ponding that remained will

Figure 24 - Tapered insulation plan.
