# ENEMIES OF THE ROOF

BY JOHN W. WELLS, RRO

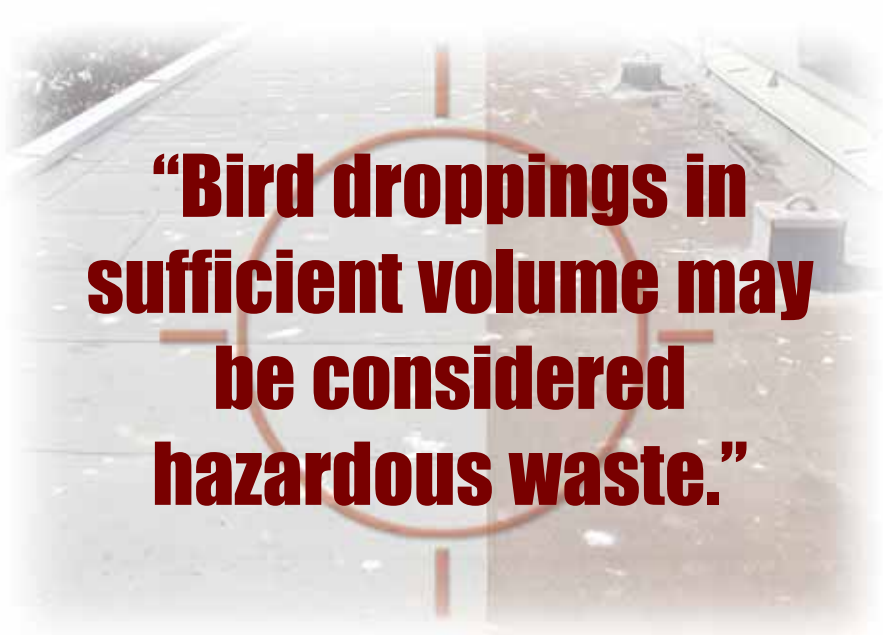
*There is a significant objectionable odor on the roof, which is exacerbated after*

*the short (to early August) periods of rain experienced. The odor is easily picked up by the building air intakes and distributed in the building. Since this report was commenced, more significant rain has been experienced, and dilution and some washing have taken place. The membrane damage has, however, been done, and major steps to repair and pro-*
