# THE DAY AFTER:

## Documentation of Damage to Roofs from a Hailstorm and the Subsequent Restoration Efforts

By Karl A. Schaack, RRC, PE

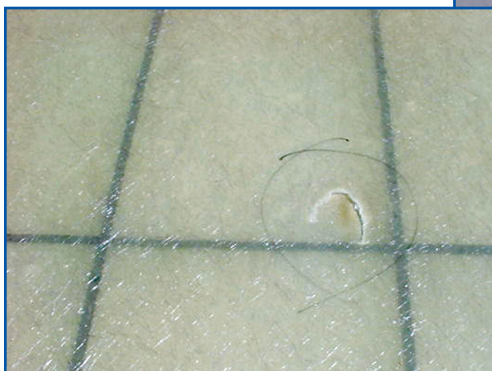
Damage to skylights included fracturing of glazing material (i.e., fiberglass and acrylic). See *Photos 14* and *15*. Large punctures and holes completely penetrated the glazing material (*Photos 16* and

*Photo 14 – Fracture in fiberglass skylight.*
