Multidisciplinary Historic Rehabilitation of Rockefeller Memorial Chapel

By Donald Kilpatrick and Barry O'Quinn

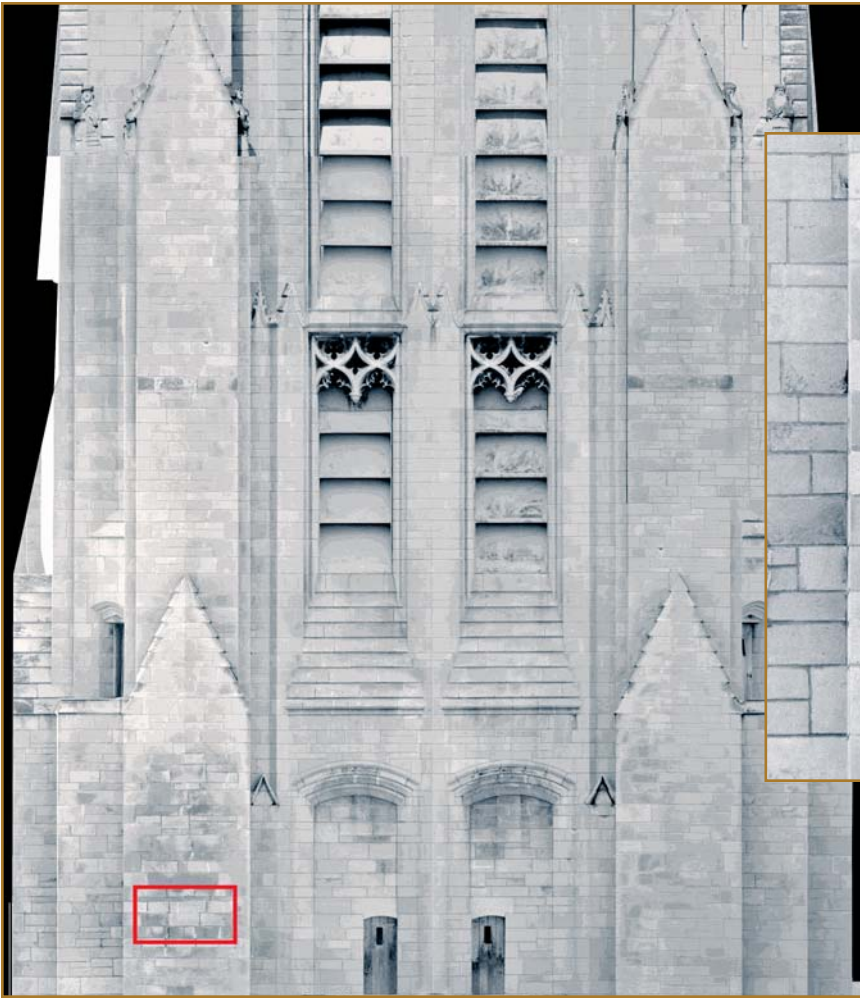
Photo 6 – Digital photogrammetry of partial east tower elevation.

In the absence of a full complement of original building drawings, digital photogrammetry was selected as a means to record present-day condition indices and was subsequently utilized as the primary method to graphically impart site-specific work scope locations and limits to the bidders (Photo 6). The high-resolution photography delivers a permanent record of building and can be integrated with AutoCAD, accommodating manipulation of the images in full and partial elevations. The graphic representation derived from the photogrammetry yielded a significant reduction in cost over traditional methods of delivery (line drawings) while achieving unsurpassed interpretive quality of the building's varied features. Using the images, the engineering staff was able to view the building stone-by-stone, locating and cataloging over 4,000 individual units requiring varied repairs ranging from wholesale replacement to injection and patching (Photo 7). [Editor's note: See "Digital Close-Range Stereophotogrammetry for Heritage Recording: The Impact of Responsible Measurement," by Peter Belden Trieb and Don Kilpatrick, *Interface*, November/December 2004.]

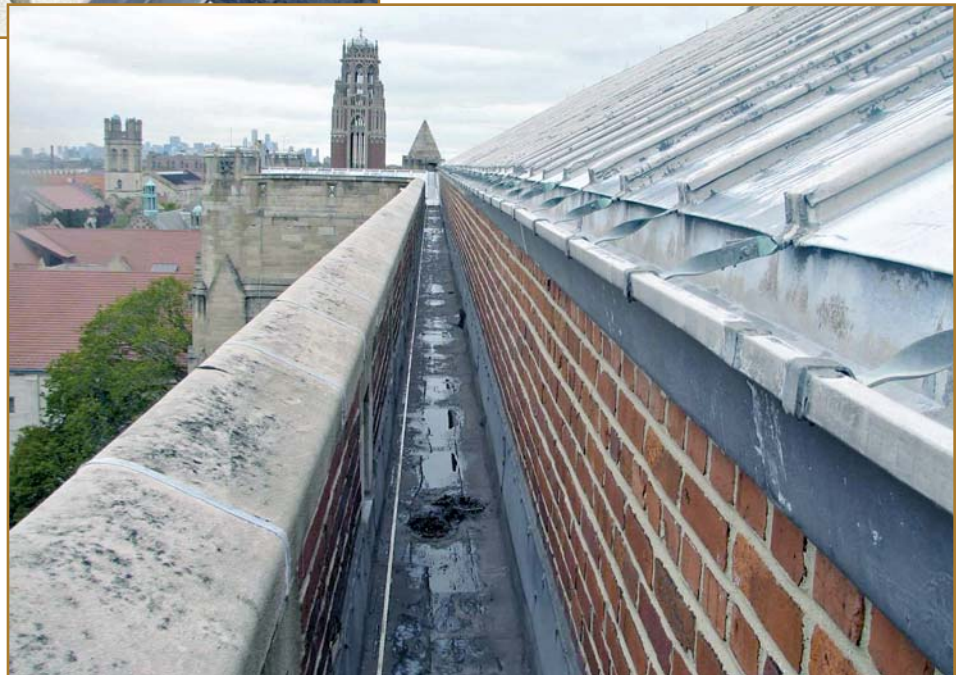
Photo 9 – Typical integral gallery at the east and west sides of the nave (below).

Integral gutters or long, narrow gallery roofs are present between the lead-coated, copper batten-seam roof of the nave and visible from grade parapet wall condition (Photo 9). These roof areas are served by wall-mounted exterior/interior drain heads that are routed to the attic, where they are combined with attached downspouts from the nave roof above. Revisions to the building drainage will require select demolition and reconstruction of the parapet wall features to accommodate new drain-head elevations at a level that will ensure the required 1/8-in-per-ft slope on new laterals on the attic interior from the south end of

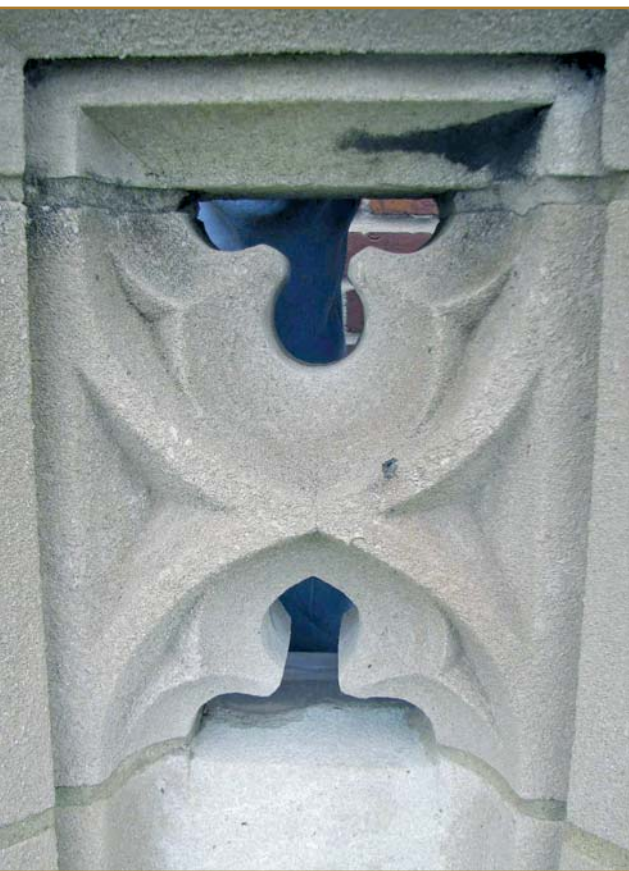
Photo 10 – Carved stone central to the three-stone set establishing the portal openings.

set establishing the portal openings. The center stone will be removed and saw cut, salvaging the stone surrounding the opening, and new pieces of similar ornamentation (less the opening through the wall) will be carved and set as infill. This will accommodate the final revised height of the finished integral gutter assembly, assuring positive slope to drain (*Photos 10 and 11*).

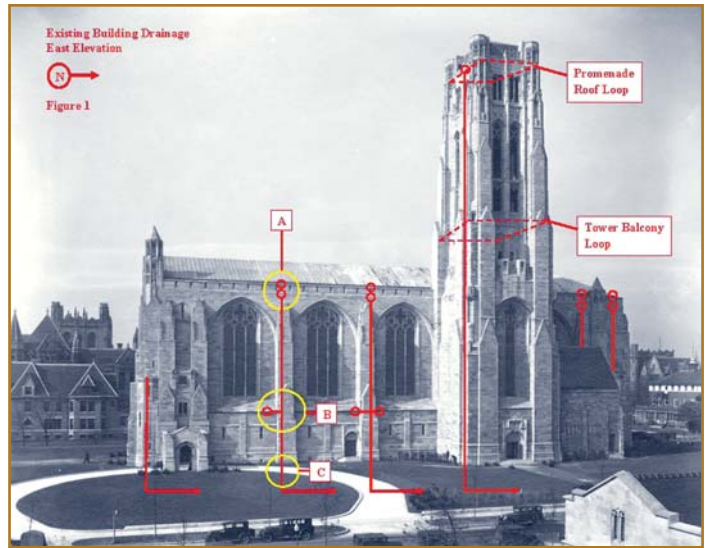
Figure 1 – Existing building drainage, east elevation.

high parapet walls (*Figure 1, Condition A*). Both drain heads are routed to the nave attic interior, where accessory lead-coated copper piping is interfaced with the cast-iron risers, continuing into the masonry walls at the base of the vaulted ceilings. The risers continue down the interior side of the buttress and turn toward the building exterior, where the piping follows the contours established by the steel-reinforced, poured concrete deck for the stone weathering. The stone weathering roof areas are served by lead-coated copper gutters with one drain per segment on each side of the buttress as presented on the building exterior (*Figure 1, Condition B*). These drains are combined with the single riser dedicated to the nave drains, and again are presented, with cleanouts, at regular intervals in the basement (*Figure 1, Condition C*).

Figure 1, Condition A – Original drawings reflecting the current configuration of drain heads serving the nave, lead-coated copper batten-seam roof assembly, and the integral gutter combined into a common riser.

Figure 1, Condition B – Original building drawing section at the juncture of the stone weathering centered between the buttresses, reflecting approximate location of drain risers through the changes in plane.

Figure 1, Condition C – Typical drain leader exiting the buttress as presented in the basement.

Understanding that the combined nave riser and stone weathering drainage layout could not be replaced in kind, the new design focused on provisions that would accommodate the installation of a

new system without requiring disruption of interior finishes. Design parameters must also acknowledge ease of installation and end use with respect to future maintenance and servicing. The resultant design maximizes the opportunity presented in the attic of the nave combined with available chase locations for risers on the north end of the building interior (*Figure 2, Revised Building Drainage*). An initial survey of the attic interior indicated the available tolerances between the base of the ceiling vaults and upper limits of the interior masonry backup wall were adequate to establish new lateral runs at

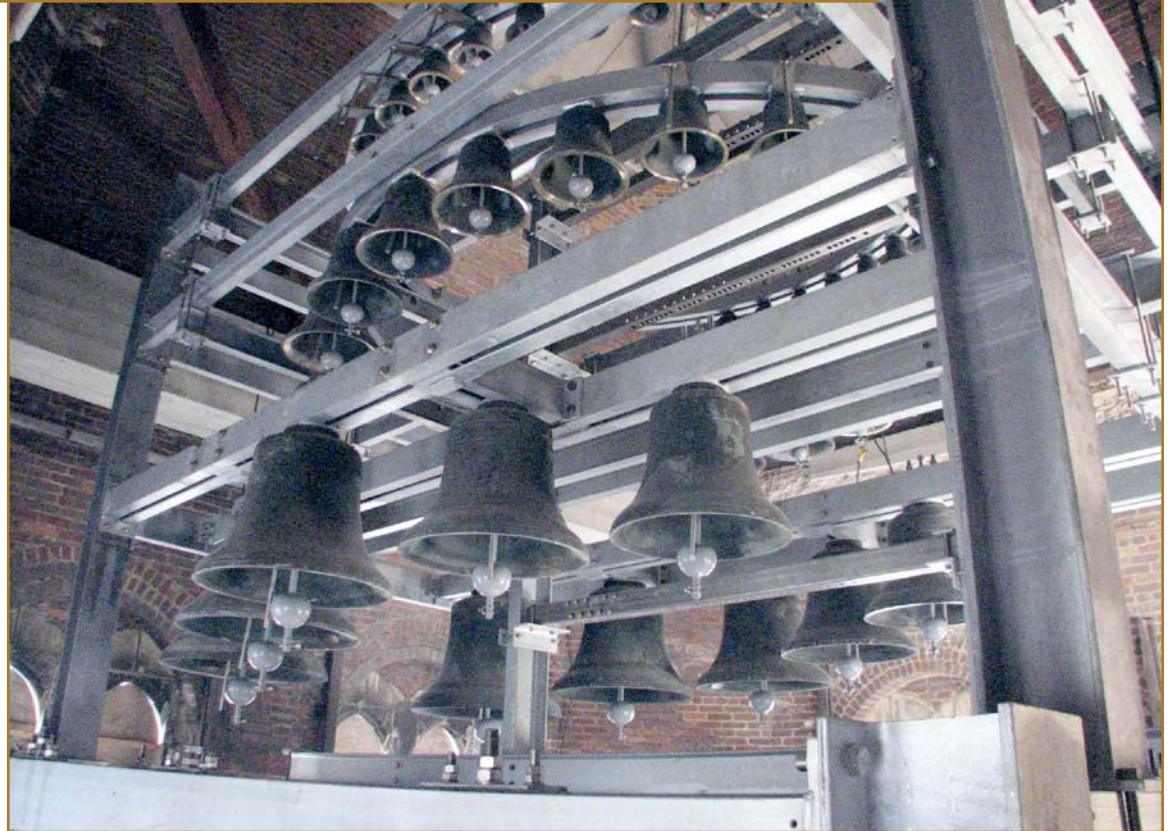
Photo 19 – Restored bell array above the playing cabin on the tower interior.

interfaced with the floor slab, projecting through and above the roof line of the cabin (Photo 19). Removed from past alterations to the once-operable louvers, occasional upgrades and repairs to the workings of the instrument, the carillon, and playing cabin
