POST-9/11 RESTORATION OF THE EXTERIOR OF 90 WEST STREET, NYC

By Richard W. Lefever, PE, LEED AP and Mark Anderson, AIA

ABSTRACT

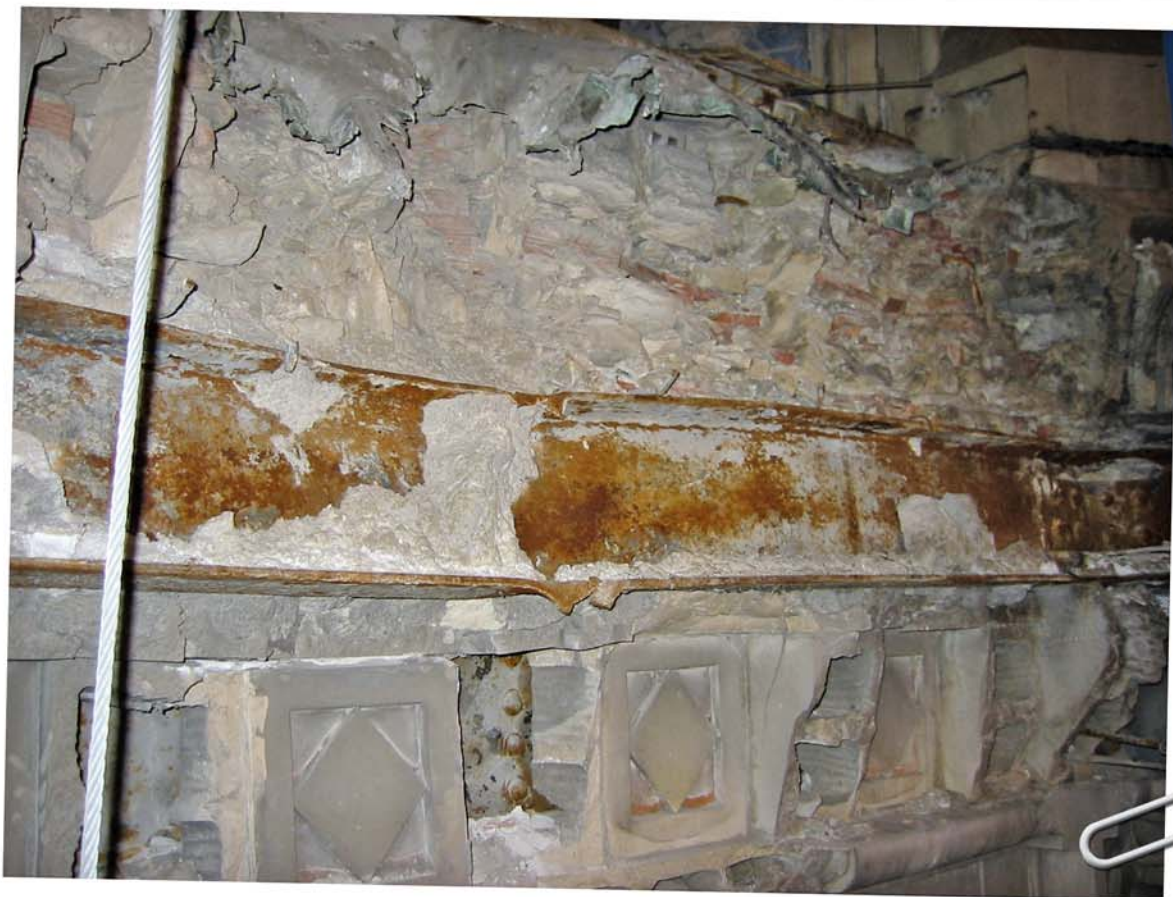
Figure 7 – North façade. Impact damage crushed terra cotta and bent and nearly sheared through a steel spandrel beam.

The majority of the façade is of ornamental, hand-pressed terra cotta with brick backup. The north elevations sustained the most severe deterioration from impact and fire. The façade was completely missing at several locations, due mostly to impact (Figure 7). Fire damage originated from both the interior and exterior at all elevations.

The brick was cleaned with Light Duty Restoration Cleaner (Prosoco), and the terra cotta was cleaned with Lemon Joy dish-washing liquid and warm water. Loose and unsafe areas of the façade needed to be removed and shored up before work could begin (Figures 6 and 7). Access to the façade was gained through an elaborate assortment of pipe and swing scaffolding and mast climbers.

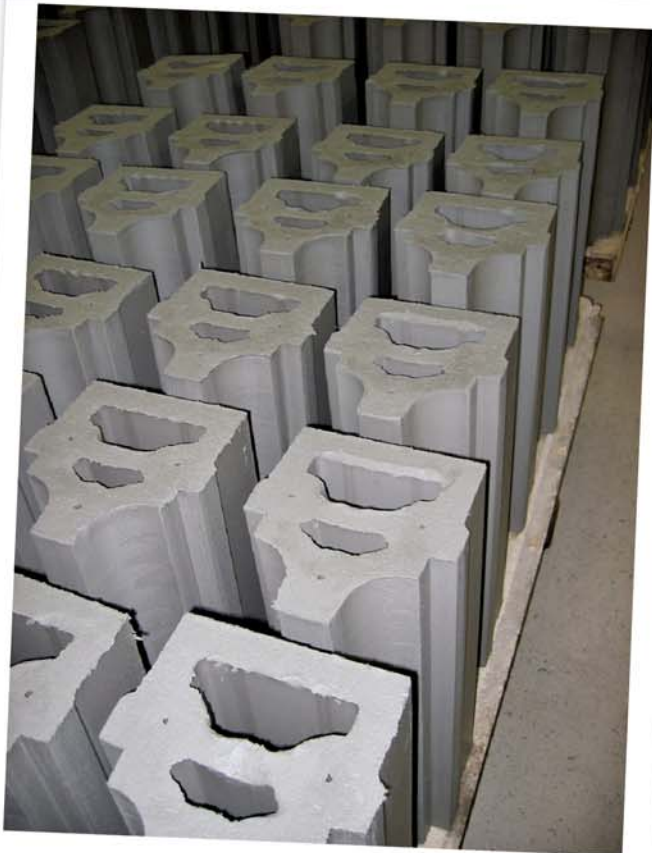
Figures 9A and 9B – New terra cotta was manufactured by extrusion and hand pressing.

- The large quantity of terra cotta replacement permitted many of the new pieces to be extruded, with the remainder being hand-pressed or hand-sculpted by Boston Valley Terra Cotta. In all, 7,853 pieces were replaced.

- A total of 80,000 bricks were custom manufactured by Belden Brick to match the existing courtyard face brick. The bricks were a special 8.25-in length and unique buff color (Figure 9A and 9B).

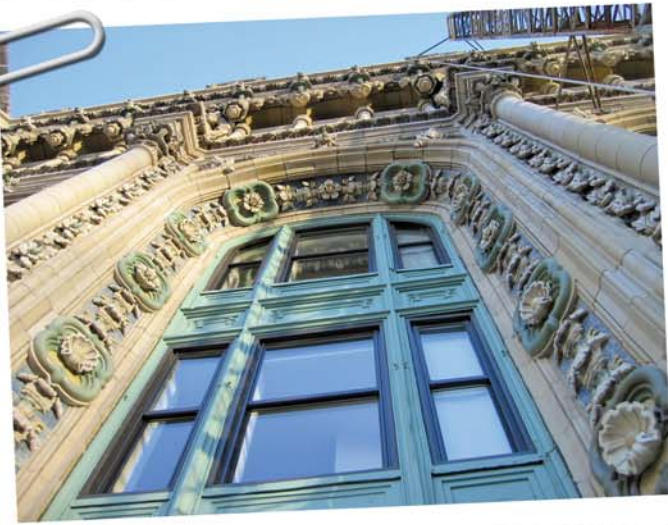
Figure 11 – Completed restoration of devastated area at top of north elevation.

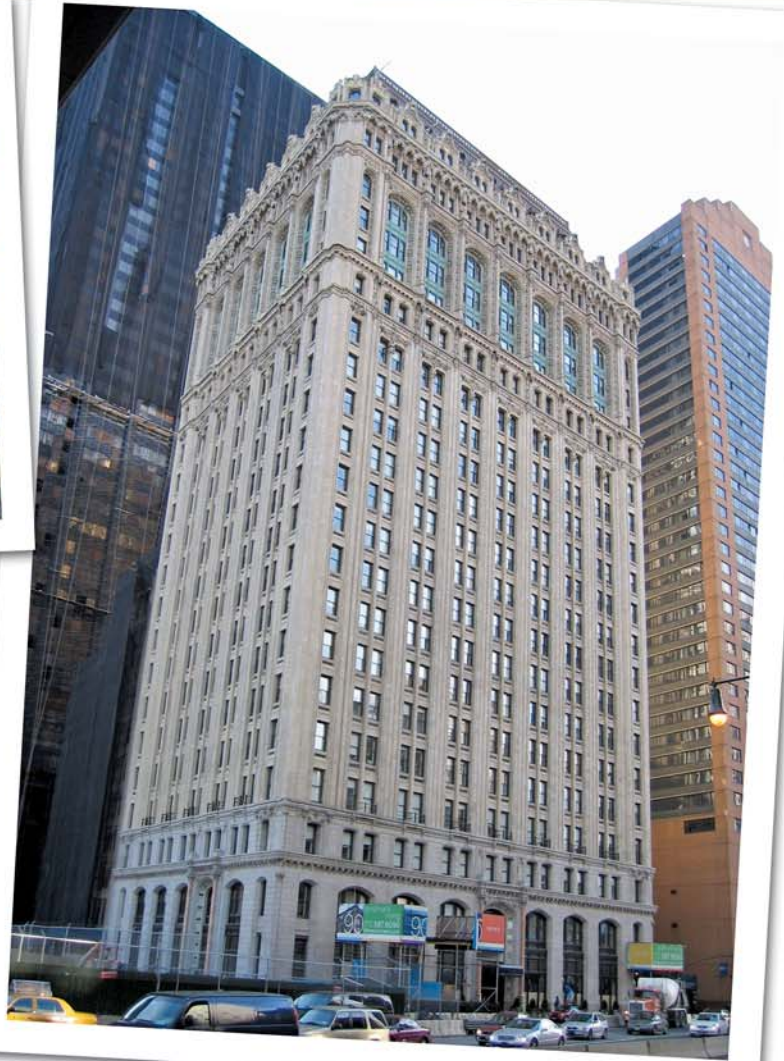
Figure 12 – Completed restoration at north and west elevations.

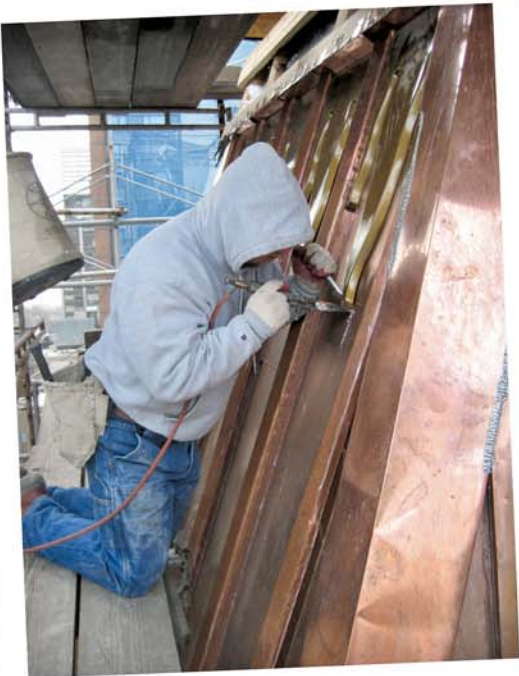
Figure 15A – Craftsman solders new icicles.

- The copper mansard was removed down to its cinder fill substrate, and new batten-seamed copper was laboriously installed by Eagle One Roofing to match the original roof (Figures 15A, 15B, 16A, and 16B).
- The entire balustrade was replaced with custom fiberglass panels by Seal Fiberglass (Figures 15A and 15B).
- The 23rd floor dormers were replaced with copper, while the 21st and 22nd floor dormers were repaired with copper wherever necessary.

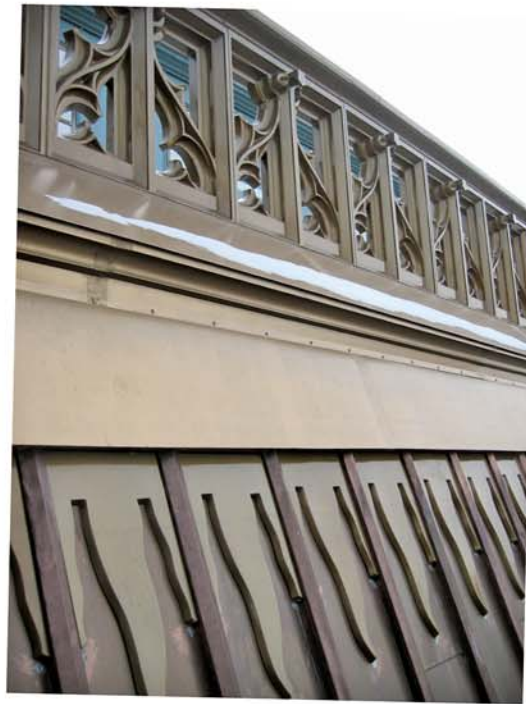
Figure 15B – Completed mansard roof with new fiberglass balustrade and icicles.

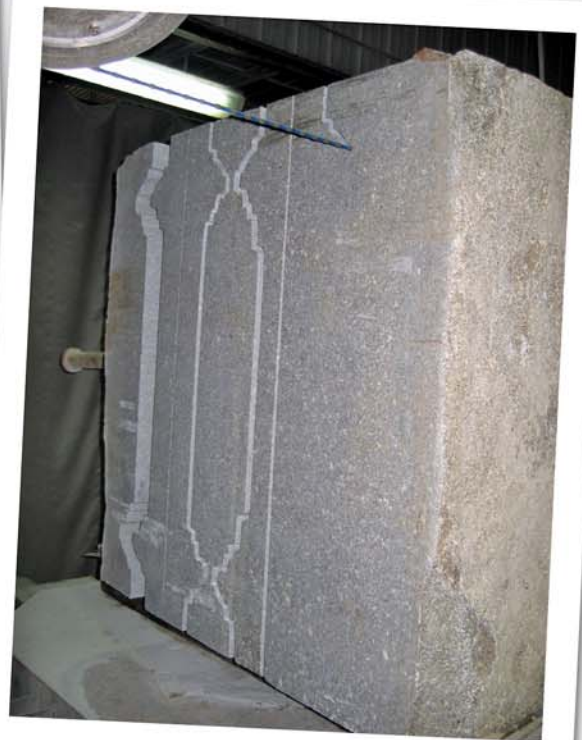
Figure 20 – New granite was custom cut in Canada by computer-guided saws.

Eighty percent of the north elevation granite base needed to be removed due to excessive impact and fire damage (Figures 17A, 17B, 18, and 19). New ornamental stone was expertly cut and carved in Canada and Italy (Figure 20).

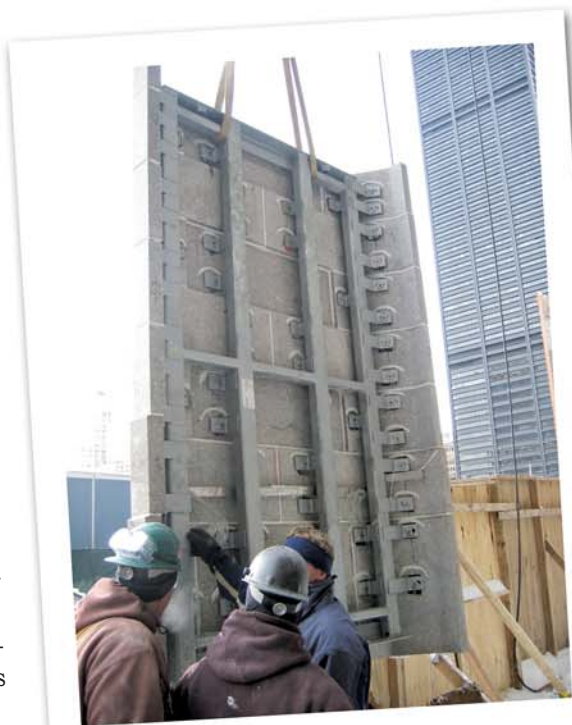
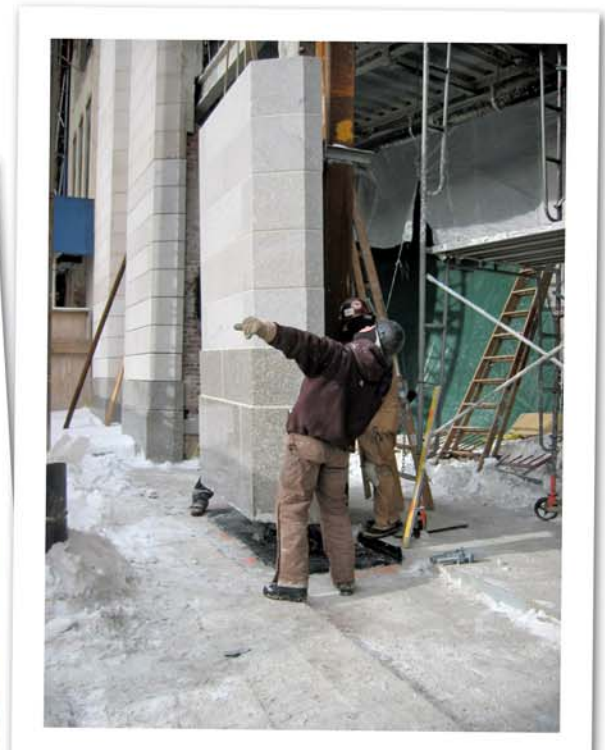
Figures 22A and 22B – New steel tube panels with stone facing installation.

An innovative, steel-framed panel system was employed to replace the heavily damaged granite base at the north elevation. This panel system met aesthetic (Figure 22) requirements, as it provided the installation of both new and original stone, a first on such a large scale. A galvanized, welded steel tube skeleton

was constructed of 3-in x 4-in tubes to which new and existing veneer stones were attached by stainless steel threaded anchors. New stone was cut approximately 3 in thick in a “hooker” pattern, which repli-

cated the original stone configuration without additional joints, which are commonly seen on new panel systems (Figures 19, 21, 23, and 24).
